# **Kuthai Lake Access Improvement Assessment - 2016**

March, 2017

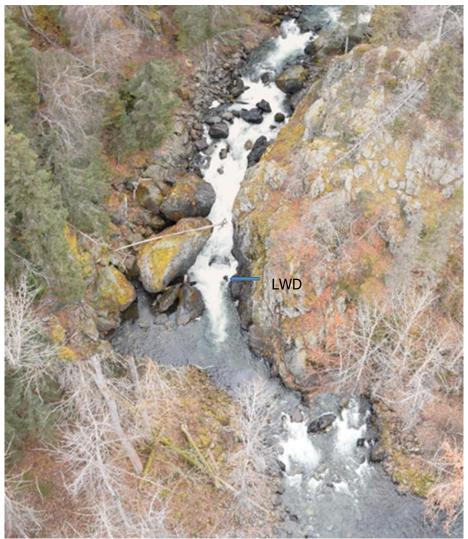
Photo 5: An aerial view of the confluence pool and upstream cascade section of rated obstacle SR-1-1.

**SR-1-1 (The "Confluence" pool)**: This obstacle is the first in the series of steps along the channel profile. The staging pool is confined on river left by the bedrock wall and on river right by a boulder cluster. The staging pool has several instream boulders at the cascade/pool transition point that likely reduce sockeye jump performance. There is a piece of large woody debris at the transition point that may also hinder passage. The cascade section above the pool has very high Reynolds roughness which gives it extremely turbulent flow and high rates of air entrainment that can have a negative effects on salmonid swimming performance. The overall length of the cascade (from the transition zone to the first upstream holding area) is

approximately 25 meters with a vertical rise of about 3 meters. At a gradient of approximately 12% and with supercritical flow this section is a velocity and turbulence obstacle with potentially obstructing LWD.

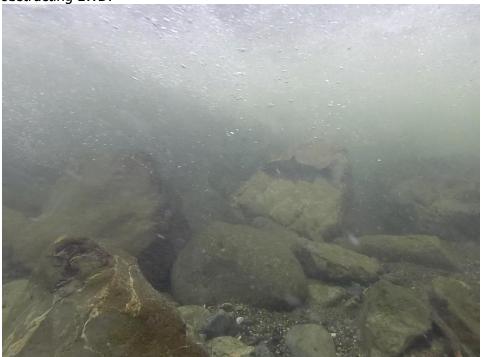
Photo 6: Underwater photo of the Confluence pool staging area showing boulder obstructions. Photo date: July 26, 2016.

Opportunistic monitoring by TRT Fisheries indicates that the ratio of jump attempts to successes may be quite low from the staging pool to the holding water above the cascade. Tagged sockeye have also been observed to back out of the staging pool and return to hold in the main stem. The subsurface photo above shows a number of medium sized boulders immediately (approximately 0.5 meter B axis) downstream of the transition from cascade to pool. These boulder clasts may limit the staging pool dimension and have a negative effect on jump performance. The overall assessment of section SR-1-1 is that it is a complex obstacle with limited staging pool dimensions, potentially obstructing LWD and an upstream cascade section with turbulence and velocity issues. The coarse textured sediment in the cascade section reduces the flow cross sectional area since much of the flow is interstitial.

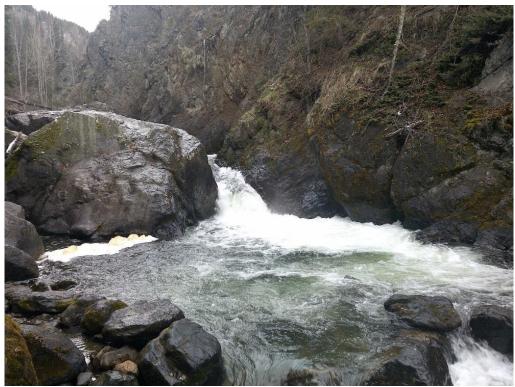
**SR-1-2 (The "Foam Pool"):** SR-1-2 is a bedrock controlled jump height obstacle at a pinch point spill between a large boulder and the canyon wall. The obstacle jump height is approximately 2 meters vertical over a distance of 2 meters horizontal. Most of the flow is contained to this spill point but there is some interstitial flow at river right. This site has a deep staging pool that should provide good jump performance. Photo 8 is an underwater shot of the staging pool below the plunge point. The photo shows a deep staging area without major obstructions. The overall assessment of SR-1-2 is that the staging pool is deep and relatively unobstructed which should result in good jump performance and minimal passage issues.

Photo 7: Section SR1-2, the "Foam" pool.

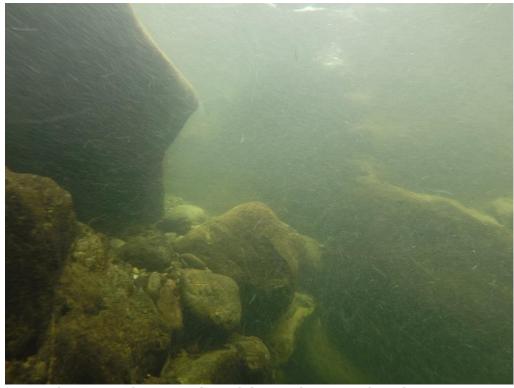
Photo 8: Underwater view of the staging area of section SR1-2.

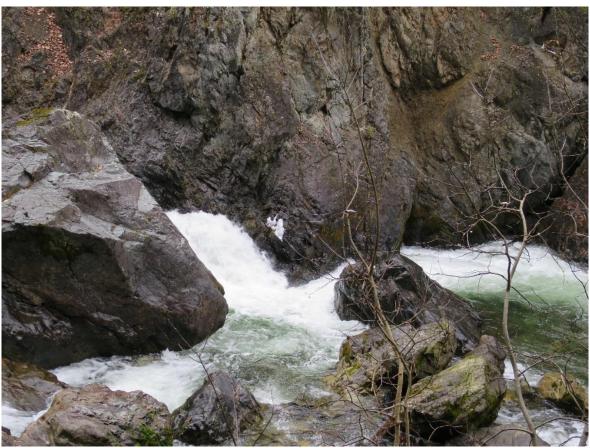
**SR-1-3: The "Angle" pool**: SR-1-3 is an obstacle formed in the pinch point between the canyon wall and a large boulder. There is also some surface flow on river right that may be passable at higher stage. The staging pool has a massive boulder directly in line with the spill point which limits the dimensions of the staging area. The jump height is approximately 2.2 over a horizontal distance of 2.0 meters. There is a small holding pool (approx. 6m²) below the staging pool and a larger holding pool above (approx. 30m²). The top of a piece of large woody debris (LWD) can be seen wedged into a rock on river left 5 meters below the plunge. The butt of that piece of LWD appears to span the staging area and can be seen in the underwater shot below. Given the tight space in the staging pool it is likely that this piece of LWD is obstructing the staging area. The overall assessment of this obstacle is that the staging pool is limited in size by the obstructing boulder but, judging from the underwater video, the staging pool appears to have good depth which should allow for good jumping performance. The obstructing LWD could be assessed at lower stage and removed if possible.

Photo 9: The "Angle" pool (SR-1-2). A submerged piece of LWD may be obstructing this staging area.

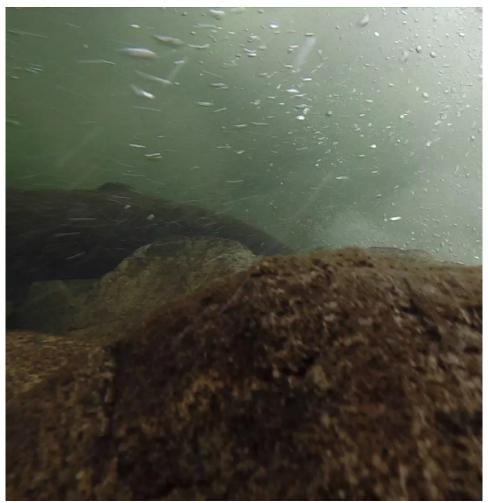
Photo 10: Underwater photo at the Angle pool indicating a piece of LWD (center left) potentially obstructing the staging area.

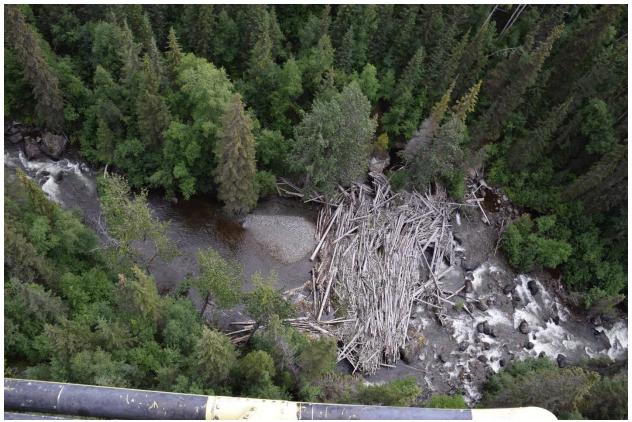
Photo 11: A LWD jam in the middle of the alluvial reach. The jam is stable, with several high flow channels through the trees on river left and right. There is a small sediment wedge stalled ahead of the jam that is one of the few instream mobile sediment sources.

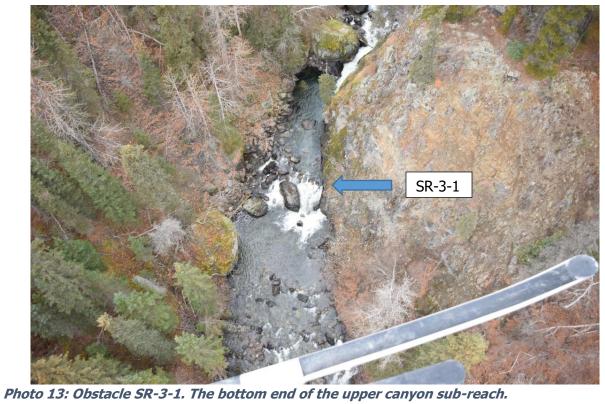
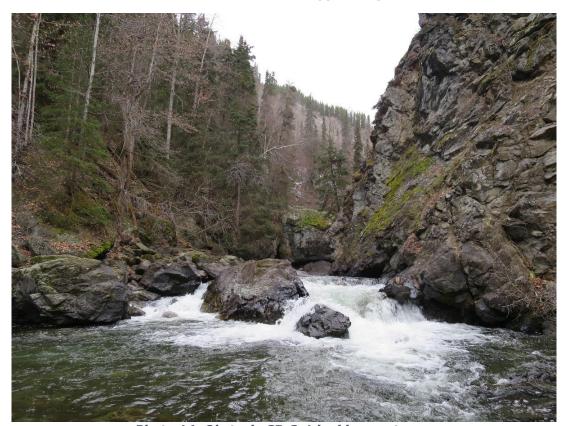
**SR-3-1**: Moving upstream from the bottom of sub-reach 3 the first obstacle is SR-3-1, a short cascade section with a cluster of boulders obstructing the plunge pool. The jump height required is 1.5 meters over 2 meters of horizontal distance. The staging pool is obstructed with a cluster of boulders. There are three potential passage points on this section that may provide additional fish passable options at higher flows.

Photo 14: Obstacle SR-3-1 looking upstream.

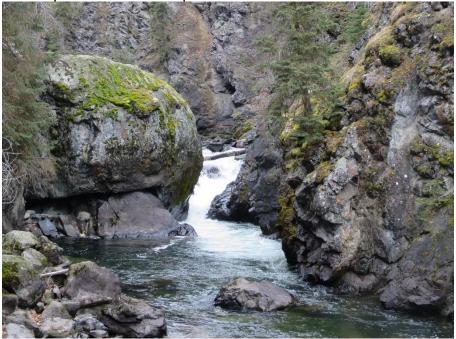
**SR-3-2**: This obstacle is called the "Tank" pool given the great depth of the staging pool. The staging pool is estimated at over 4 meters deep. This is a good holding pool with abundant depth cover. There is a short cascade section immediately above the tank pool. It was not possible to get into the tank pool with the underwater camera but looking at it from several angle the pool is likely over 4 meters deep.

Photo 15: The cascade section above the Tank.

The tank pool provides good quality holding water for migrating fish that is very deep and unaccessible to bears. The pool should provide for good jumping performance. More information on jump attempt and success ratios would be useful to confirm the status of the feature as a potential obstruction but at this point it appears quite passable and doesn't appear to have any obstructing LWD or boulders. A closer look during low flow conditions (April) will be necessary to confirm the assessment.

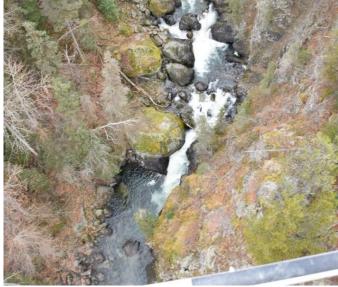
Photo 16: The Cascade above the Tank from the air.

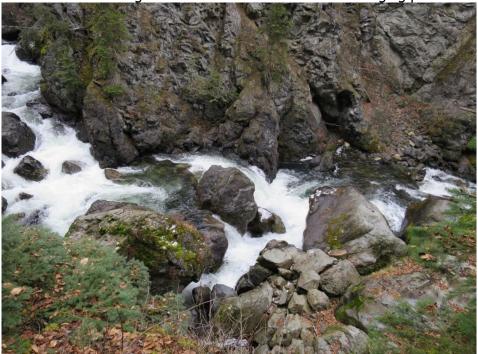
Photo 17: Obstacle SR-3-3

**SR-3-3:** Obstacle SR-3-3 has three spill points across an upstream crest of large boulders. The pool to pool jump height is approximately 2.5 meters. The main spill point has a boulder cluster at the toe of the plunge that may reduce jump performance. The secondary spill points did not look passable at the late October stage although at higher discharges this may not be the case. Further assessment at lower stage will be useful to estimate if the staging pool can be cleared.

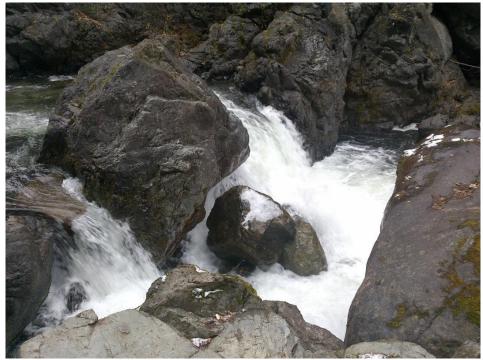
Photo 18: Close up view of SR-3-3. The staging pool is obstructed at the plunge with a clusters of boulders.

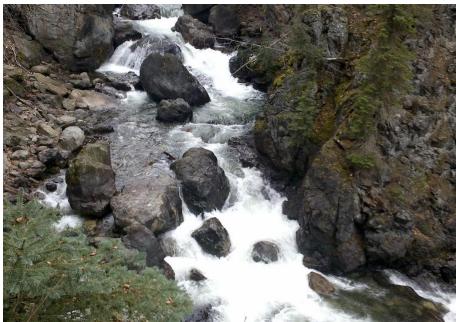
**SR-3-4 (Grizzlie Rock)**: This obstacle is called Grizzlie Rock as it is a favored feeding location. There are three main spill points, each of which may pass fish at specific stage heights. The main spill point on river left is a steep cascade about 5m long with a pool to pool jump height of 2.5m. The cascade on river left seems to the main choice for passage. Safety considerations did not allow for access with the underwater camera so the staging pool should be checked at low flow.

Photo 19: Grizzly Rock (SR-3-4) is a favored feeding location for local bears. Photo date Oct 27, 2016.

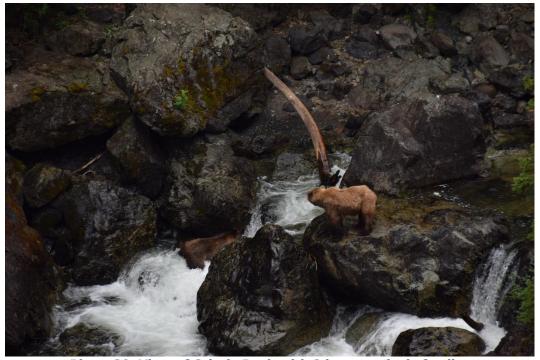
Photo 20: View of Grizzly Rock with 2 bears actively feeding.

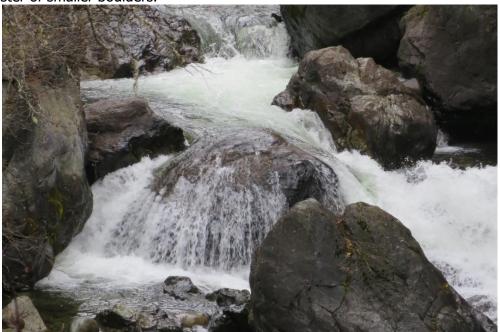
**SR-3-5 (The Mushroom)**: The "Mushroom" is the uppermost obstacle assessed. This rounded boulder has 1 main spill point and a couple of other spills on either side. The main spill appears to be the most commonly attempted passage location. The spill/ pool transition is obstructed with a cluster of smaller boulders.

Photo 21: The Mushroom (SR-5-5) from downstream.

Based on long term observations by TRT Fisheries this location is a difficult passage section. The staging pool obstruction forces fish to travel a long horizontal distance as well as the vertical jump height. This location could be surveyed at lower stage to determine if the staging pool can be improved. The main flow path appears to be obstructed by a cluster of boulders at the plunge point which may make for difficult passage conditions.

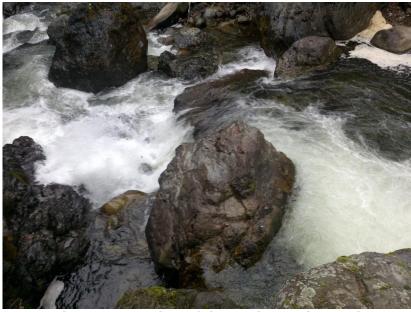
Photo 22: Top view of the Mushroom (SR-3-5).

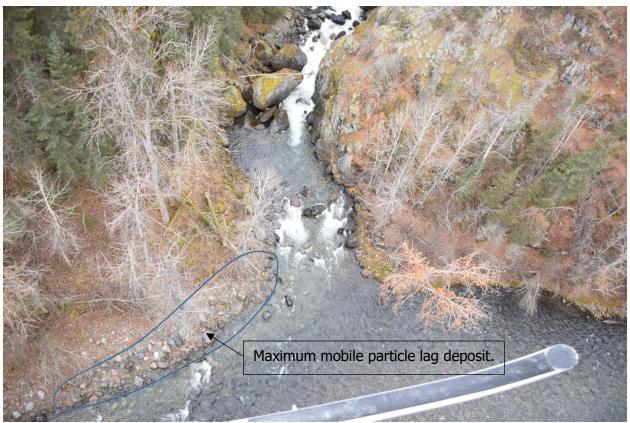
The next step is to develop a stream power estimate for the active channel. The channel reaches (SR-1 and SR-3) are very complex hydraulic environments due to large boulder step pool morphology, very high roughness and deep staging pools that make modeling very difficult. For this reason the stream power estimate is produced using published values for similar streams. Bunte (2010) published a summary of bankfull maximum mobile particle sizes for a range of small (wade-able at low flow) streams. The maximum bankfull mobile particle published for the most similar stream is 25.9 cm diameter (Stream: E. St Louis '03). A bed lag deposit was noted at the confluence of Nakina and Silver Salmon Rivers (See photo 23 below) which is also a reasonable estimate of the largest boulders that the modern hydrology can move. These boulders have been ejected from the canyon and stalled on the floodplain flat. The largest particle measured in the field from the lag deposit was 0.7 meters in diameter (B axis). This provides a range of mobile particle sizes that brackets the high flow range (bankfull to max discharge) for the current flow regime and indicates that the majority of the boulders in the canyon are stable. The high end of the range corresponds roughly with the 1:100 year modelled recurrence interval flow (22m<sup>3</sup>/s) from the discharge / recurrence plot. As a first order approximation of channel stability this suggest that the majority of key boulders in the canyon reach are immobile at any flow rate. Given the low sediment production of the reach this suggests that the canyon channel is very stable.

Photo 23: The lag deposit at the confluence of Nakina and Silver Salmon provides an estimate of the maximum mobile particle size for the Canyon Reach.

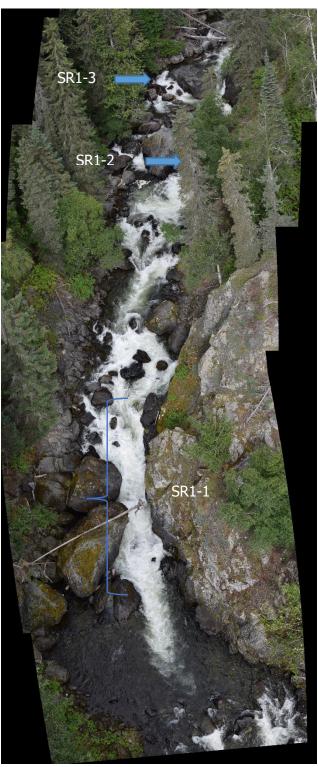
Photo A1: The three passage obstructions in the lower Silver Salmon canyon. Picture date July 2016.

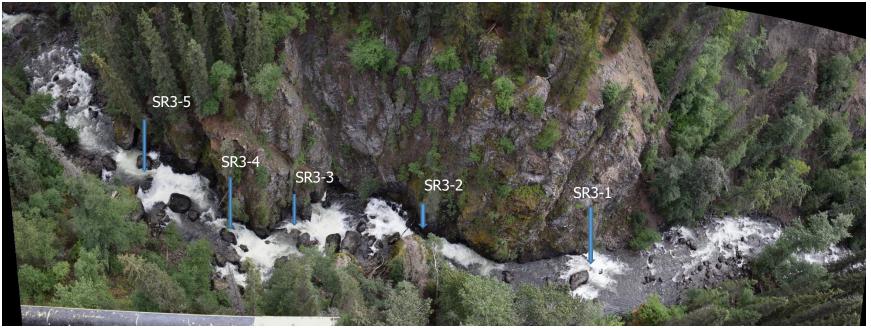
Photo A2: The upper Silver Salmon canyon obstacles. Photo date July 2016.
