# **ATNARKO SPAWNING CHANNEL**

## **INTAKE FLOW PROJECT**

**Prepared for; The Pacific Salmon Commission**

**July 19, 2008**

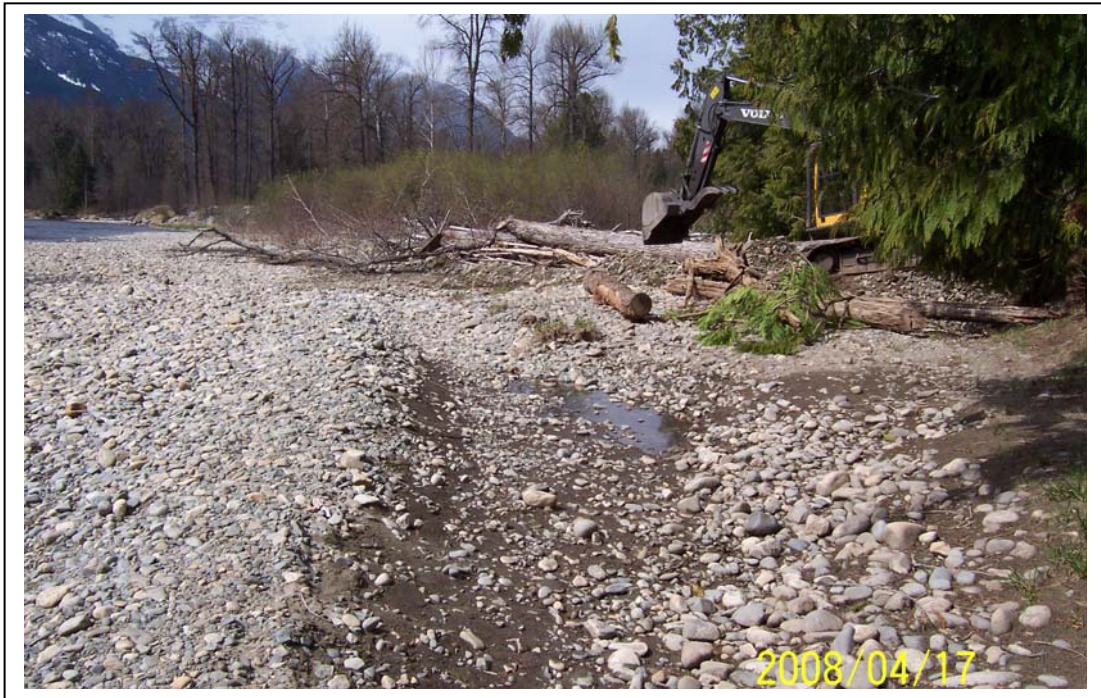
To accommodate increased intake volume the debris and gravel bar blocking the intake channel was removed.

**Figure 2. Intake channel befor construction**

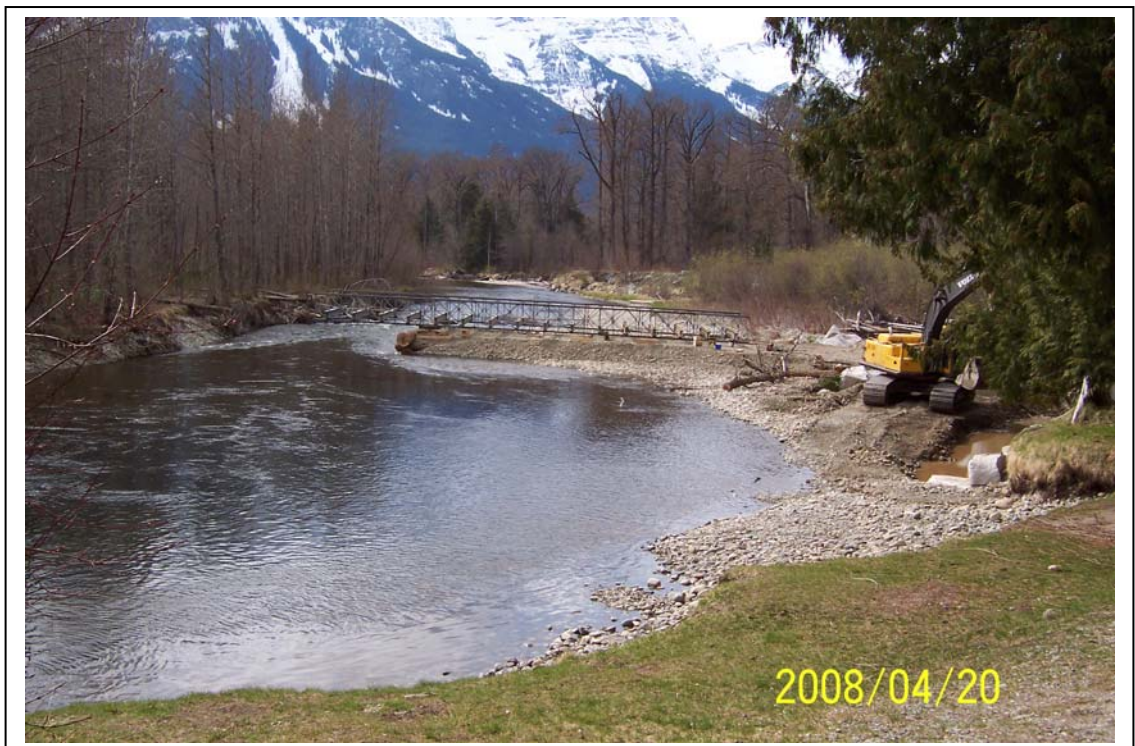
**Figure 3. Bridge construction across the Atnarko River, excavator is beginning intake channel reconstruction and rock armor placement.**

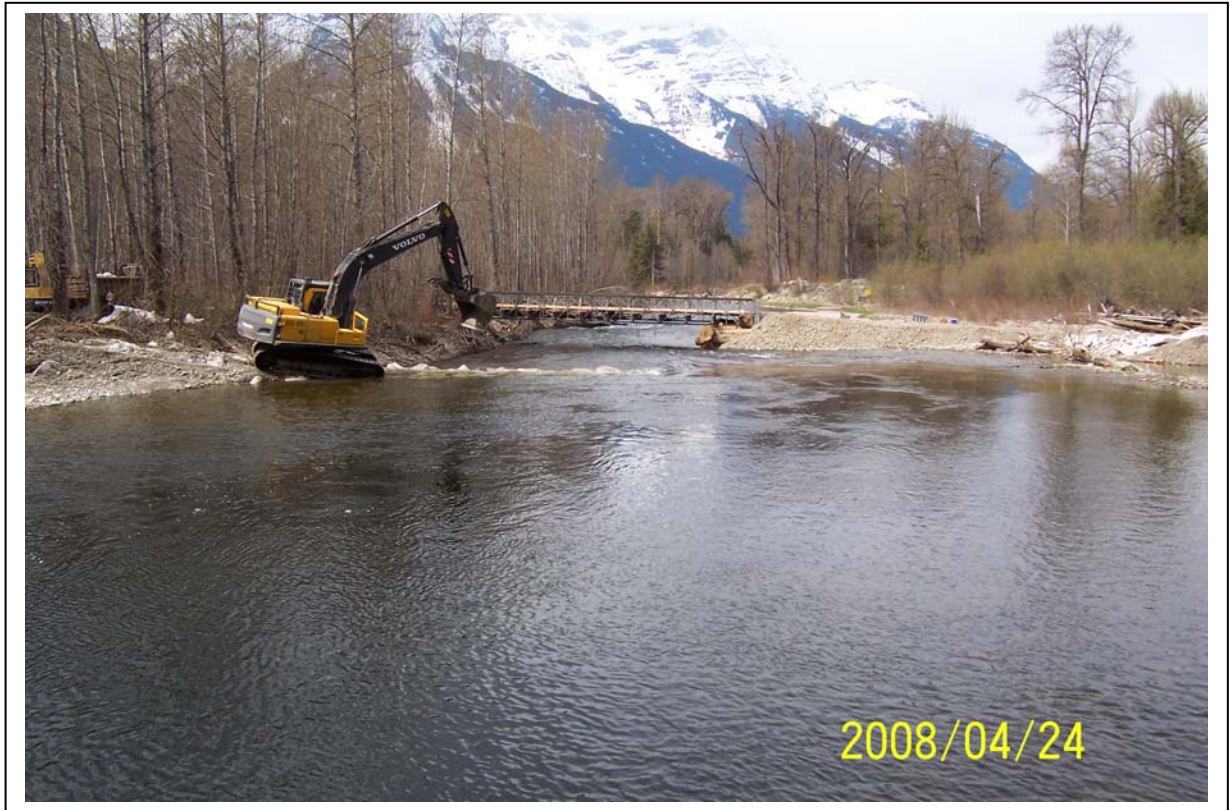
As the excavator placed the rock armor on the intake channel bank, any suitable rock for the deflection groin was set to the side. This rock was now trucked across the bridge and the excavator began placing the groyne structure. Large rock was used for this ( plus / minus 1 m<sup>3</sup> ). It was anticipated that as flood waters passed over the groyne, the downstream side would erode. To keep the structure from rolling into the void, large slabs were placed on the downstream side of the groyne

**Figure 4. Excavator placing rock deflection groyne against river bank opposite the intake channel.**

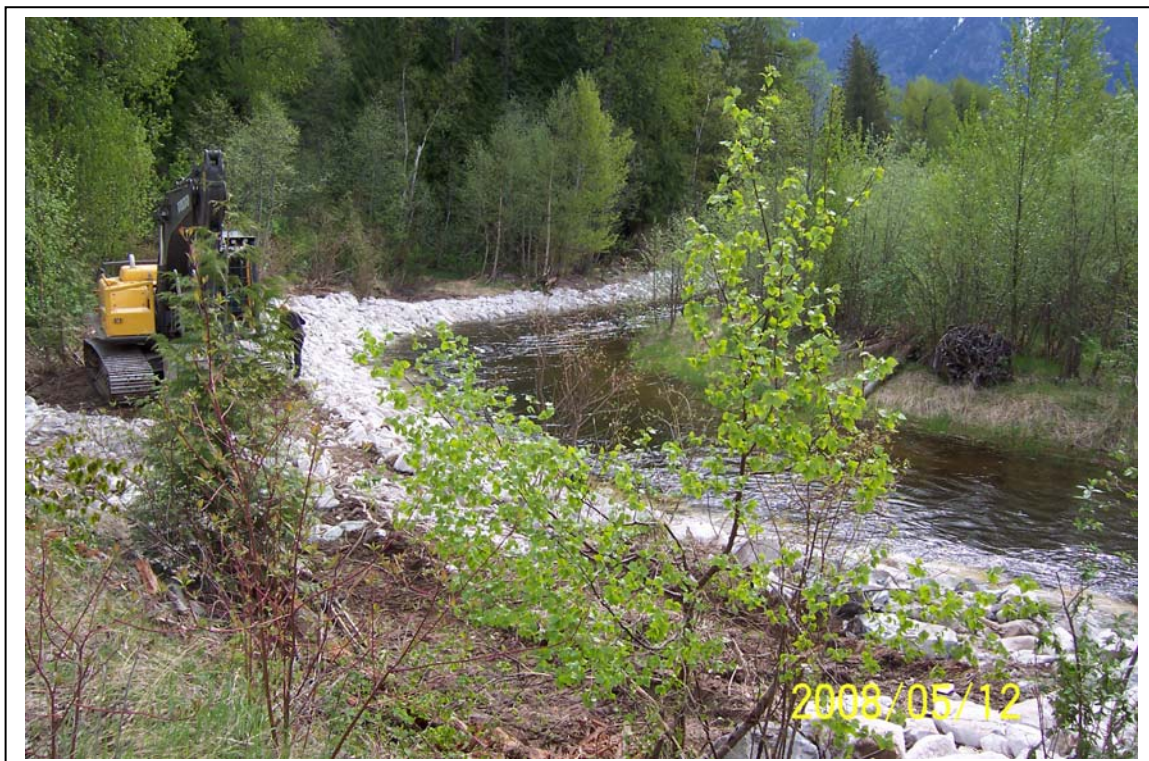
The prescription requested rip rap bank armor to guard against intake channel bank erosion.

**Figure 5. Intake channel with bank armor.**

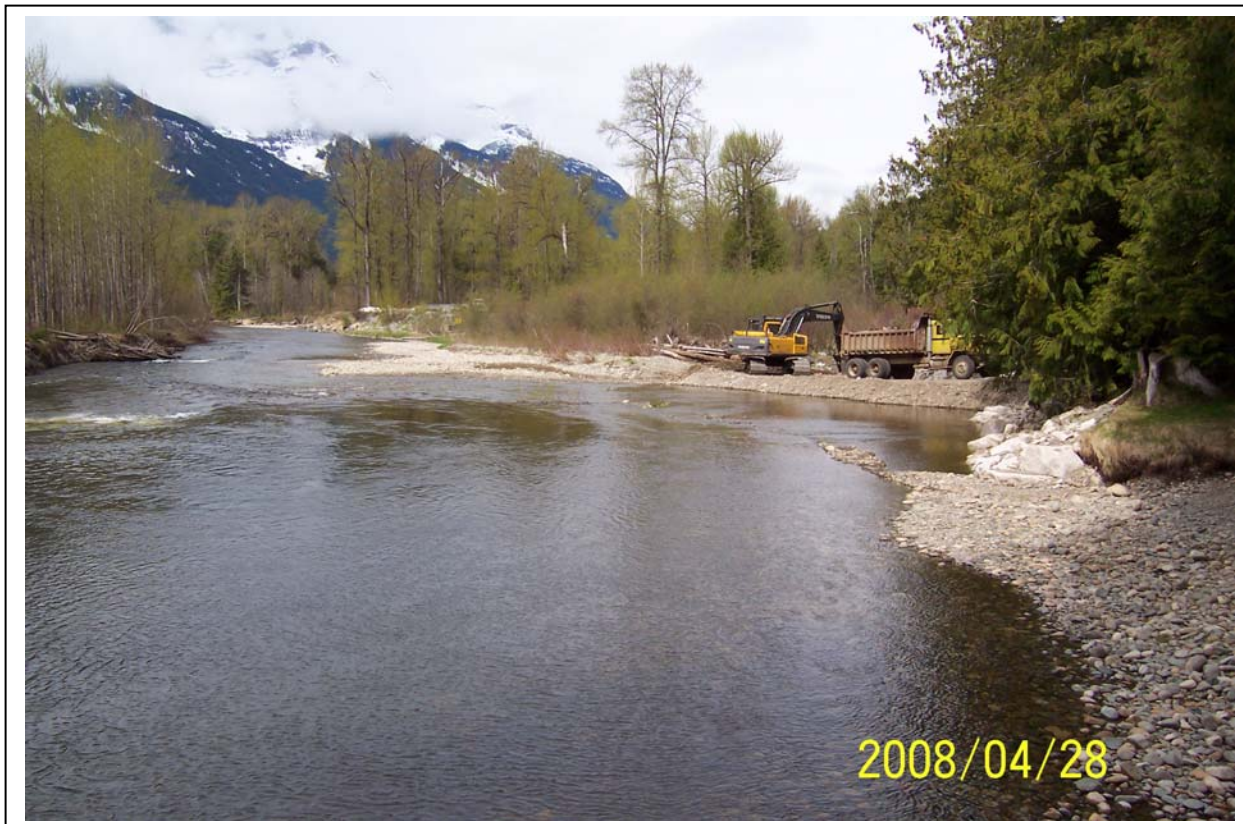
**Figure 6. Intake channel entrance after bridge removal, photo taken as the access ramp was being removed. The deflection groyne is visible at the left and bank armor is visible at the right of the photo.**

At the time of this report spring melt water has receded and it is evident that the deflection groyne has been covered with gravel and a small bar has formed directly downstream. This is encouraging as the trend has been for the river to erode the left bank thus moving the thalweg away from the channel intake.
