2019 King Salmon Creek Passage Assessment:

TRT Fisheries, Atlin BC

August 29th, 2019

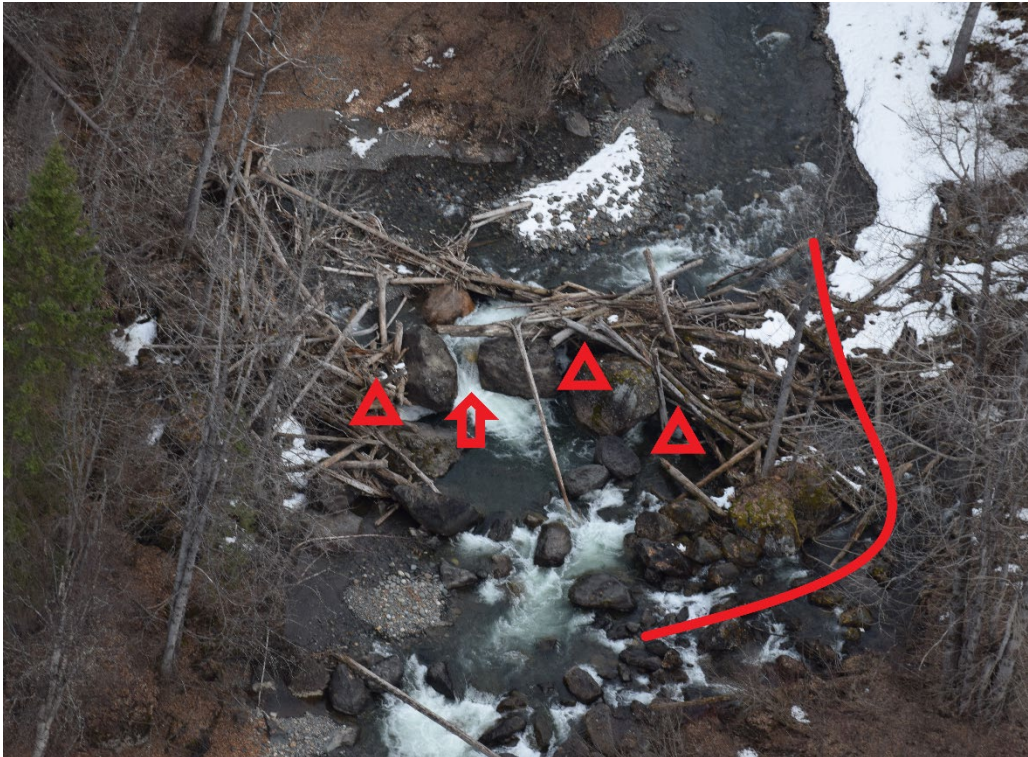
Photo 1 is an aerial view of the King Salmon Creek log jam taken on April 21st 2019. The red triangles are minor spill crests blocked with Large Woody Debris and the red arrow is the main spill, the only current passable spill point.

Photo 1: The debris jam on King Salmon Creek, April 21st, 2019. The triangles mark the location of potential historic spill points, the red arrow is the only currently passable spill point and the red line is a historic by-pass channel.

- Access the site in the early spring prior to freshet and remove some of the LWD to promote an avulsion into the historic by-pass channel on river left of the jam;

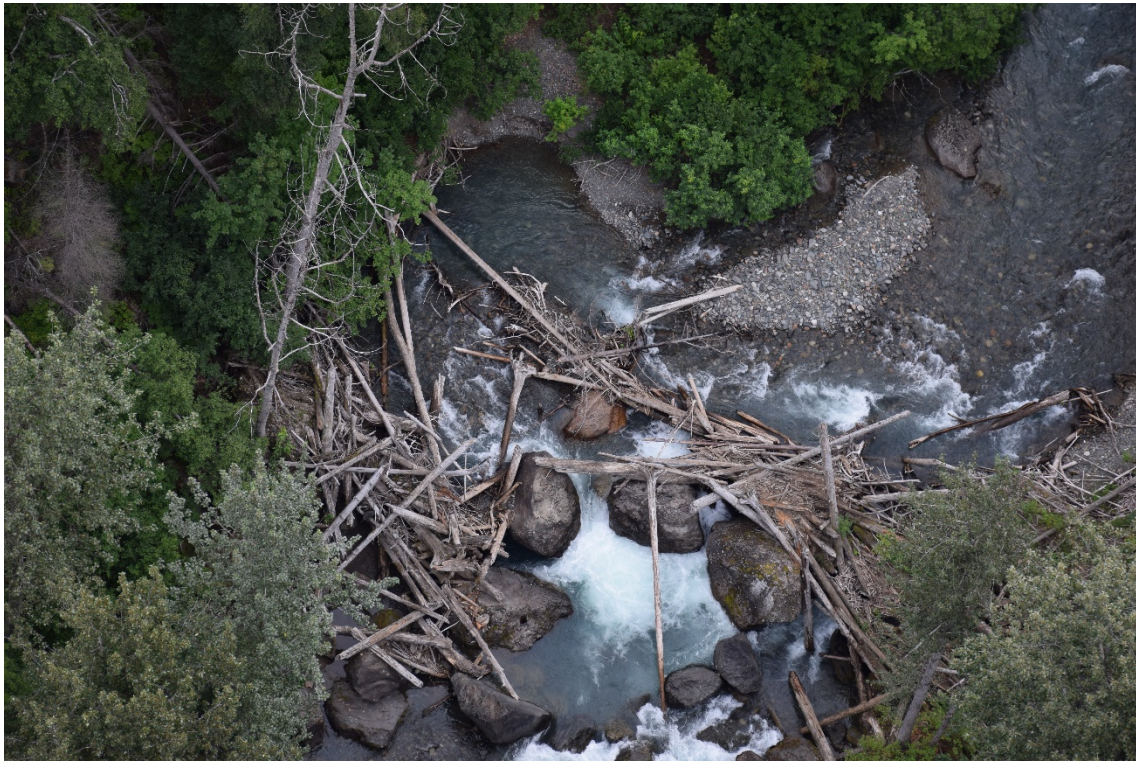
Photo 2: The King Salmon Creek debris jam as of July 27th, 2019. A comparison with photo 1 shows that the river stage is only moderately higher than the April stage based on a comparison of the two photos.

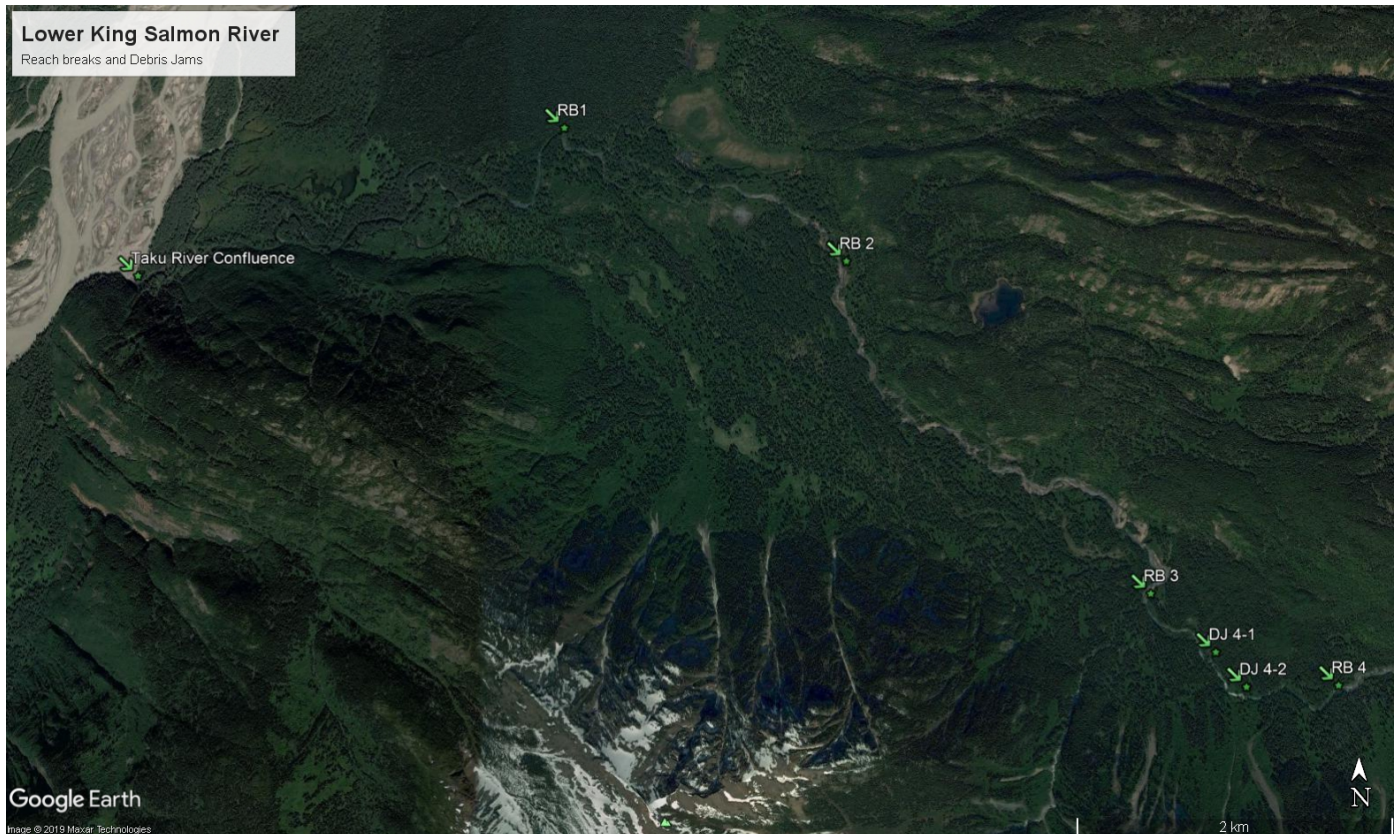
Figure 1: Google map of the lower King Salmon River showing the four reach breaks and two debris jam locations. DJ4-2 (bottom right of the map) is the jam location observed to be a migration delay.

Figure 1 shows the lower reaches of the creek with interpreted reach breaks based on geomorphic characteristics. The debris of interest is in reach 4 (DJ4-2) That section of the creek is relatively steep and confined which results in the tendency to transport bedload out of the reach rather than promoting storage in bars and sediment wedges. There are braided sections both above and below this section with sediment stored in bars and overbank locations.

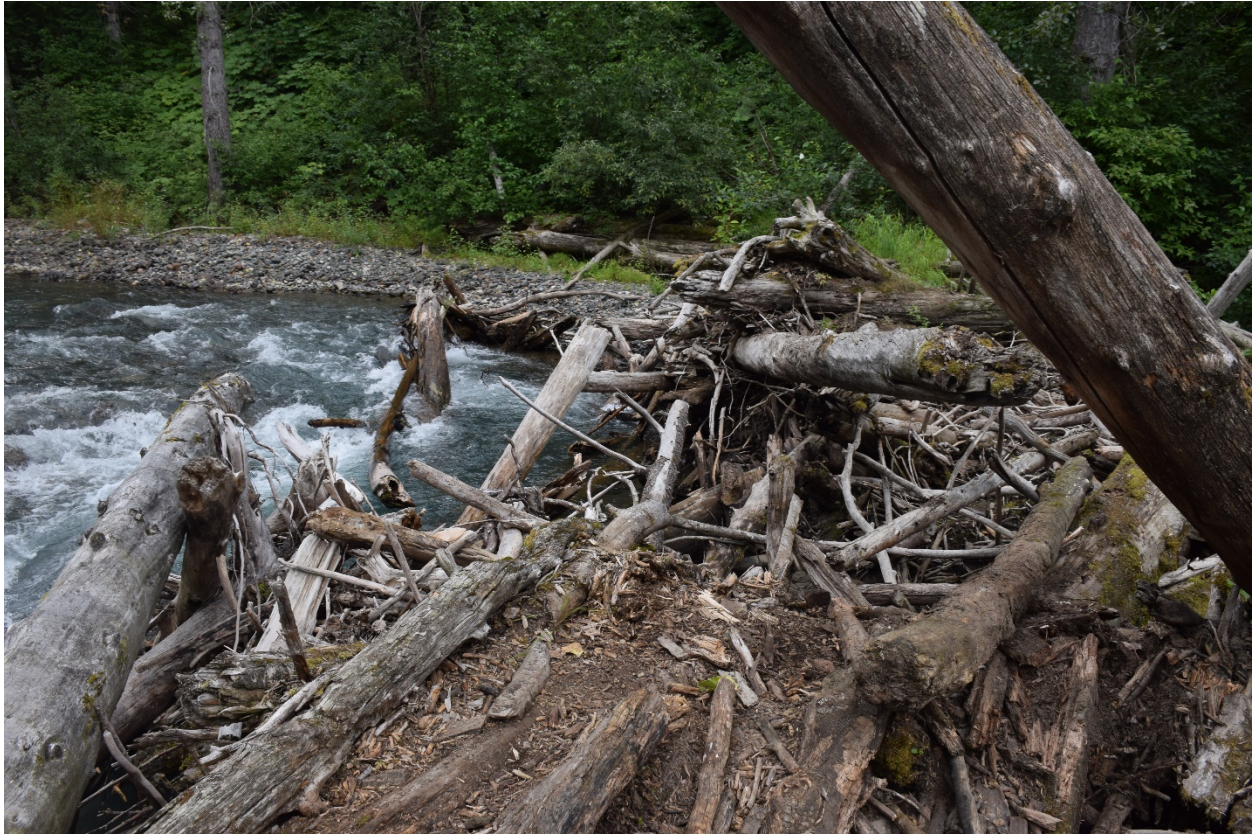
DJ4-2 is a channel spanning debris jam with a high debris trapping efficiency. Most of the individual pieces of LWD are in an advanced state of decay due to their long residence time. The jam is made up of a number of large key pieces with smaller pieces that have been strained out of the flow filling in the gaps between key pieces. At low flow this results in only one passable gap in the jam. Photo 3 (below) shows the top of jam DJ4-2 and the degree of decay in the key pieces. Key pieces are oriented

perpendicular to the direction of flow which tends to optimize debris retention and the recruitment of smaller pieces.

Photo 3: The view from the top of DJ4-2 showing the high degree of decay in the LWD making up the jam.

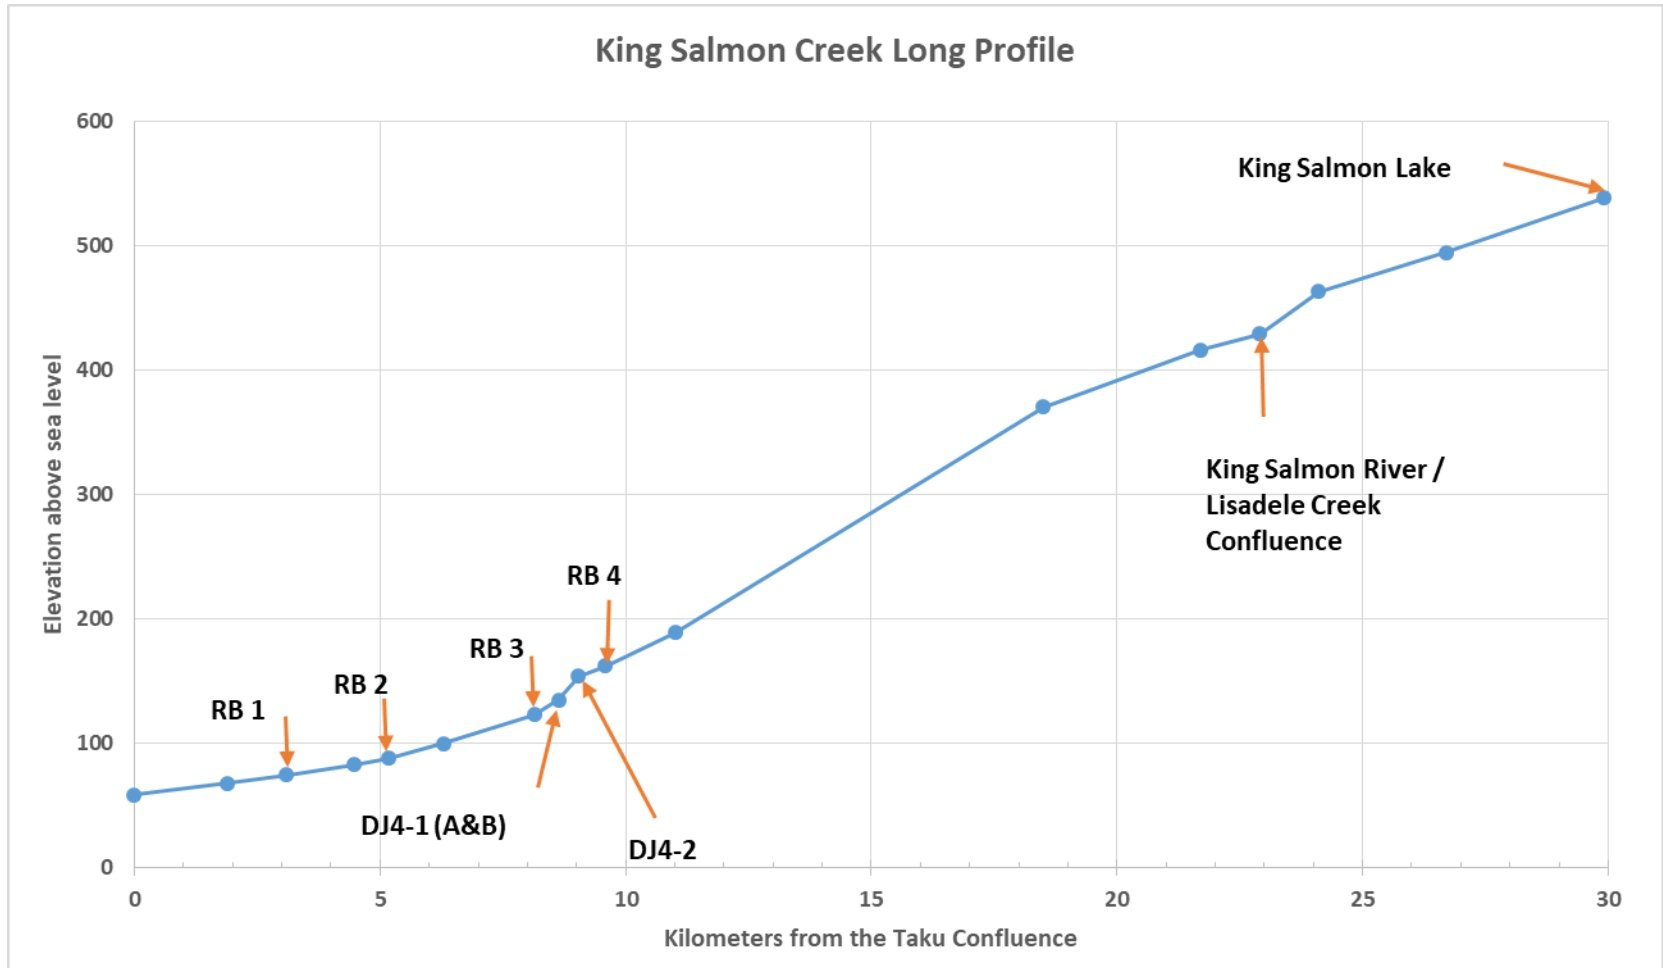
Appendix 1: King Salmon River Long Profile

The channel upstream gradient is approximately half of the downstream gradient indicating a long profile break point exists at that point. A long profile was estimated from the Google Earth DEM that also indicates the break point at the jam location. This suggests higher stream power in the downstream channel and potentially a more coarse textured bed matrix. The long profile is included as Appendix 1. The profile shows the position of the log jam in reference to the lake and the other reach breaks to give context.

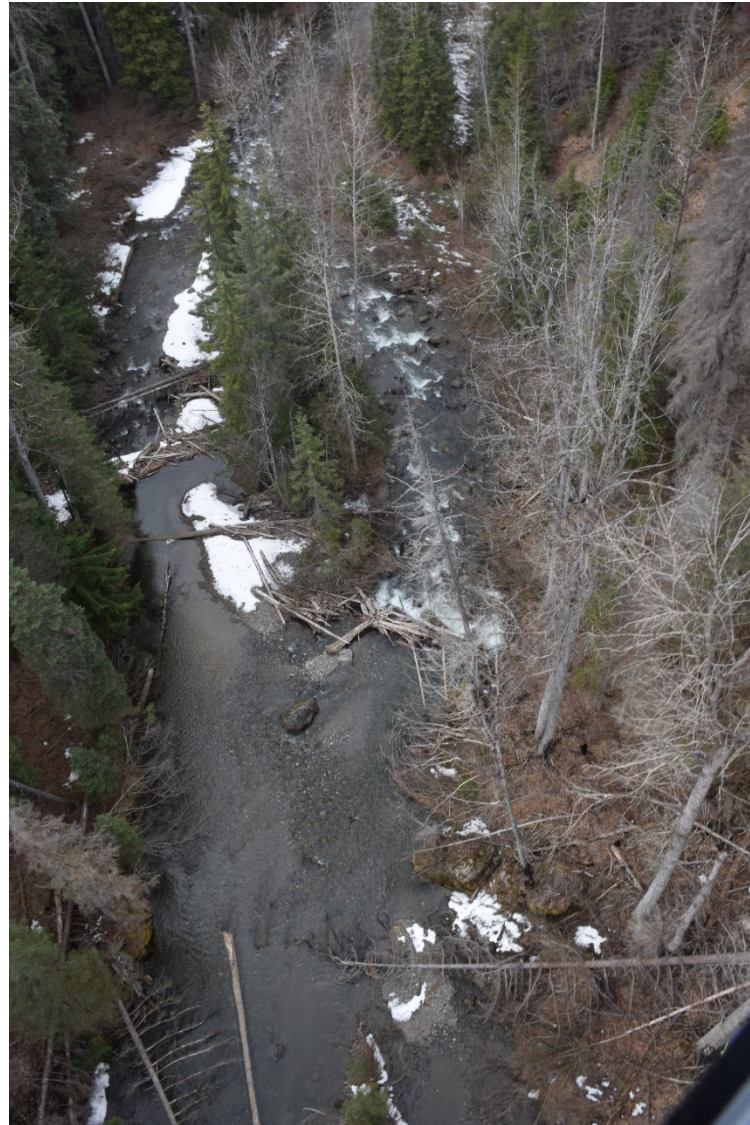
Approximately 300 meters downstream of the main jam is a pair of debris jams (DJ4-1 (L&R)) with a fish passable by-pass on river right. The channel at that point bifurcates around a small island and there are small jams in both dis-tributaries. Photos A1 and A2 (in Appendix 2) are spring time views of the downstream jam. The river right distributary appears to have a passable side channel against the right bank so the site was not visited on the ground.

Photo A1: The two debris jams (DJ4-1 L&R) located approximately 300 meters downstream of the main obstructing jam.

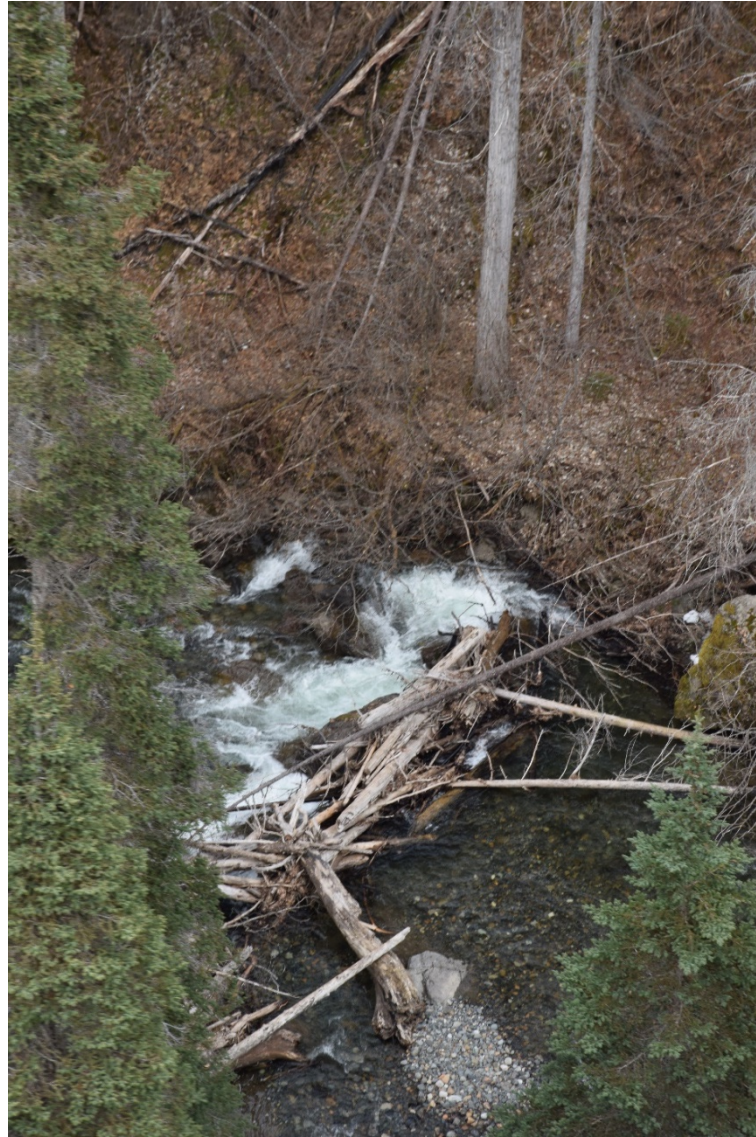
Photo A2: The lower jam (DJ4-1R) river right side distributary showing a passable side channel.

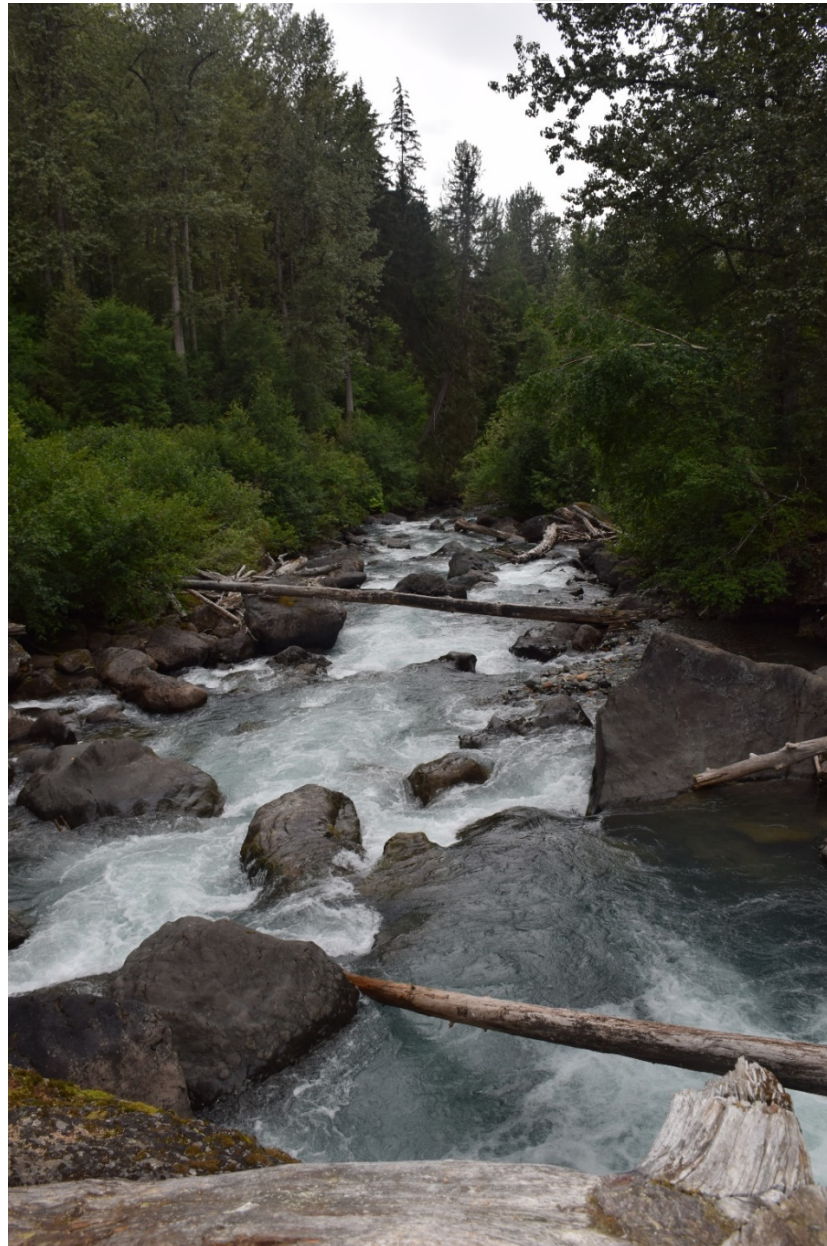
Photo A 3: Downstream view from the top of the debris jam.

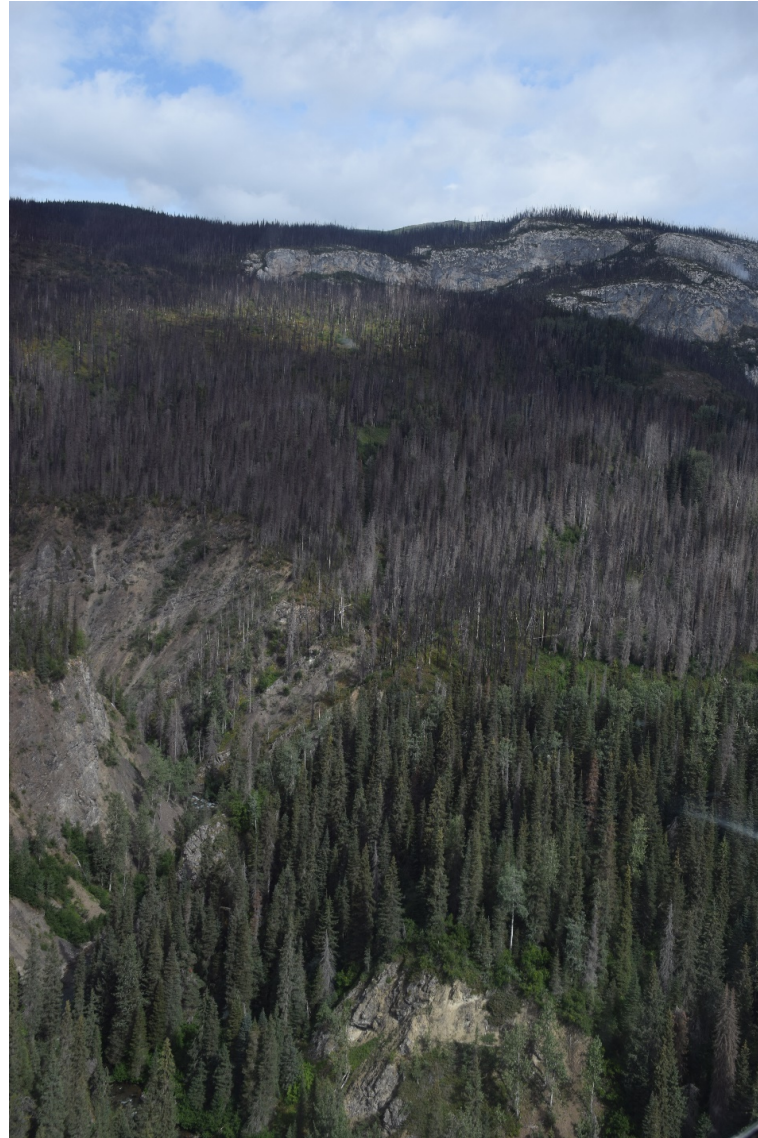
Photo A4: A view of burned over area (Fire # R90046) in the mid King Salmon Creek canyon with side slopes coupled to the channel. This is an example of where future debris recruitment may occur.

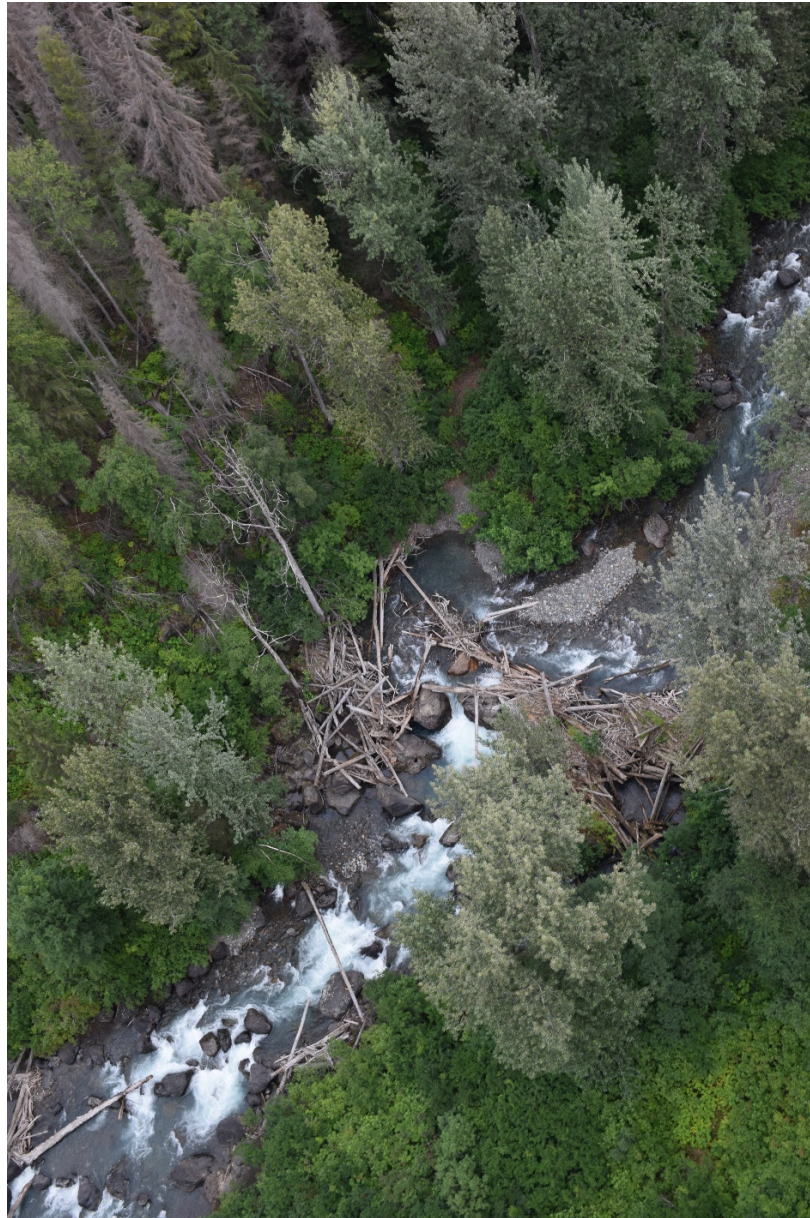
Photo A5: An overhead view of DJ4-2 during the migration period (July 27th, 2019).

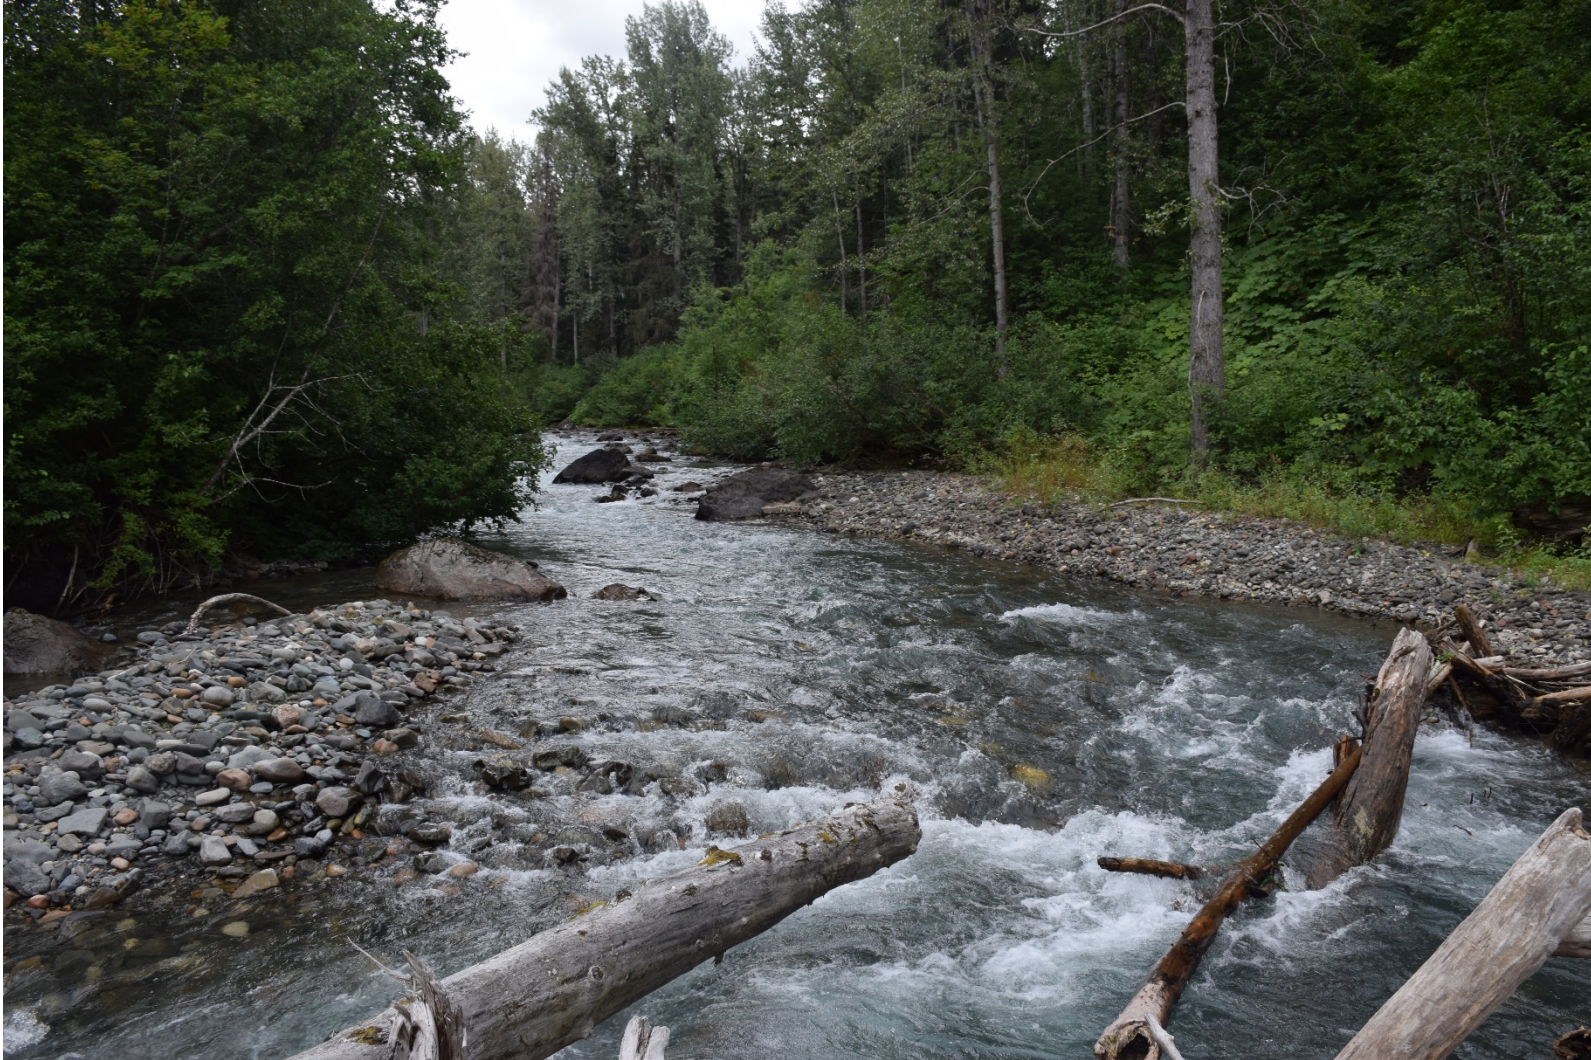
Photo A6: Upstream view from the top of DJ4-2.

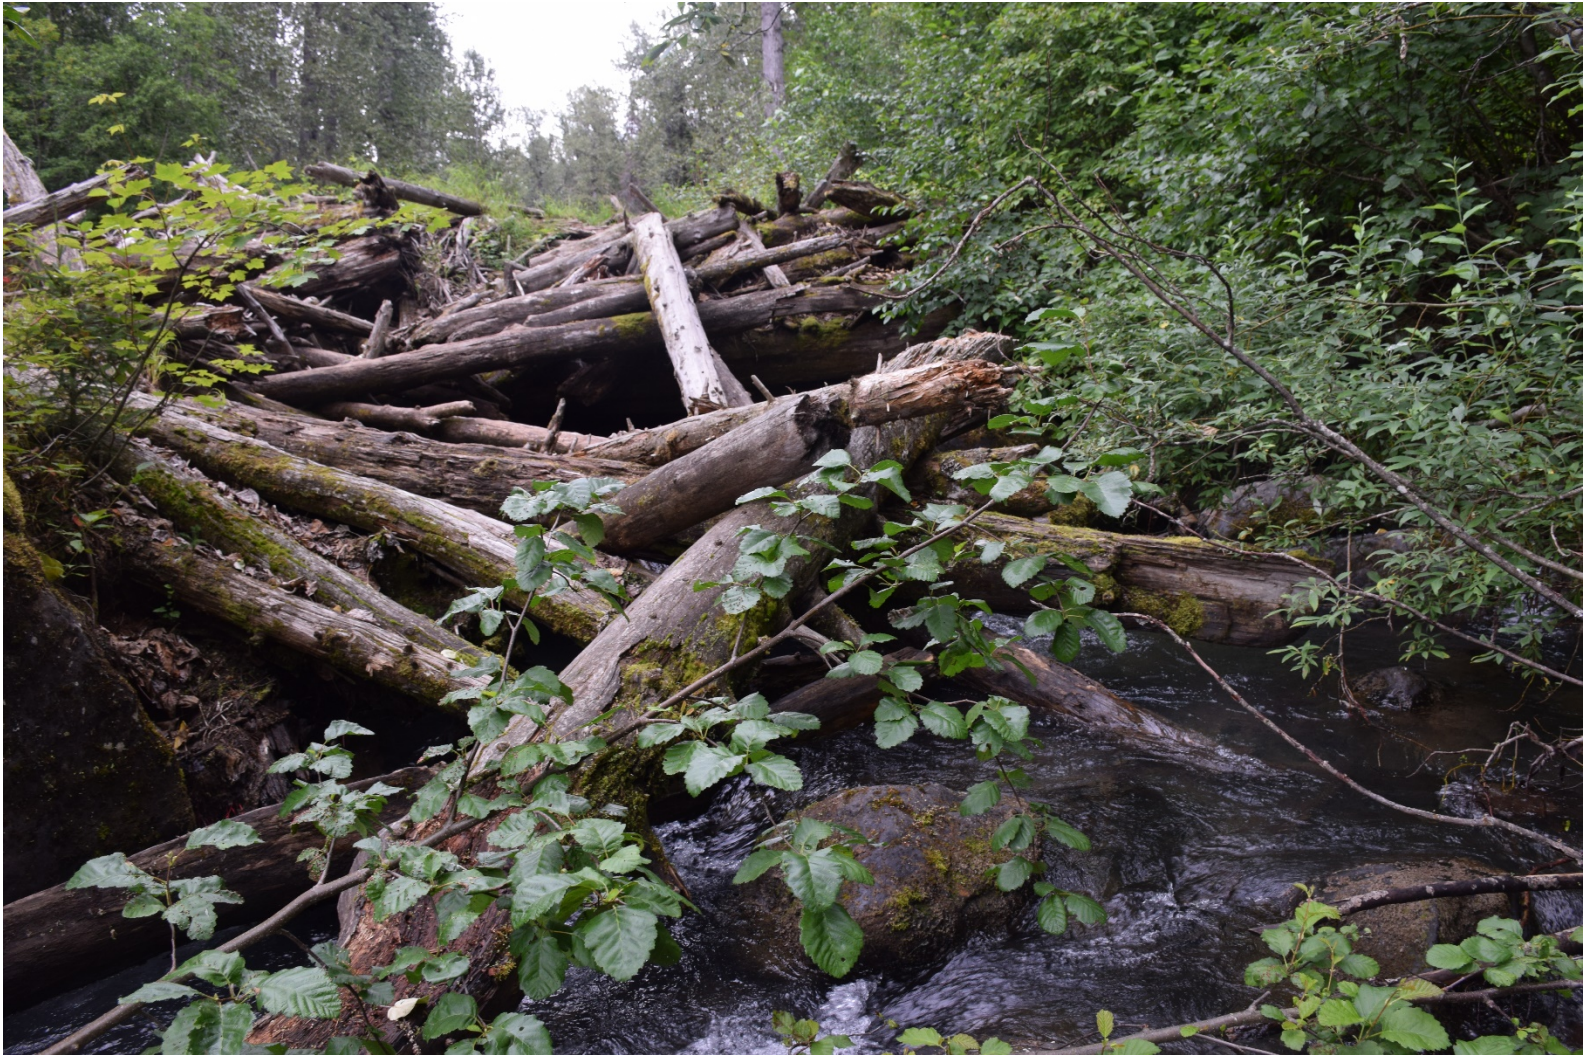
Photo A7: Close up view of the river left historic by-pass channel and the accumulated debris proposed for removal.

- The approach would be to remove (by winch) the top of the jam upstream of the by-pass channel without disturbing the sediment wedge at the leading upstream edge. In this way the failure mode may be more gradual as freshet flows will then be allowed to overtop the jam at river left, recruit sediment and infill and smooth the by-pass.

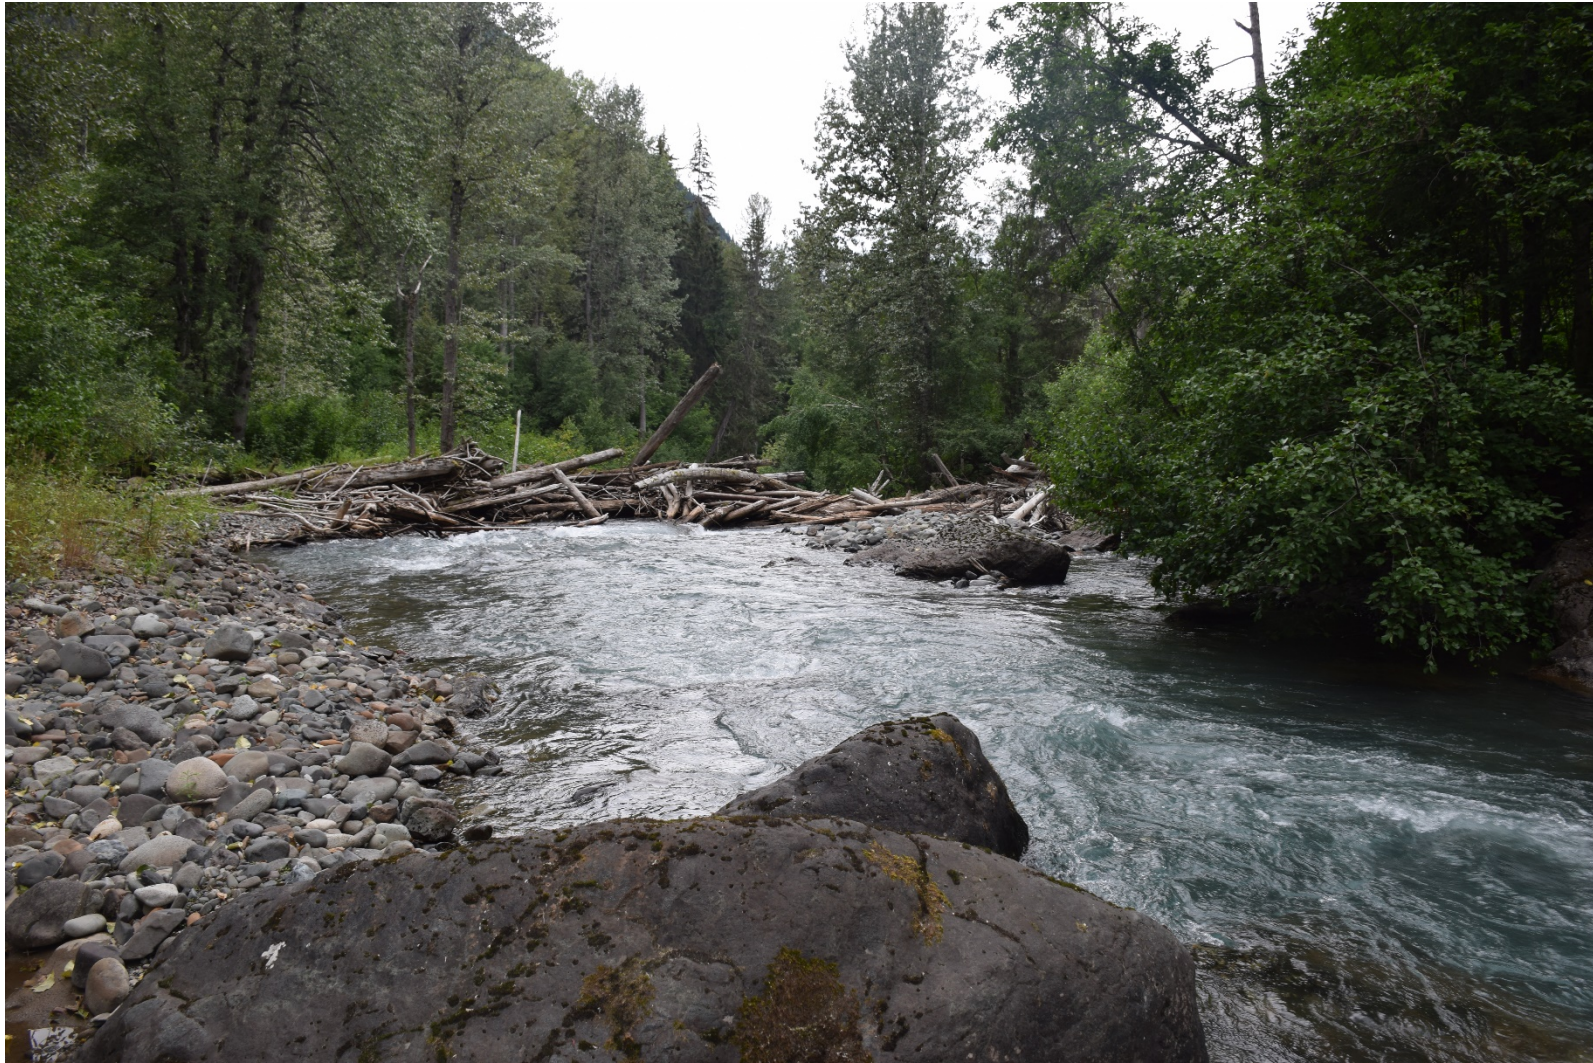
Photo A8: Downstream view toward DJ4-2. The proposed debris removal is at the left.

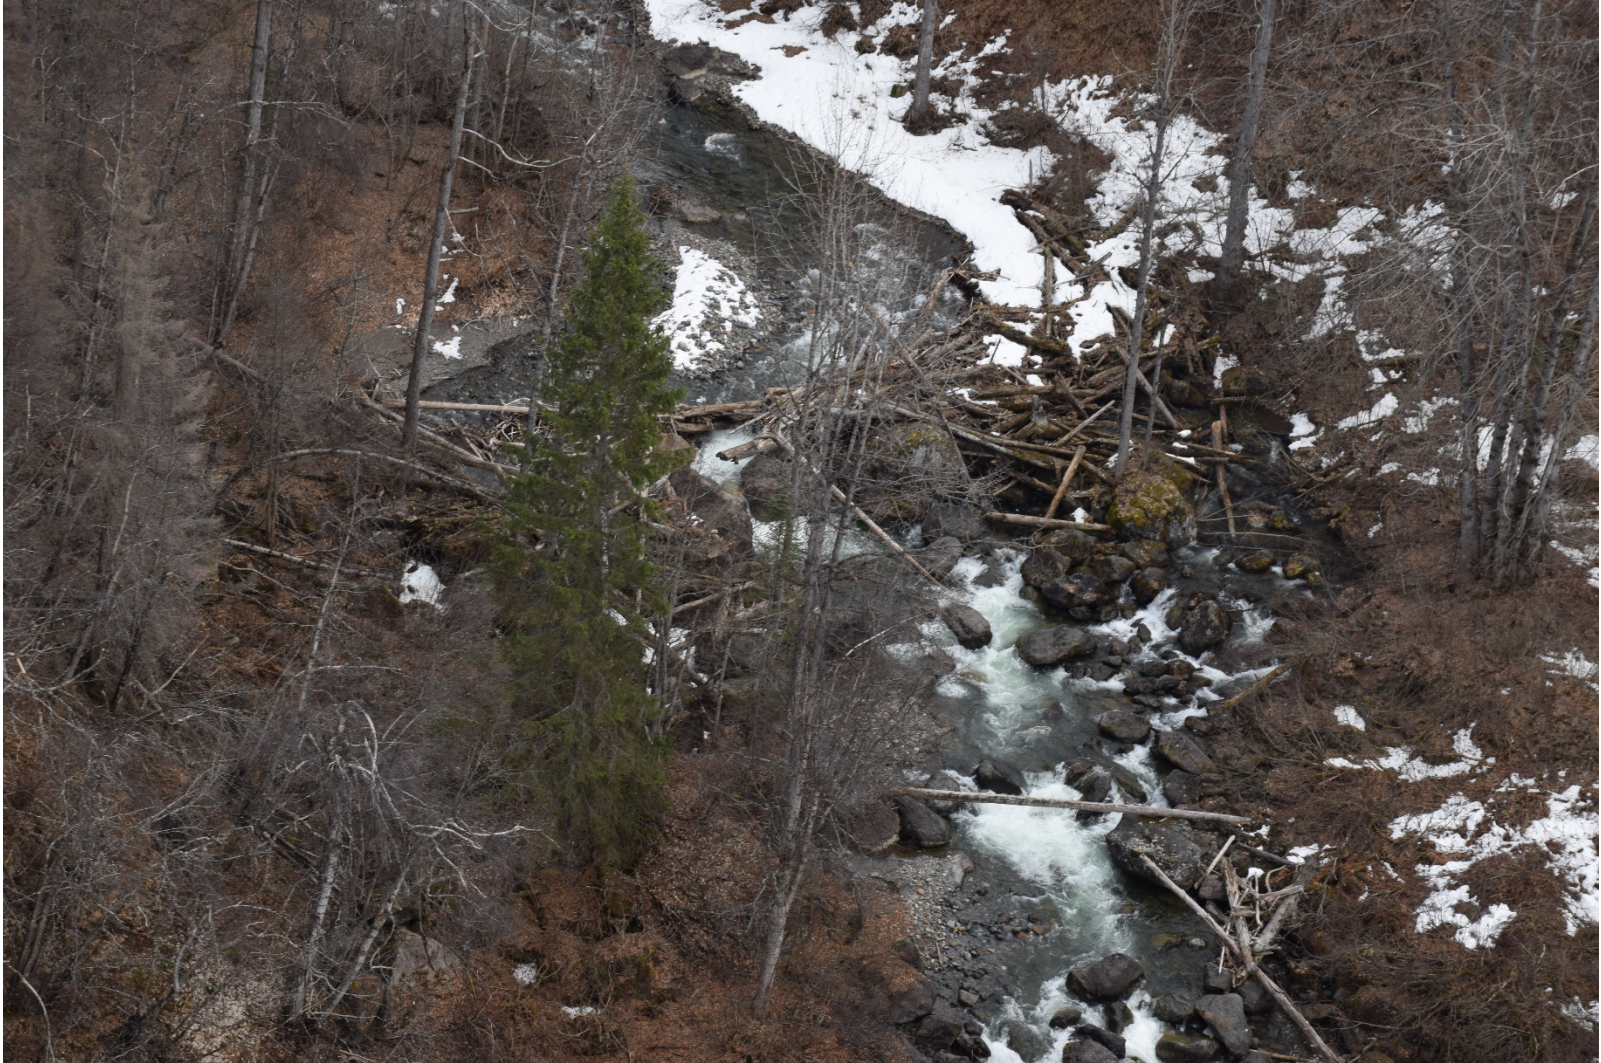
Photo A9: Overhead view of DJ4-2 during the spring site visit (April, 27, 2019).

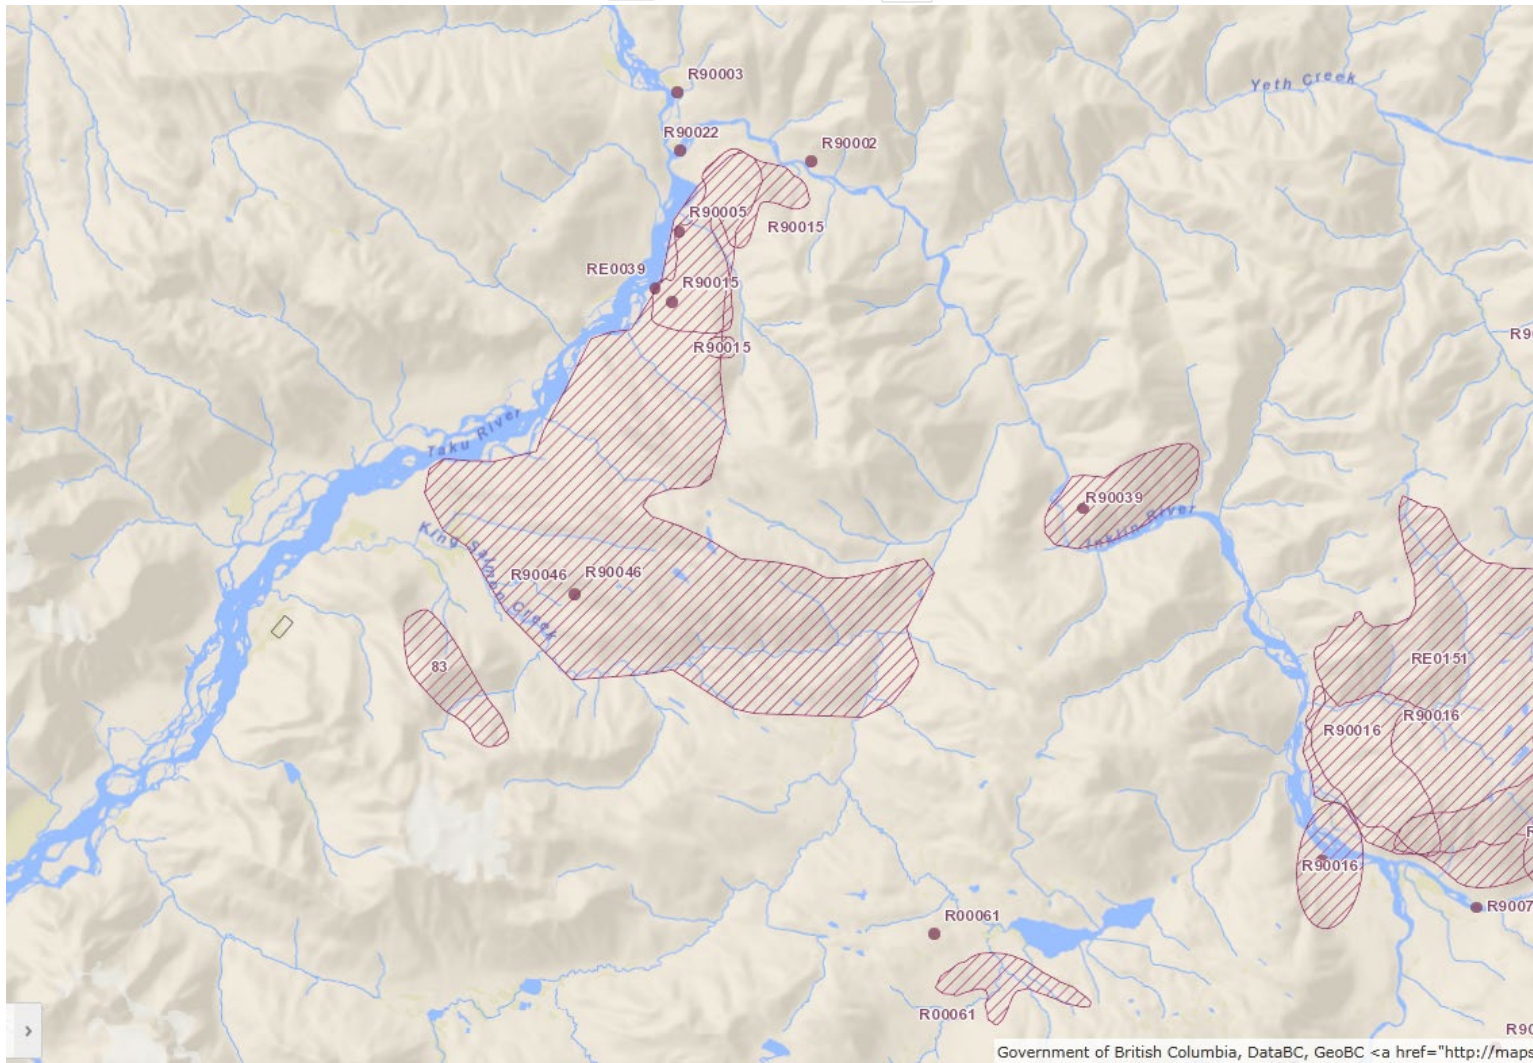
- **Risk 5:** As episodic LWD input from the upslope areas burned in Fire R90046 makes its way to the DJ4-2 site this may aggravate the passage issues. Mitigation is to promote the gradual clearance of the debris currently in the jam to minimize the development of a more complex jam architecture that may be more difficult to mitigate. Starting with the river left debris removal may be advantageous given that it is located at the initial inflection in the dog-leg turn so it will preferentially accrue any newly recruited LWD without the historic collapsing debris. This may result in a more passable channel with the stabilizing influence of inlet

Figure A1: A fire history map for the King Salmon watershed. Fire number dates as follows; 2015-R90046, 1992-R90015, 1951-R00061 (Southwest of King Salmon Lake), 1930-83.
