# Resurrection Creek

## Stream Restoration Project

Seward Ranger District

Chugach National  
Forest

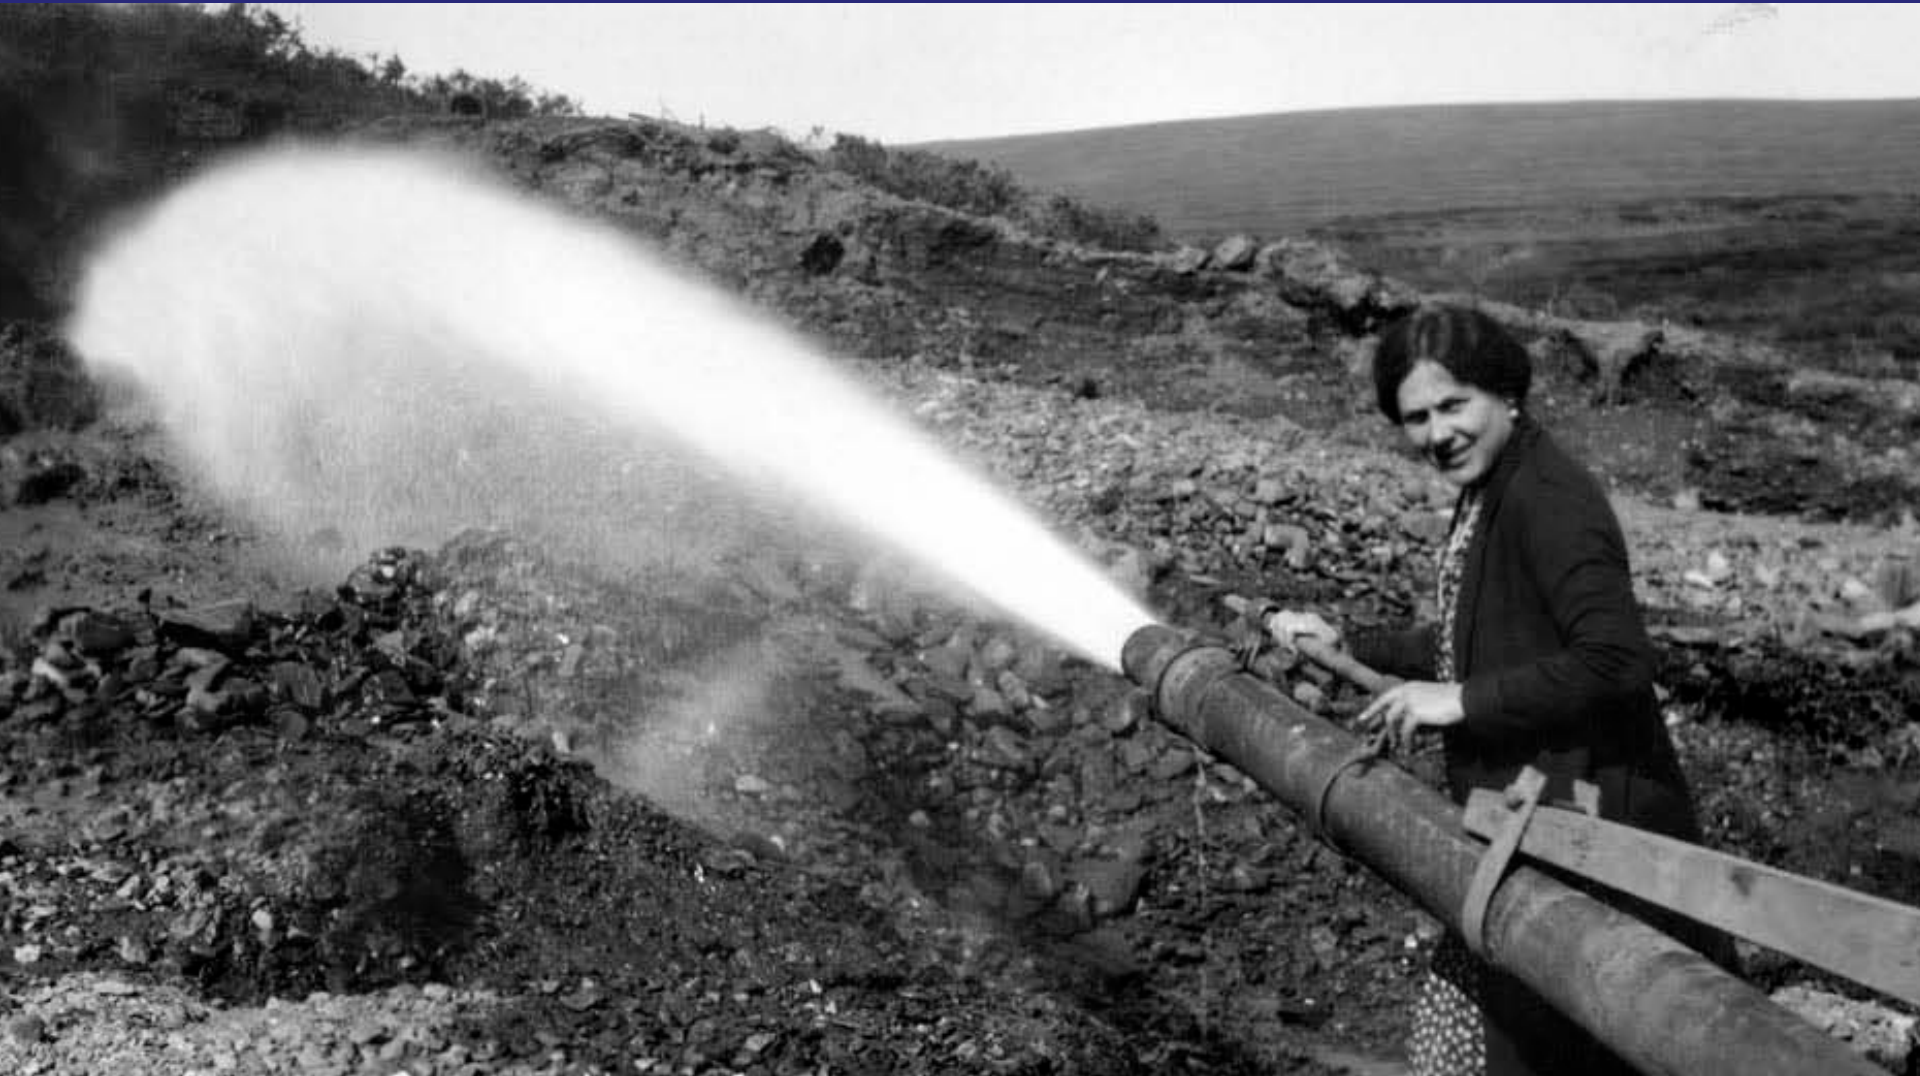
Extensive hydraulic and hand placer mining began in 1895 and continued intermittently into the 1950s.

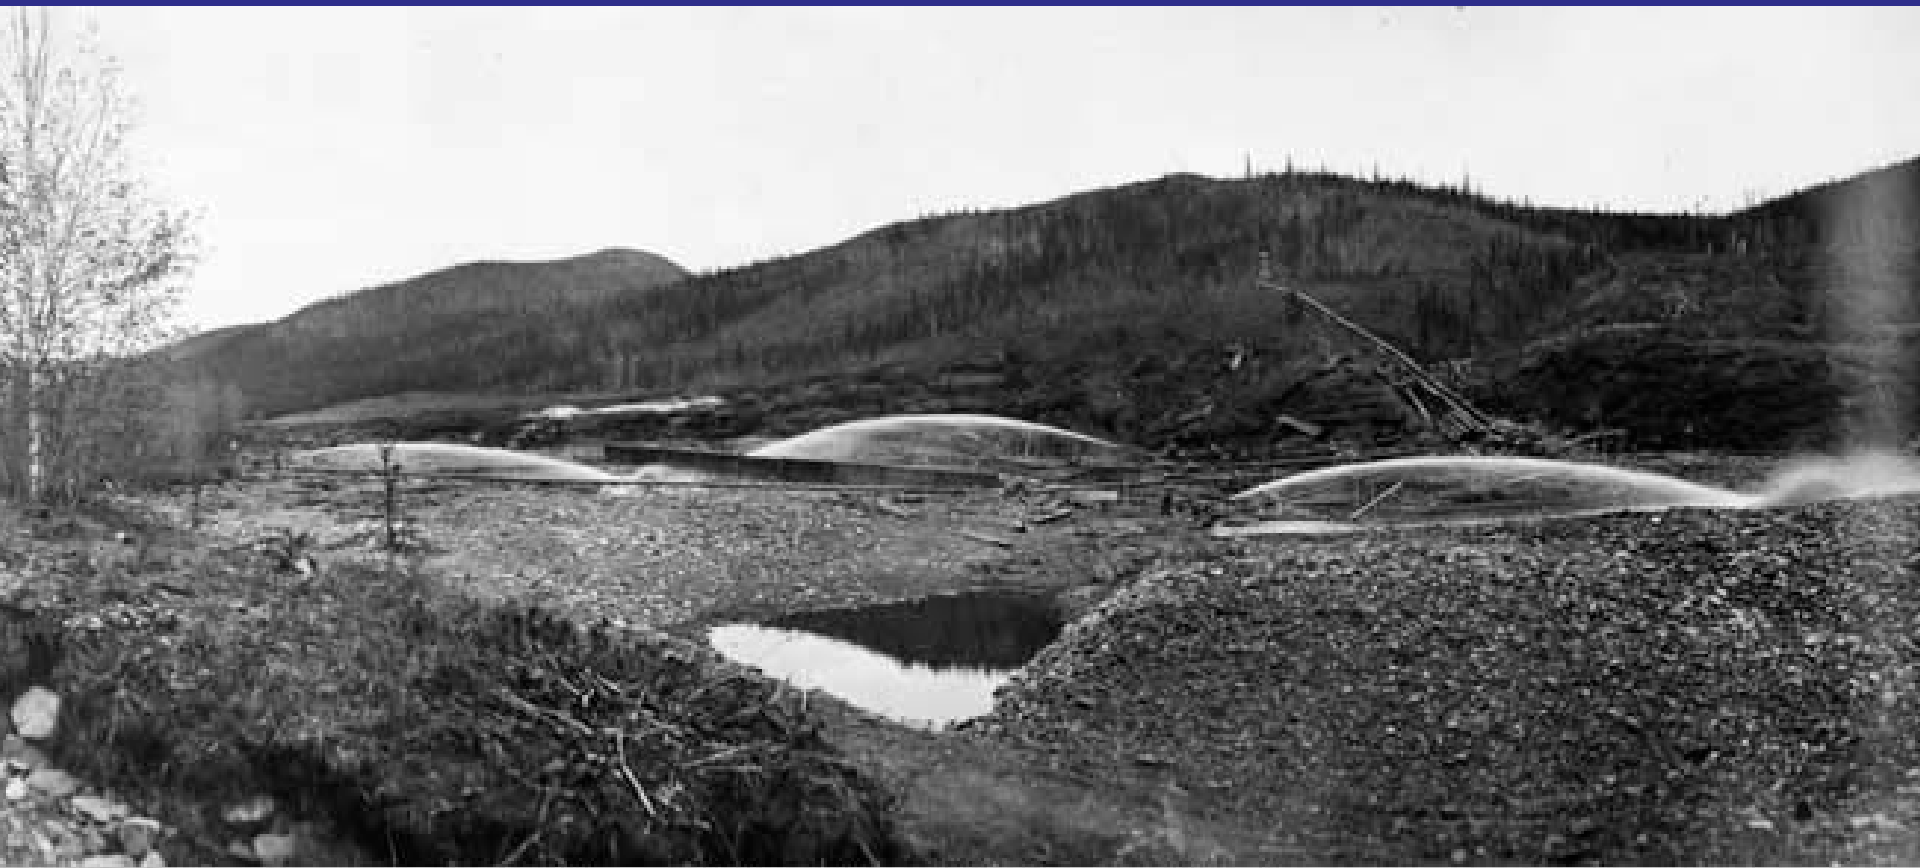
Hydraulic mining provided the power needed to process large volumes of alluvial gravels for gold.

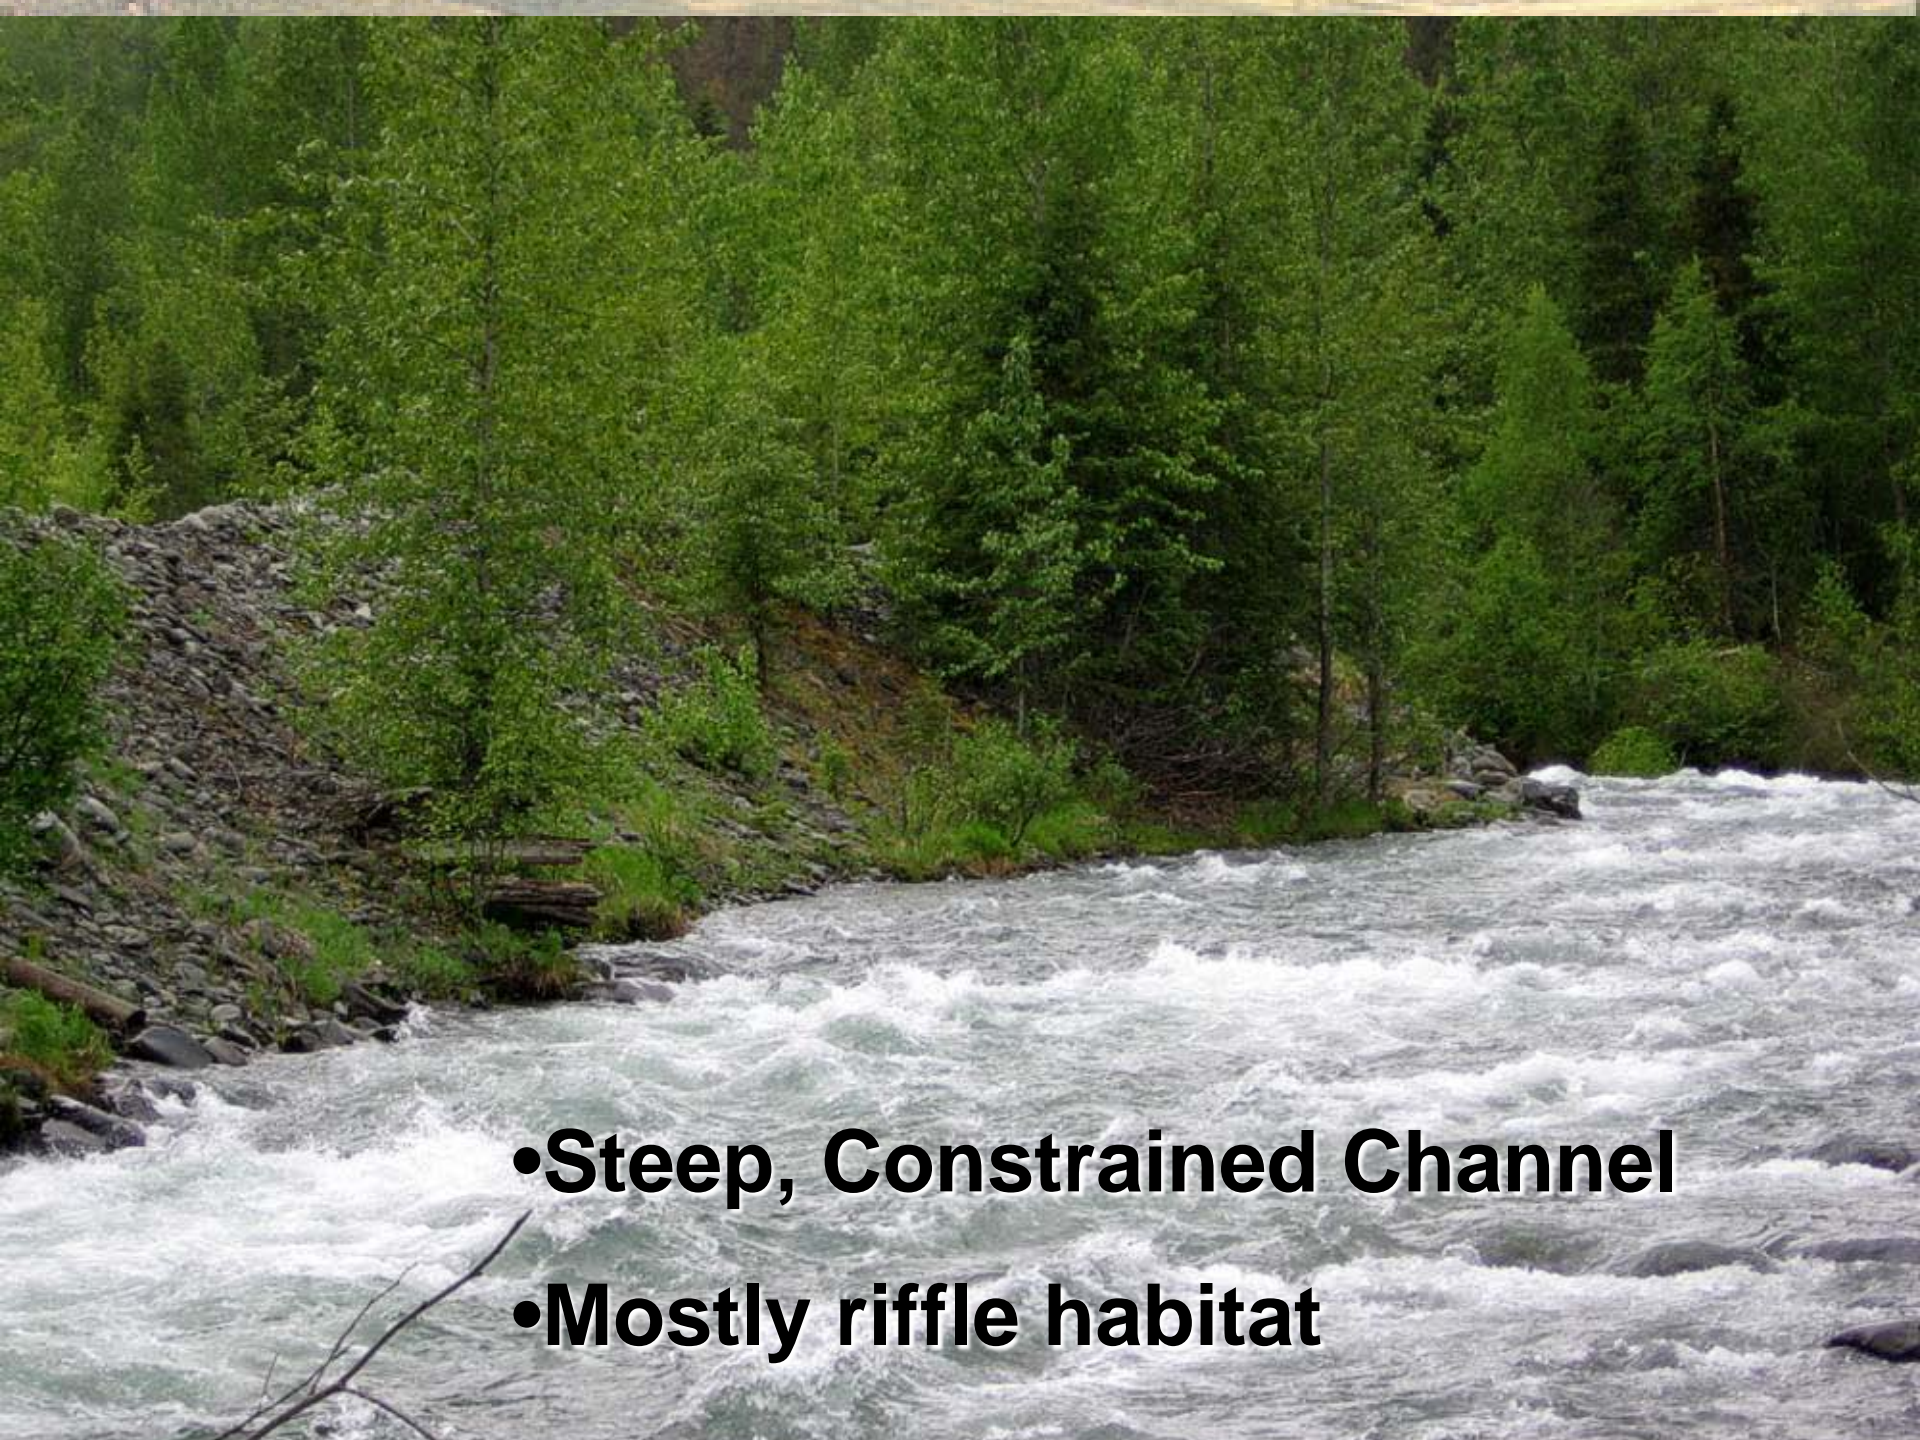
- **Steep, Constrained Channel**
- **Mostly riffle habitat**

***Without intervention, poor fish and wildlife habitat conditions will persist, conceivably for centuries***

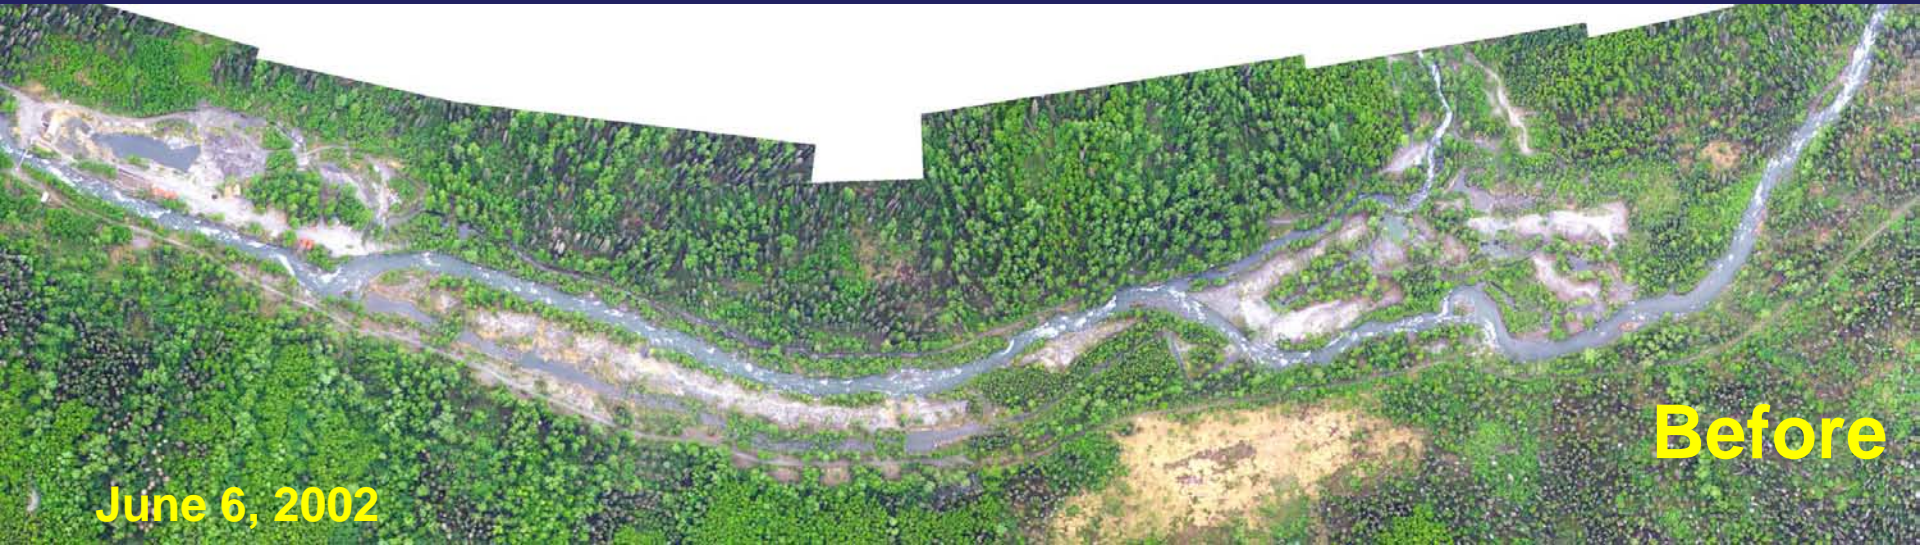
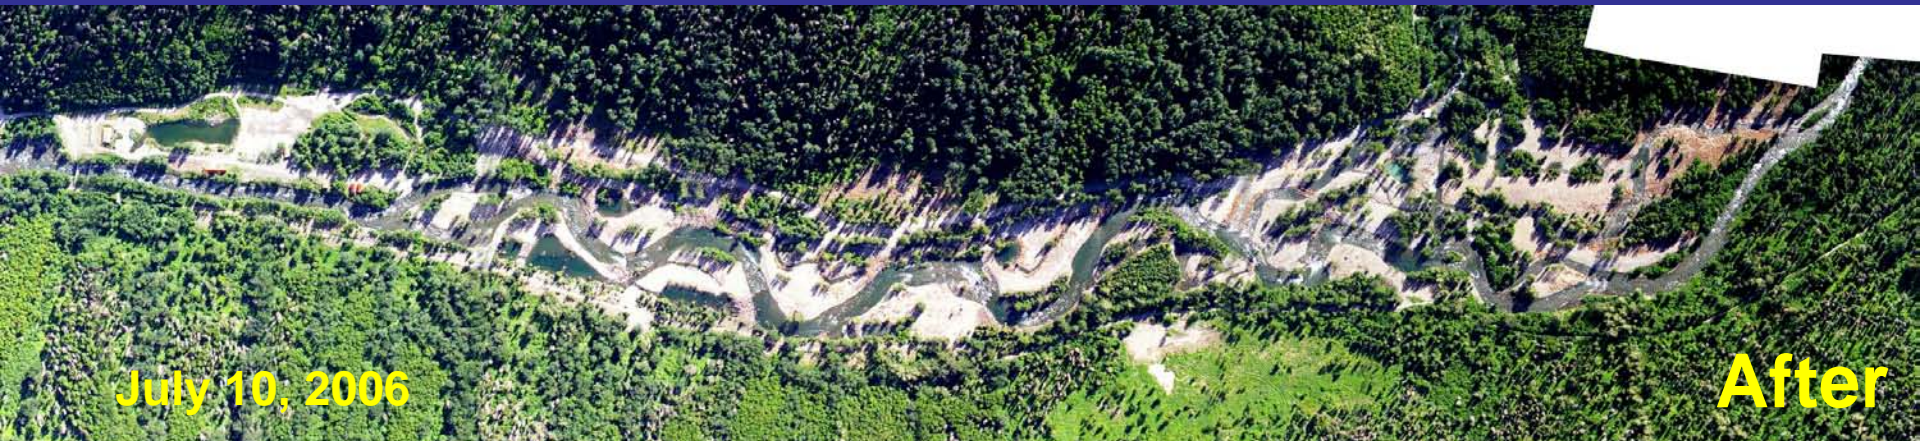
~1.4 Mile Stream

~1.3 Miles Side Channels

~160,000 yd<sup>3</sup>

60 Acres of Flood Plain

2002 photo with  
new 2005-6 stream channel  
features mapped on

2002 Photo  
with new 2005-6  
stream channel  
features mapped on

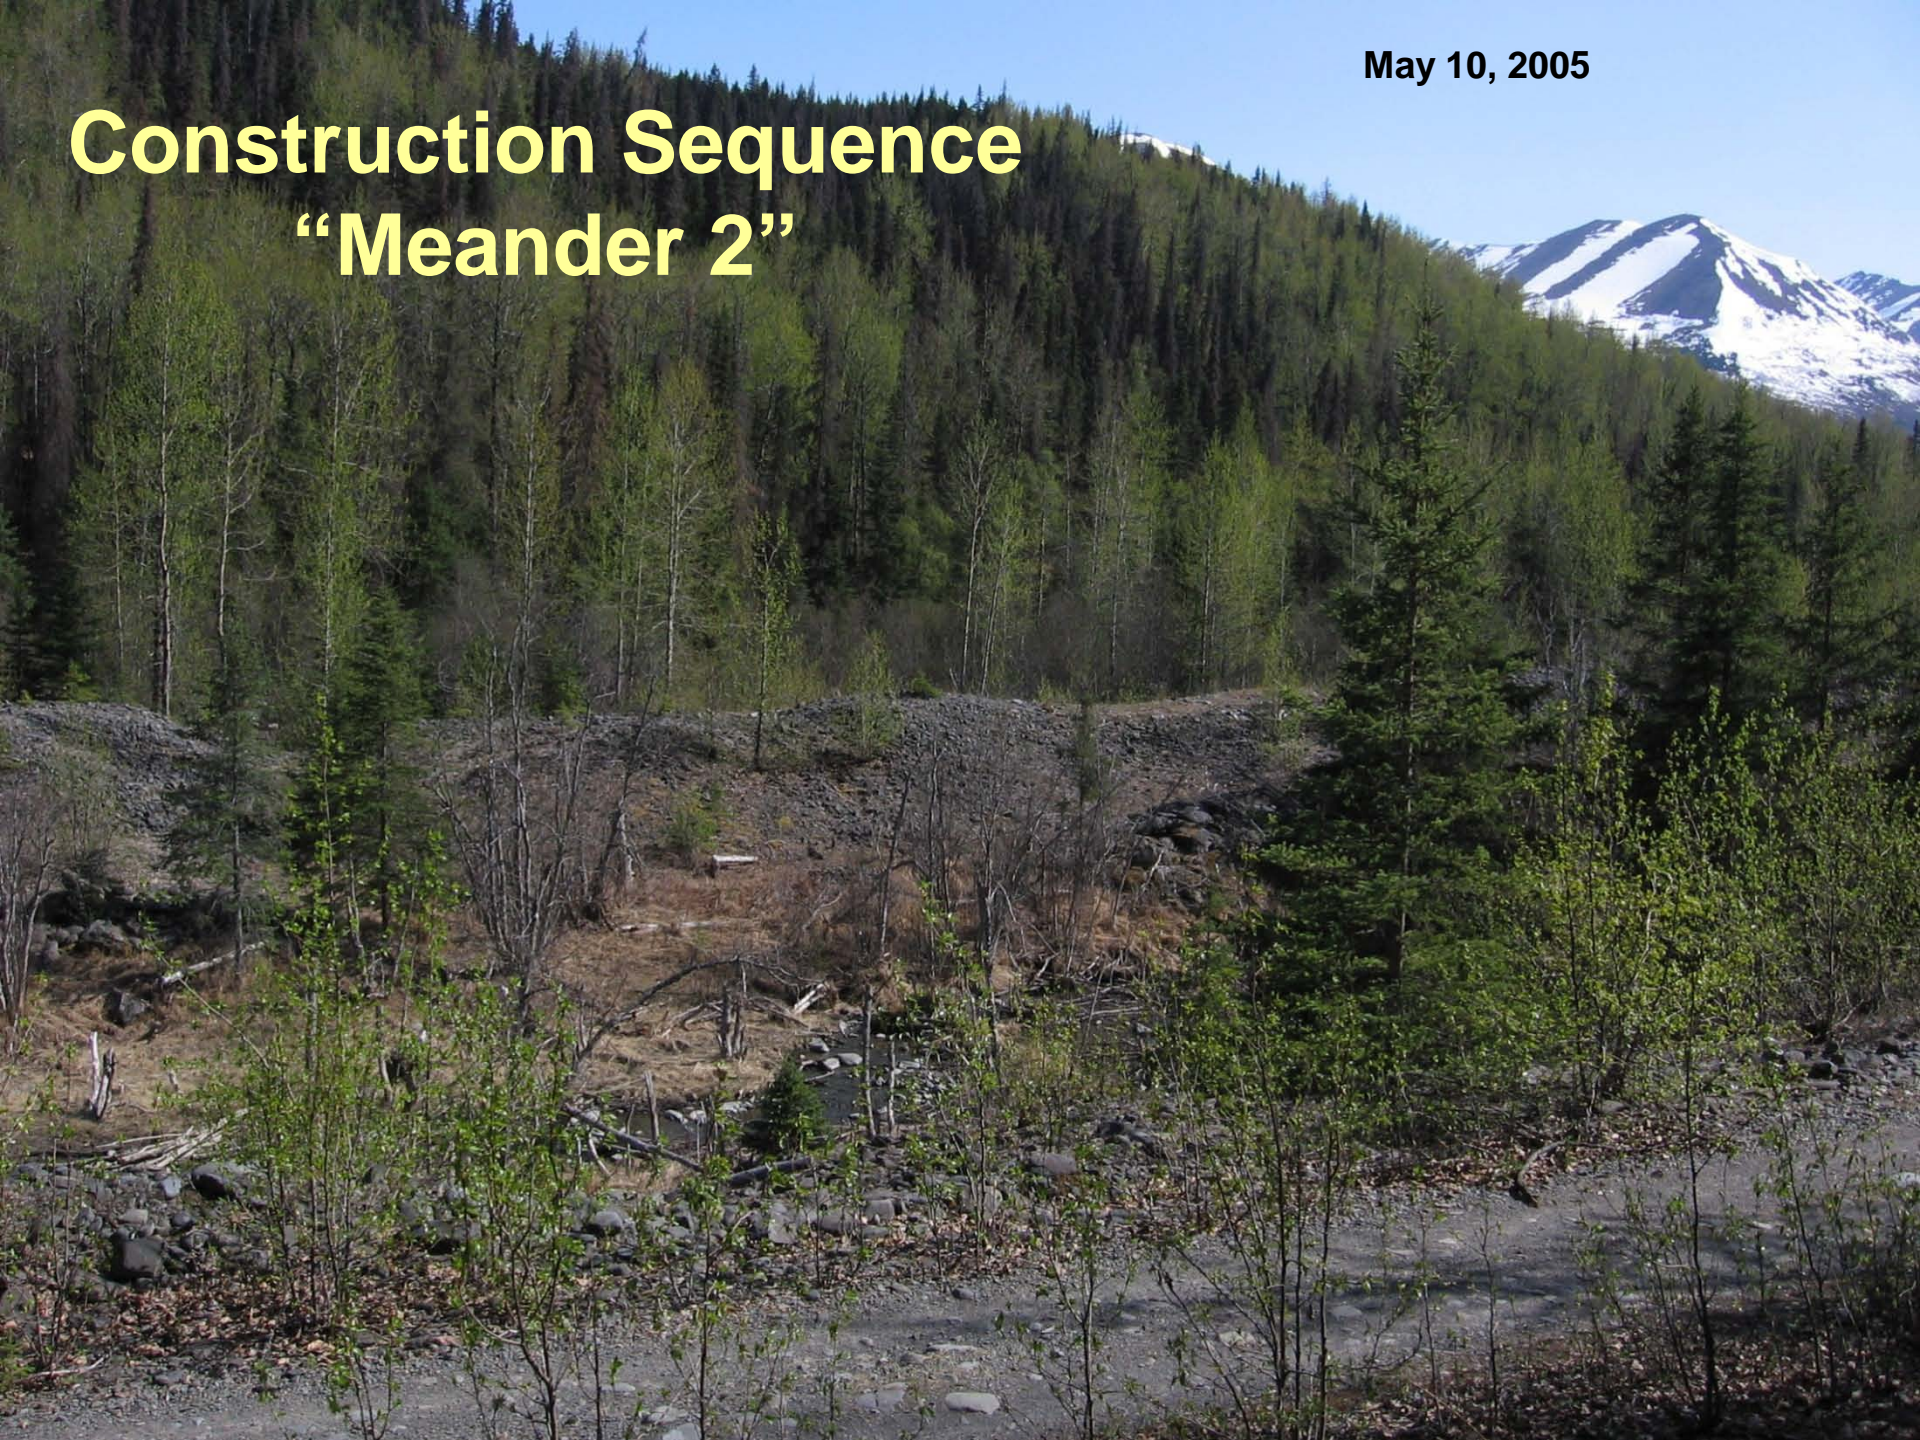
# Construction Sequence “Meander 2”

May 10, 2005

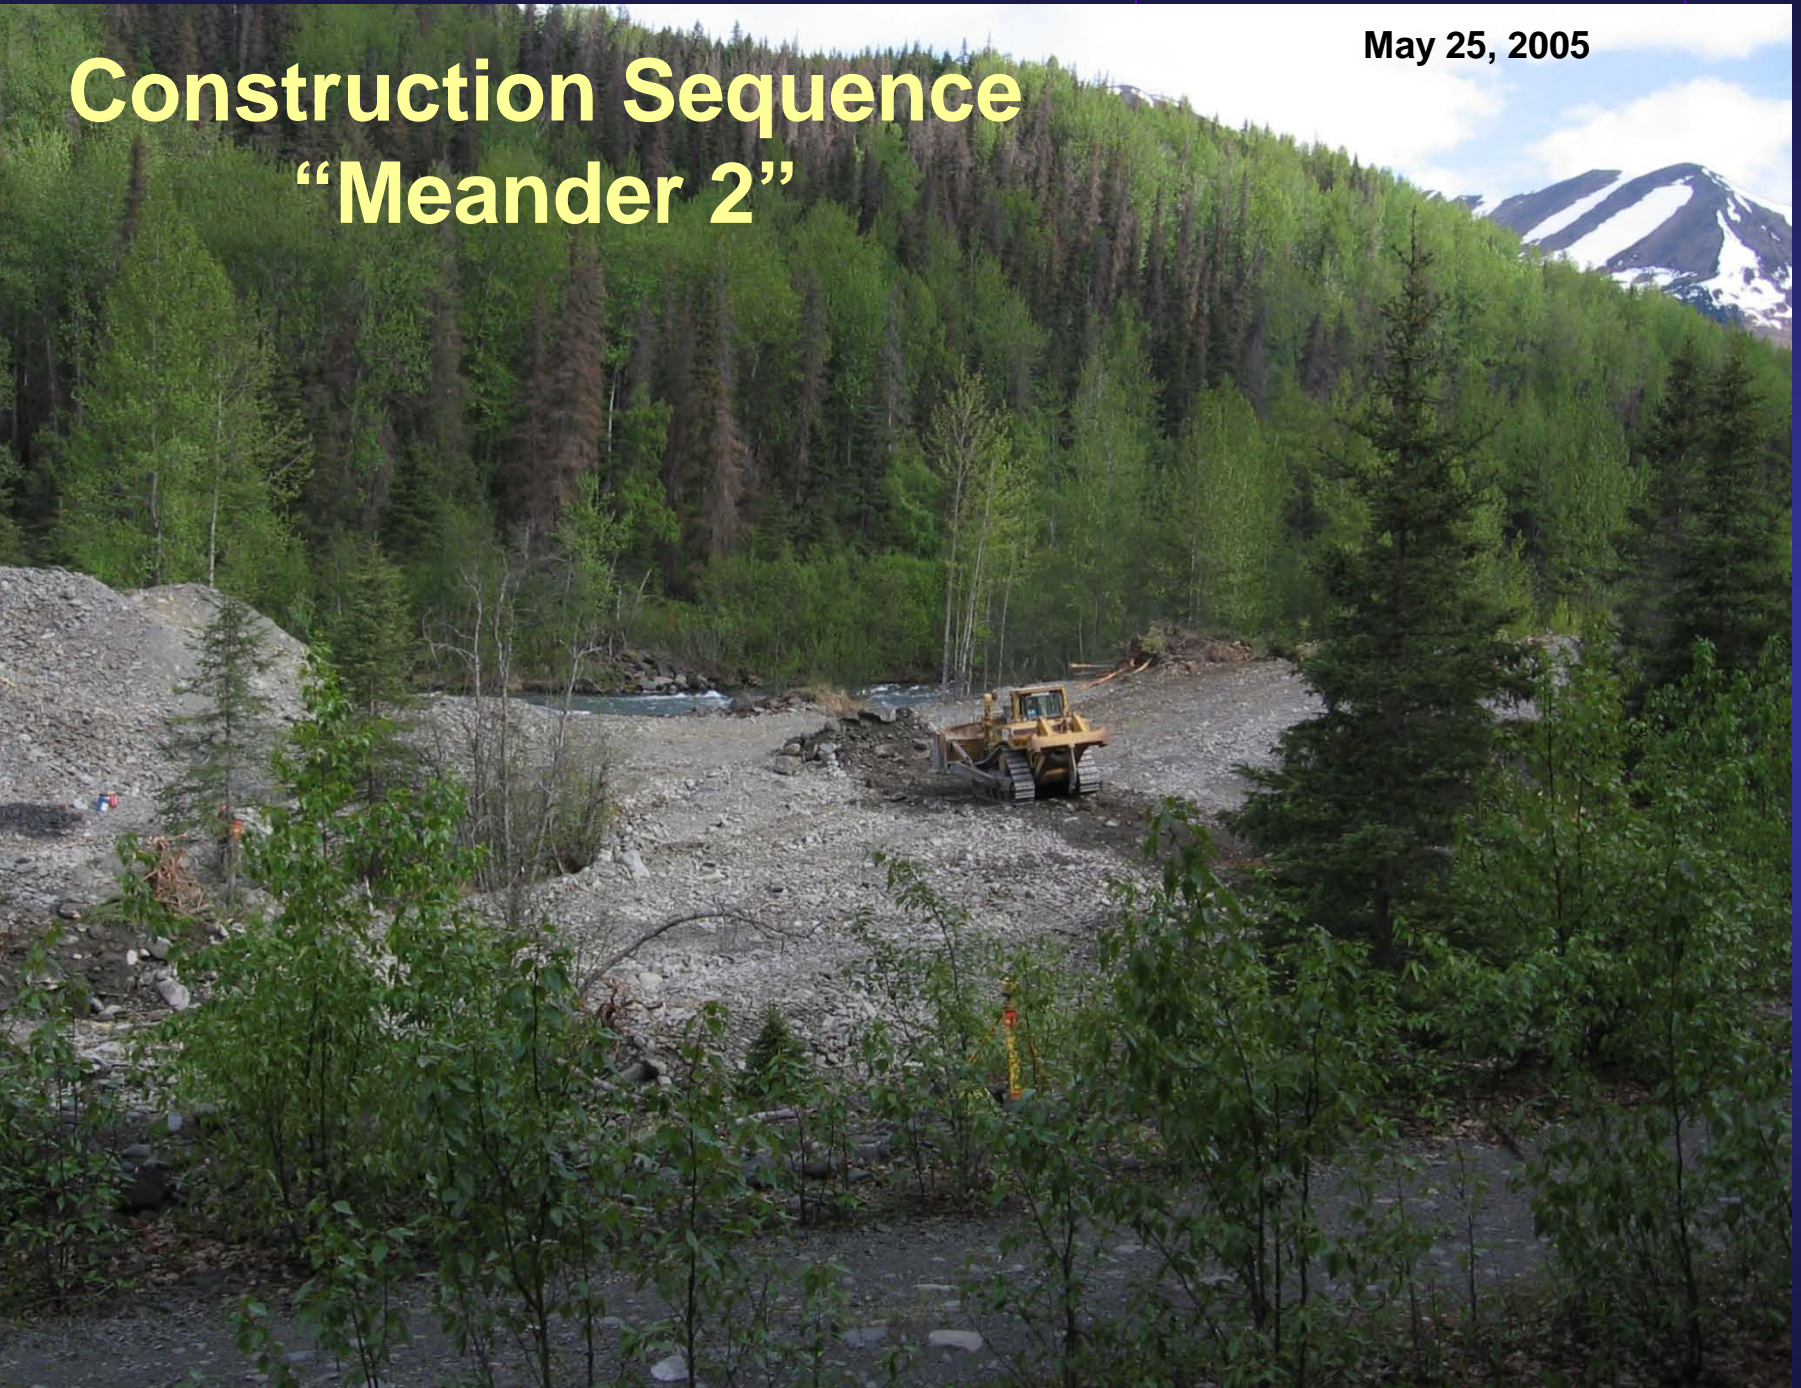
# Construction Sequence “Meander 2”

May 25, 2005

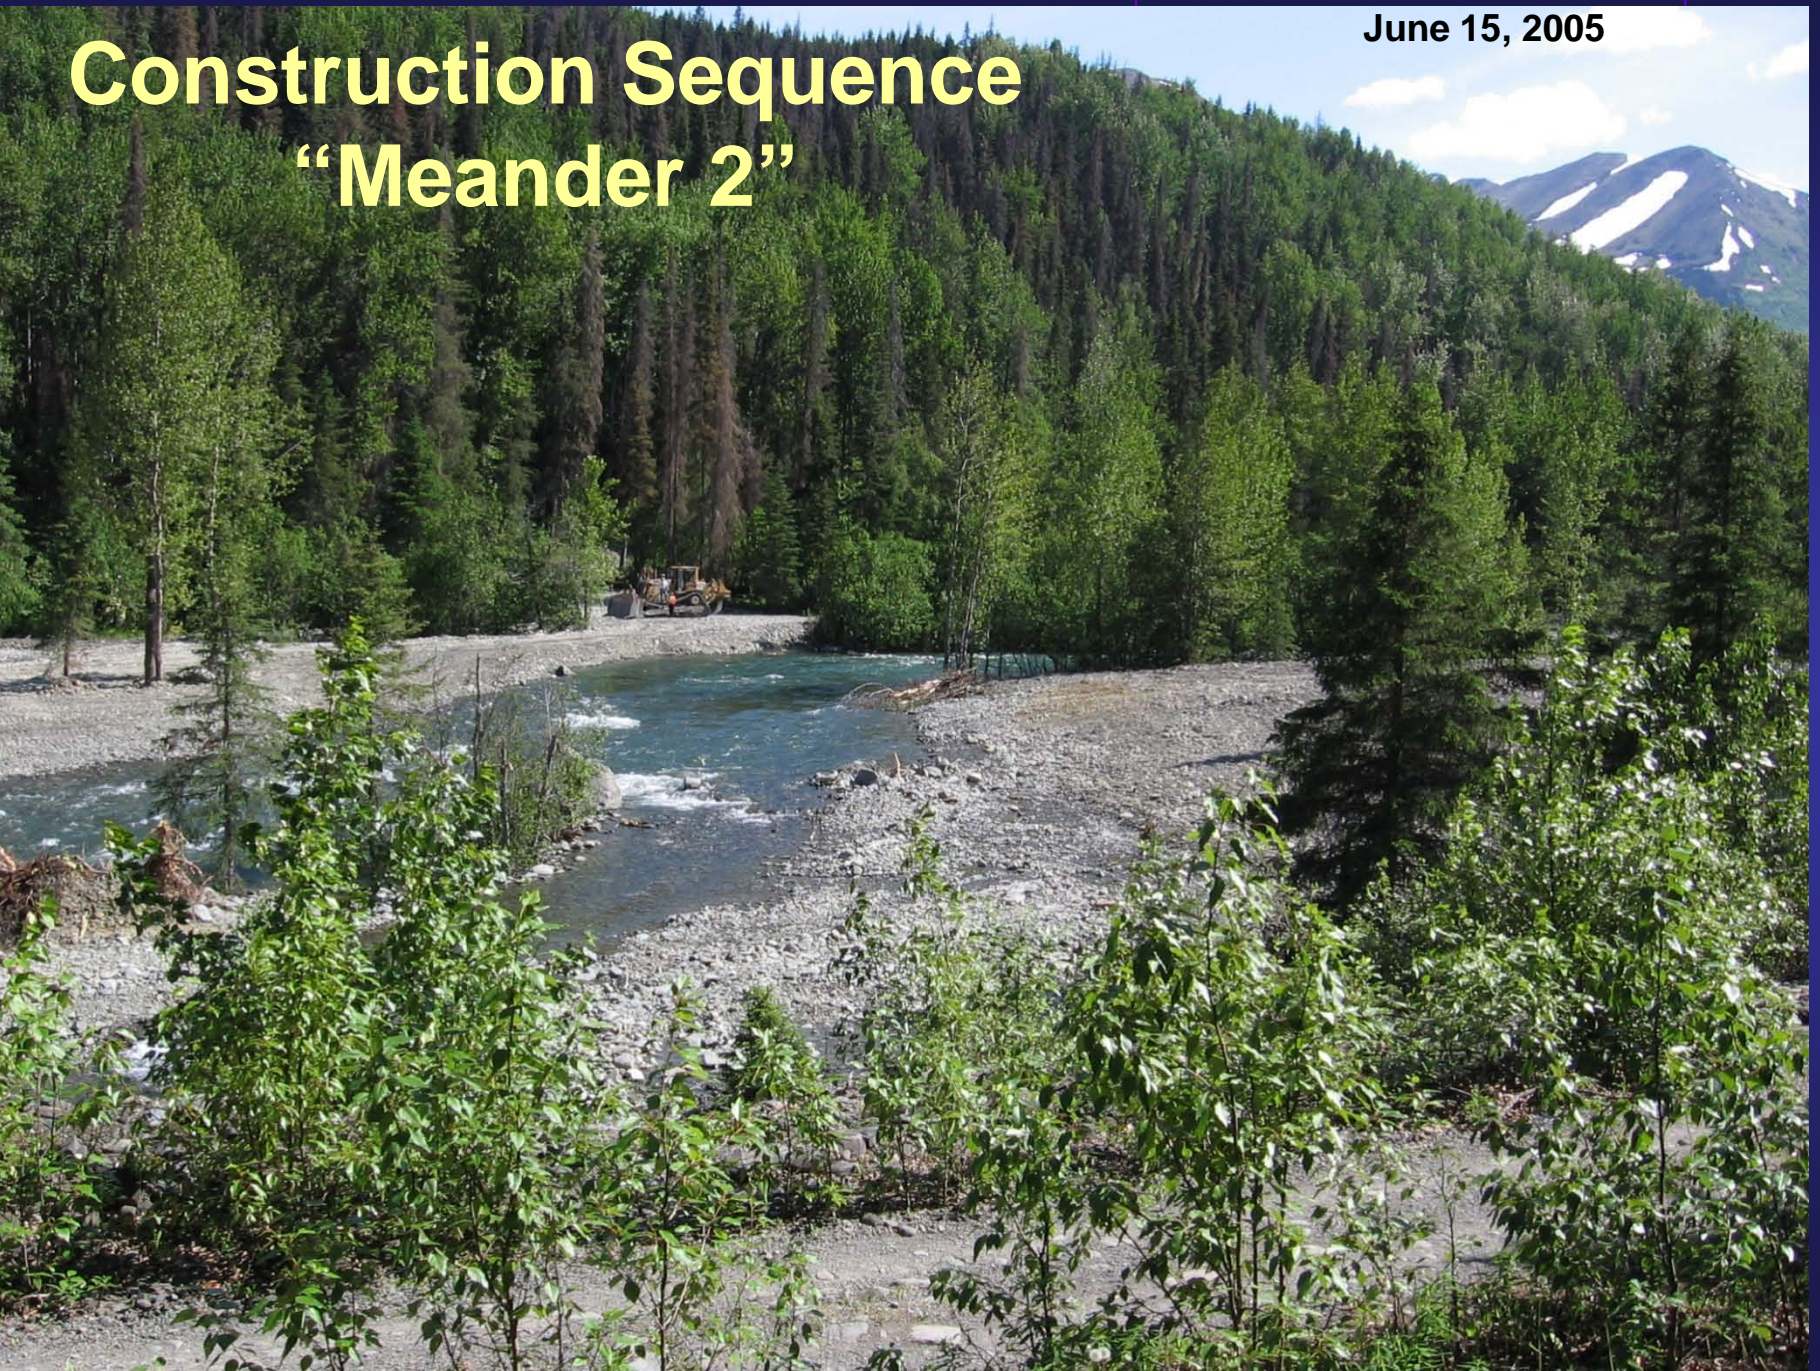
# Construction Sequence “Meander 2”

June 15, 2005

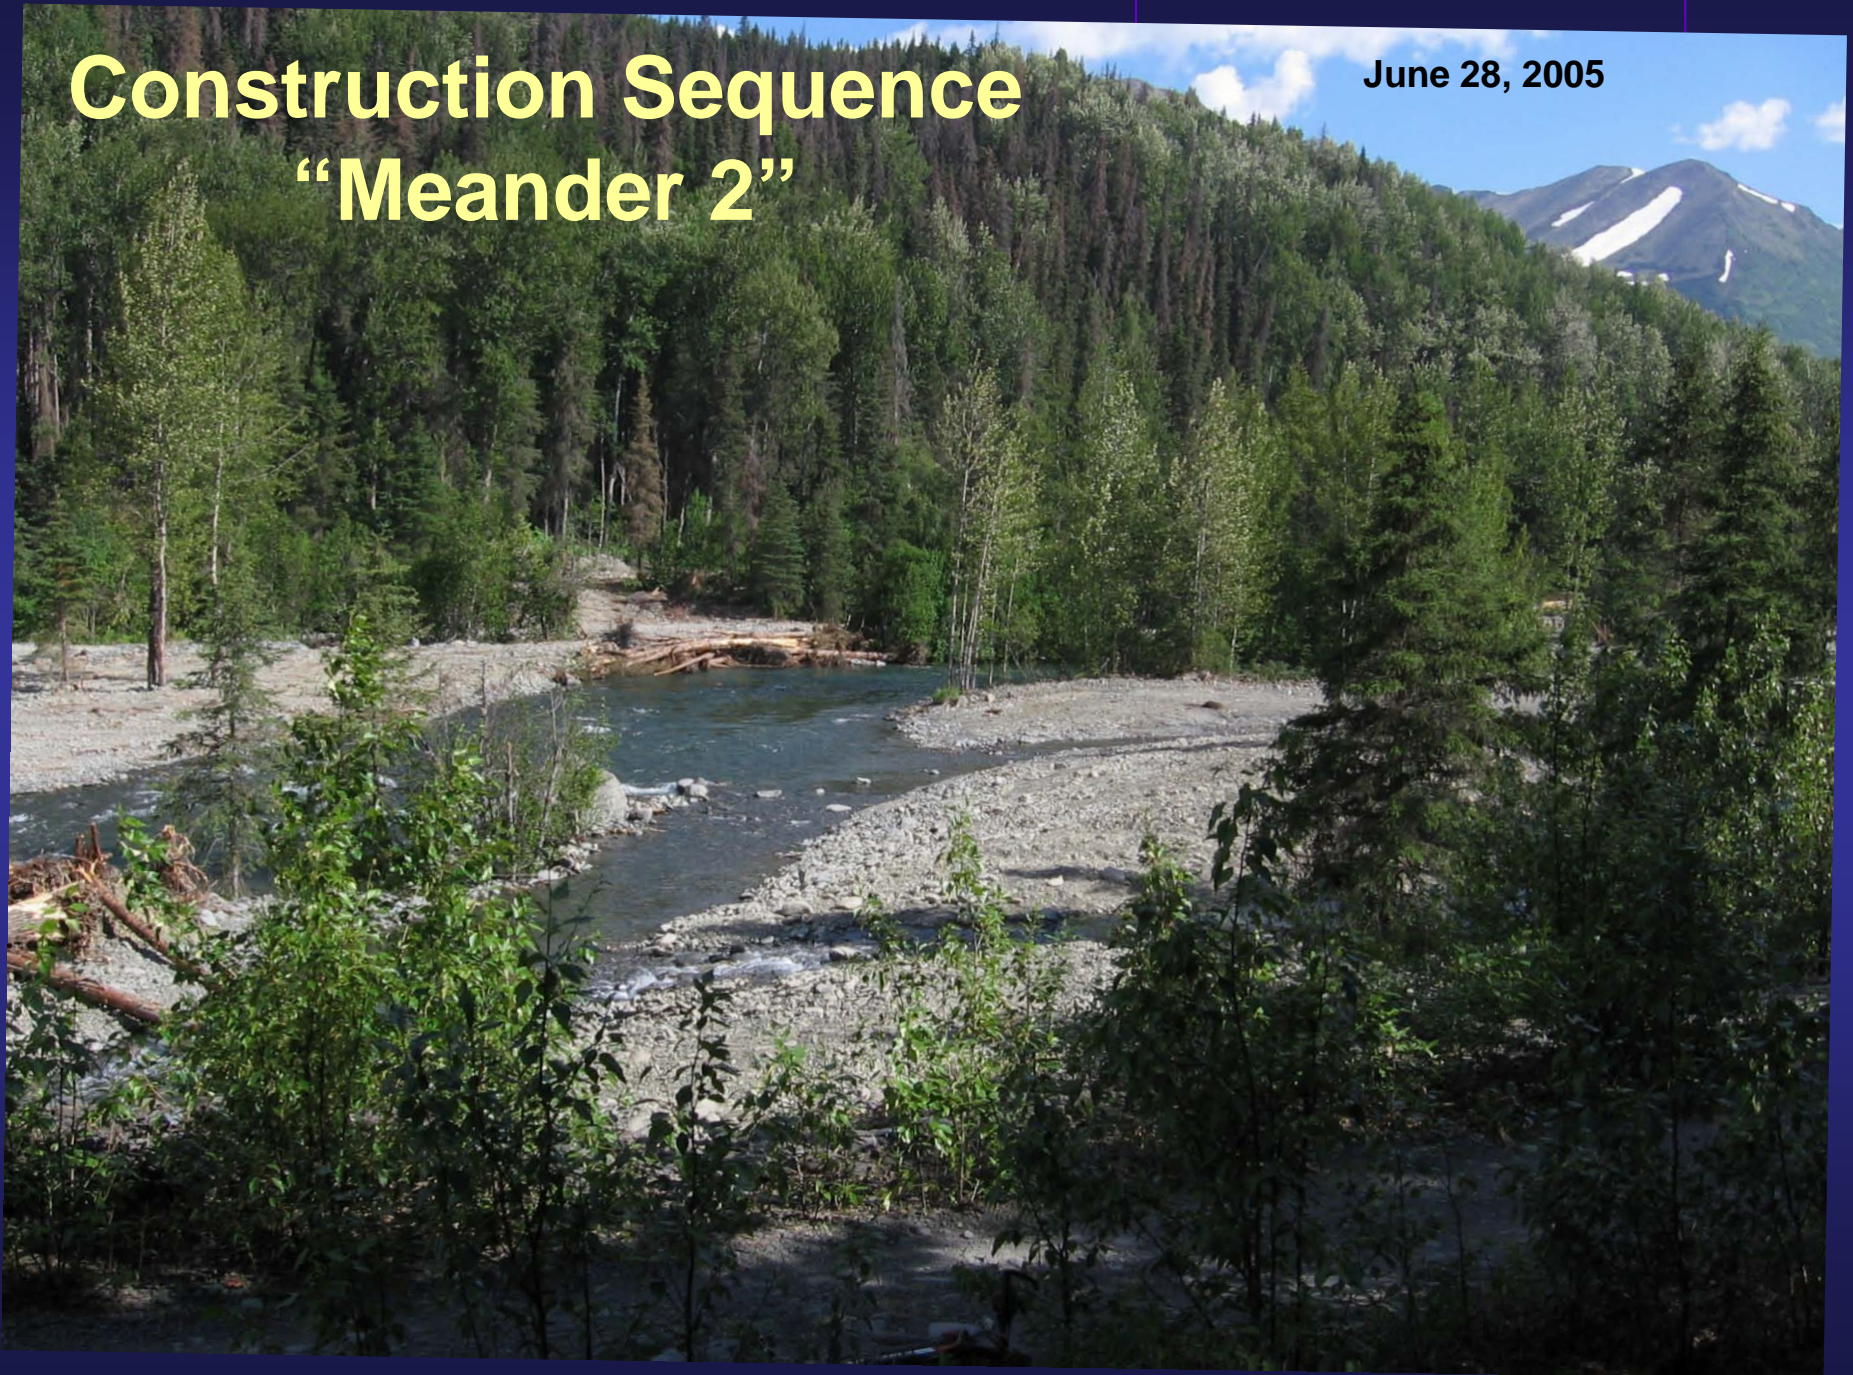
# Construction Sequence “Meander 2”

June 28, 2005

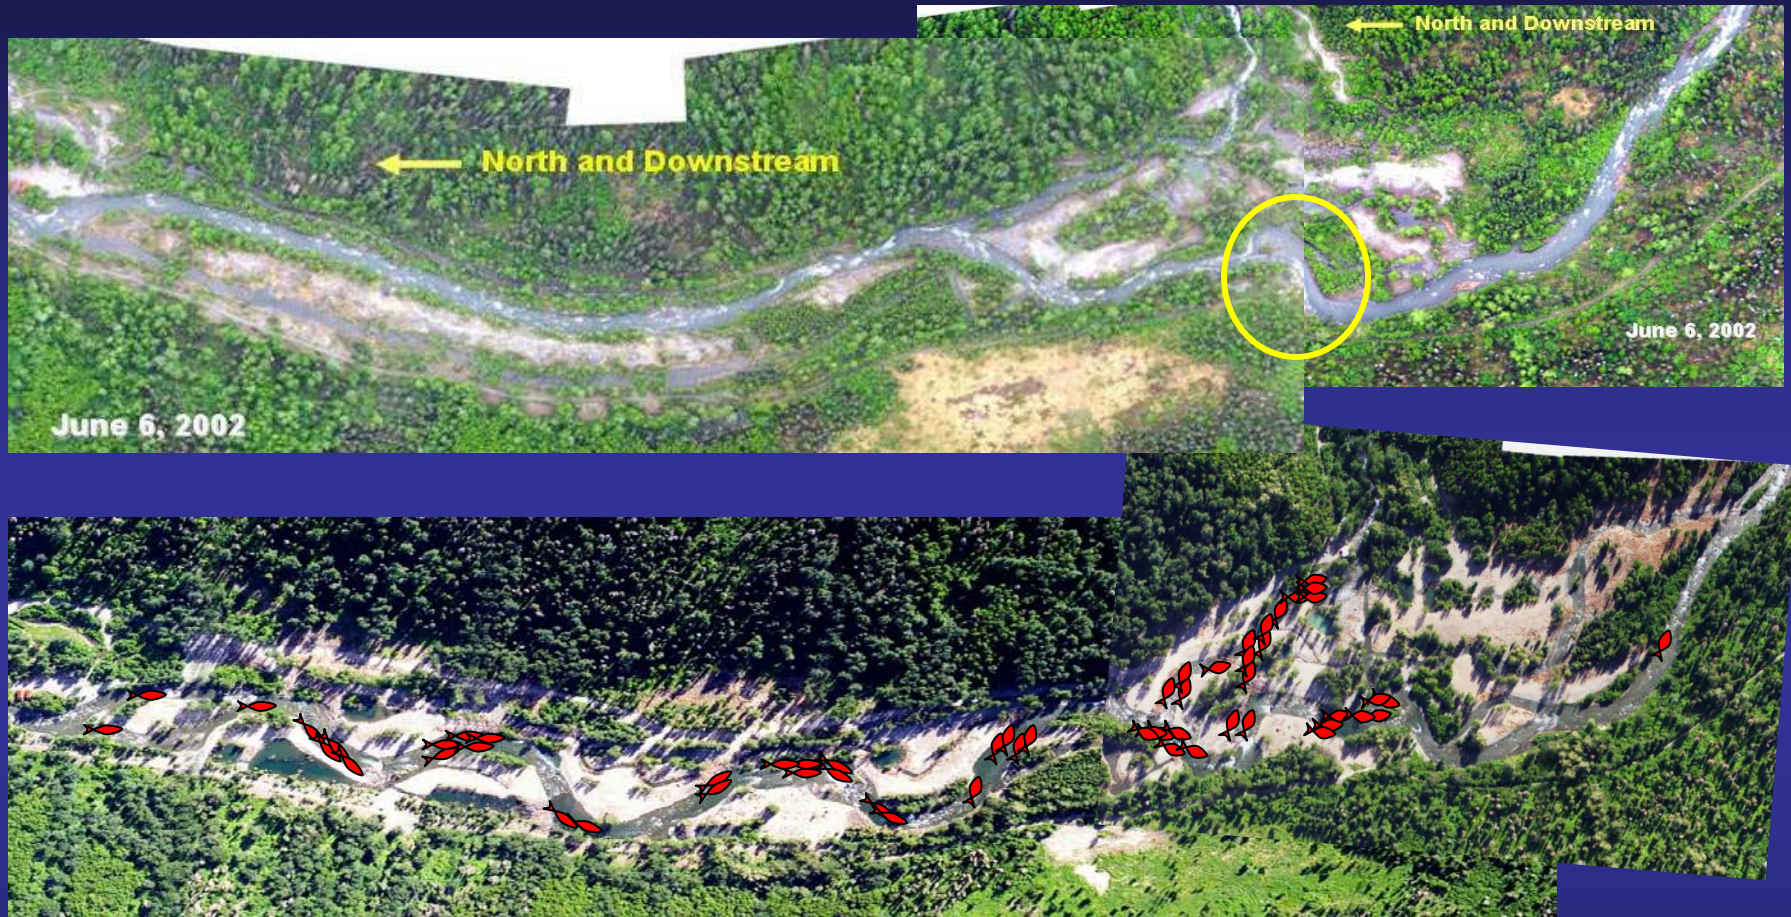
**Adult Chinook Salmon Locations  
Mid to Late in Run – August 3, 2006**

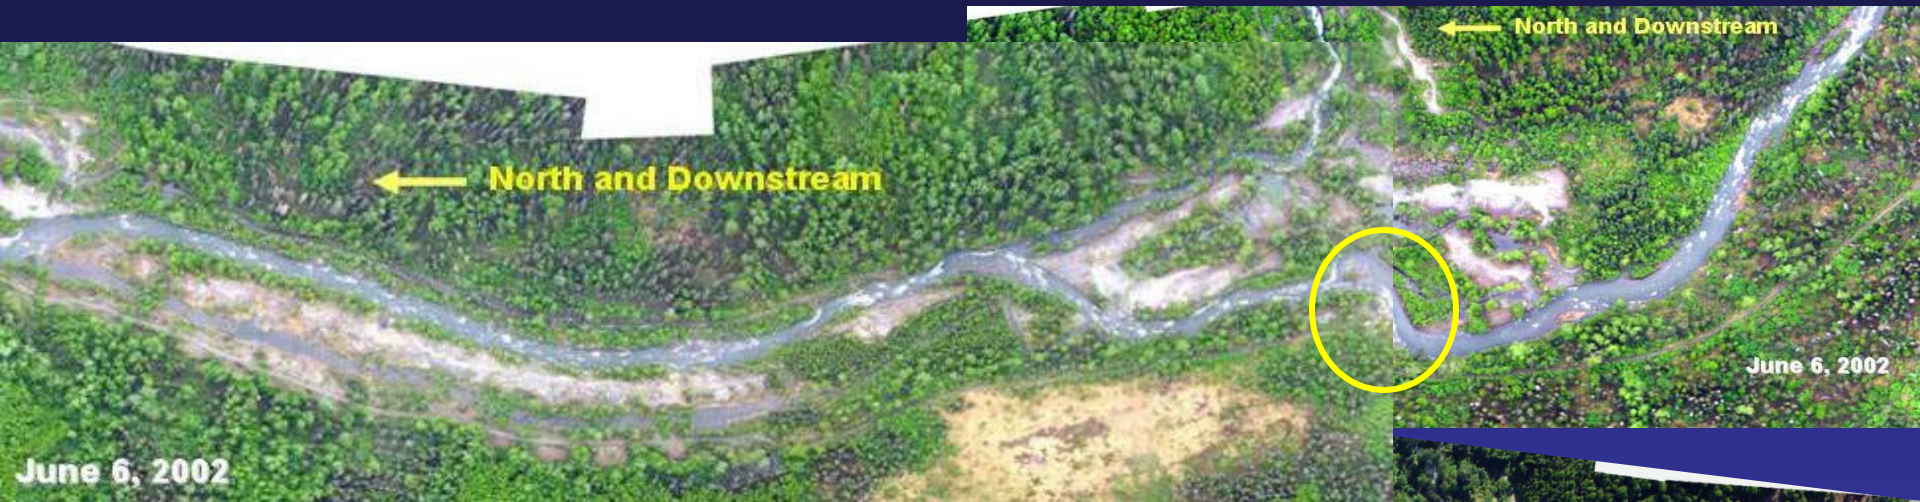
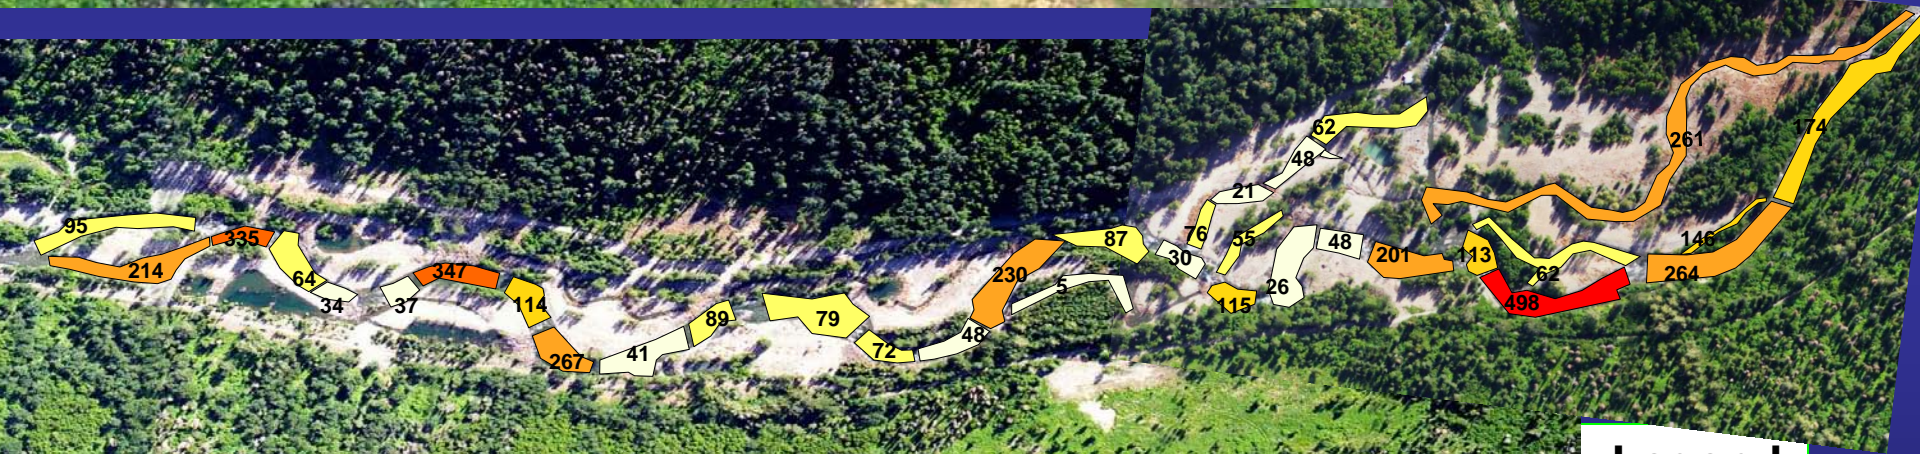
**Adult Pink Salmon Numbers by Location**  
**Peak of Run – August 17, 2006**
