## Little Tahltan River Chinook Assessment - 2016

Tahltan Fisheries

March, 2017

This report is a summary of the 2016 Reconnaissance Survey of the Little Tahltan Watershed, which was funded through the Northern Fund of the Pacific Salmon Commission. The overarching scope of this work is to look at physical habitat in the watershed and assess for factors that may relate to the decline of Chinook salmon escapement. The work in 2016 largely involved conducting an overflight of the watershed to photo-document the existing habitat, and installing a hydrometric station and gauging the main stem flows.

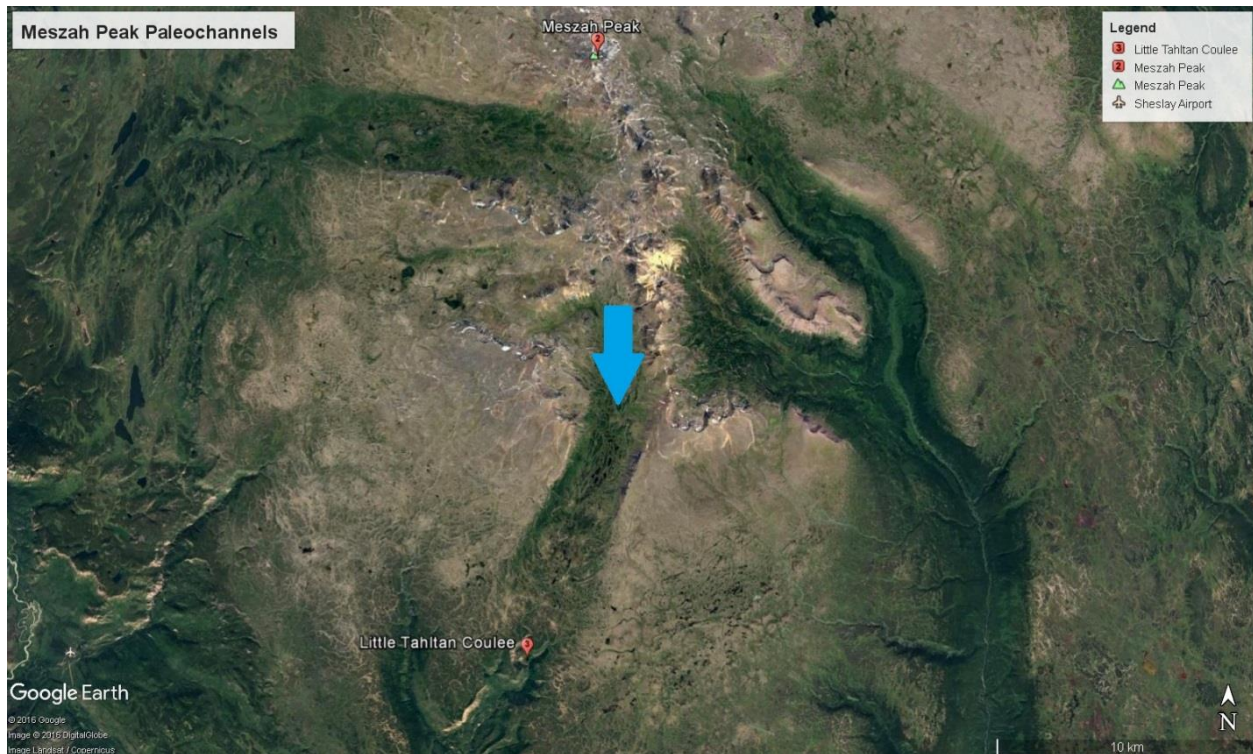
**Figure 3: A Google image of the Little Tahltan headwaters and Meszah Peak. The dark green channels are paleochannels emanating from Meszah Peak from massive outburst flooding. The blue arrow indicates the flow path toward the Little Tahltan River.**

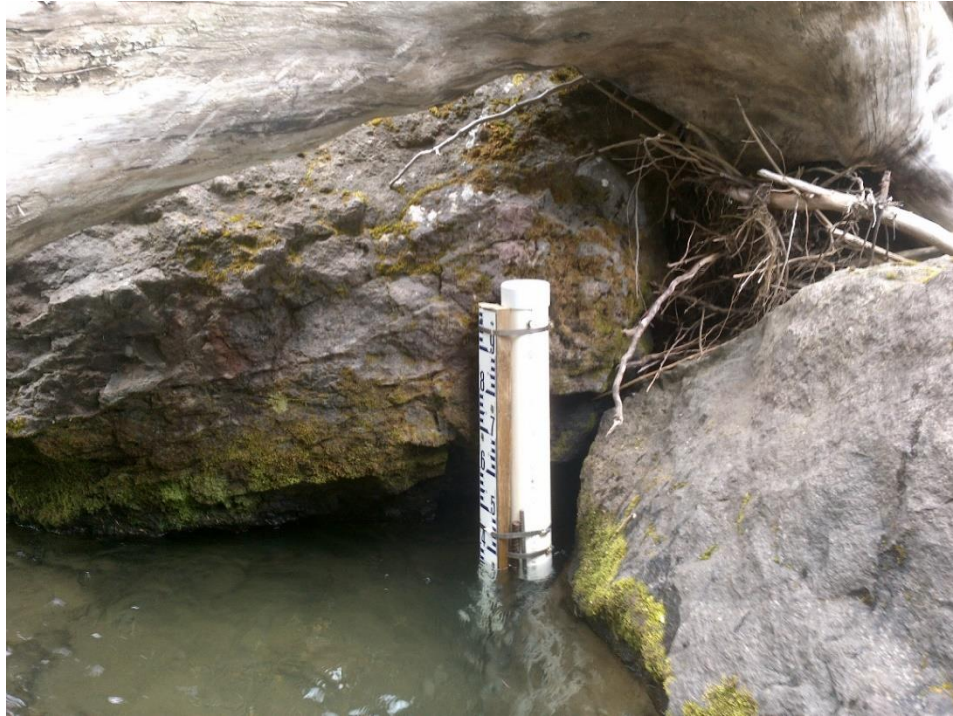
*Photo 1: The hydrometric station as installed on July 30, 2016.*

As a part of the scope of work a hydrometric station was installed approximately 250 meters upstream of the 2016 weir location. The station was instrumented with a Solinst pressure transducer and staff gauge and surveyed to a sturdy bench mark for hydrometric leveling. The flow was then gauged at a location between the weir and the hydrometric station. Survey notes and details are included in Appendix 2 and deployment records for all data loggers are in Appendix 3. Spot water quality data was also collected at the time of gauging. The data is included in Table 2 below.

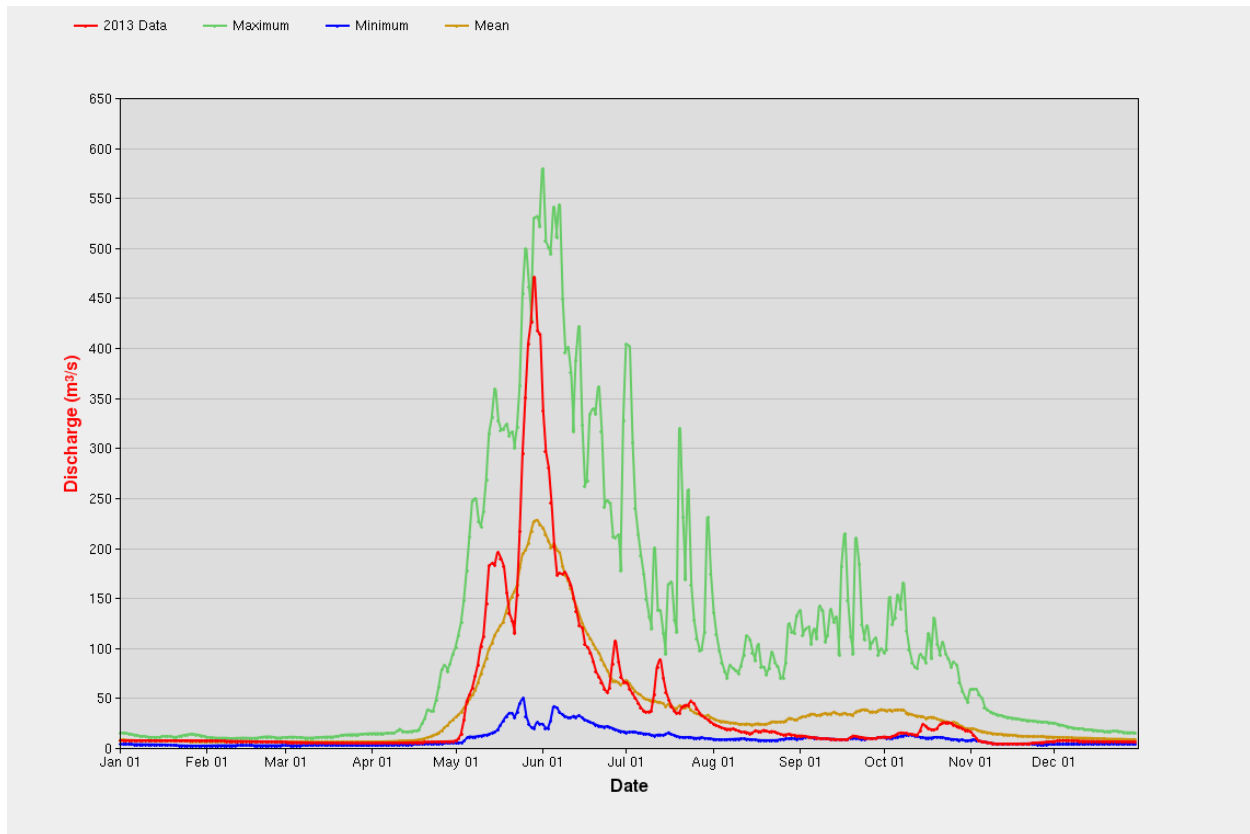
*Figure 4: Water Survey of Canada discharge data for Tuya River (WSC station 08CD001) is displayed to show the annual hydrograph pattern for Tuya River, the closest and most representative regional gauge.*

The gauging resulted in a flow estimate for Little Tahltan River on July 30, 2016, of 1.86 m<sup>3</sup>/s. Figure 4, below is a graph of Tuya River flows for the 52 year hydrometric record and the hydrograph for 2013 (the most recent 100% Quality Assured data). The plot shows a typical spring snowmelt driven hydrograph with a minor peak corresponding with fall storm precipitation. Their close proximity and geographical similarity make the comparison of Tuya and Little Tahltan data reasonably representative.

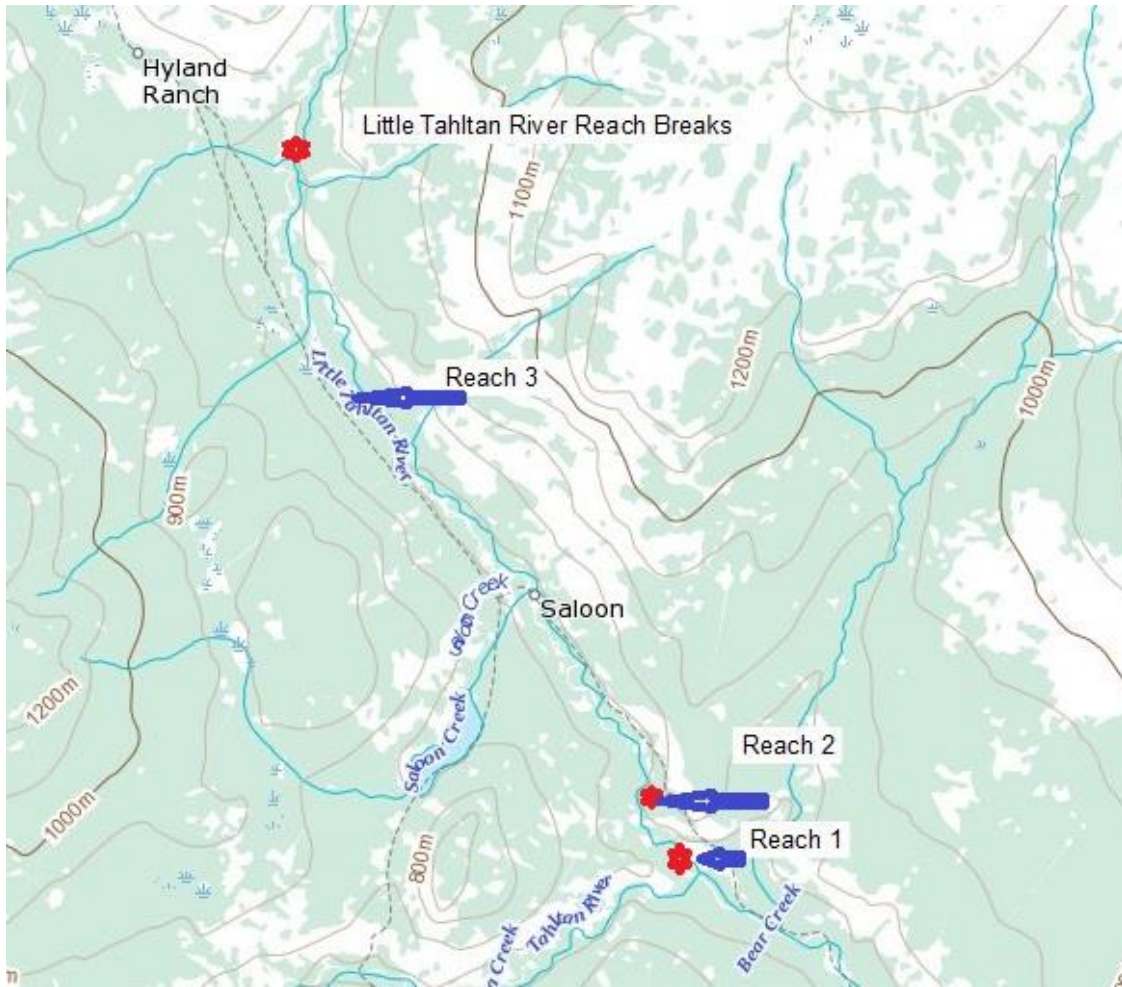
Figure 5: A map of the reach break delineation for the length of Little Tahltan River assessed during the field tour.

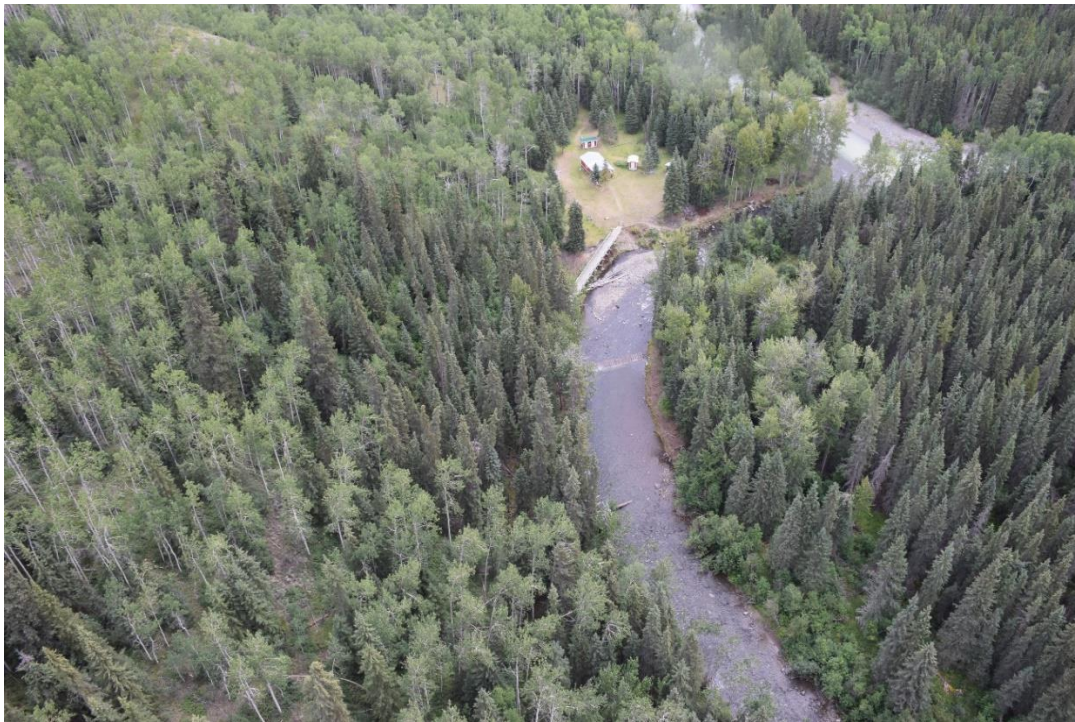
*Photo 2: Aerial view of Reach 1 on the alluvial fan.*

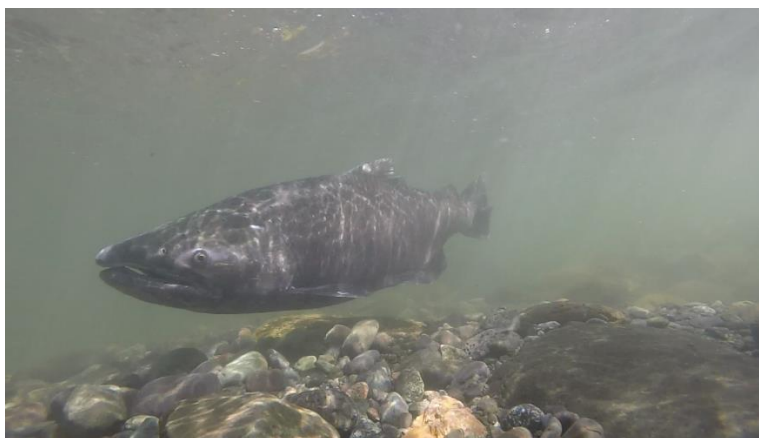
*Photo 3: Underwater shot of a Chinook at the gauging section in Reach 1 30 meters above the weir. The sediment mix of sands, gravels and cobbles with a boulder lag deposit is typical of the reach. Several Chinook pairs were observed spawning in reach 1 above the weir.*

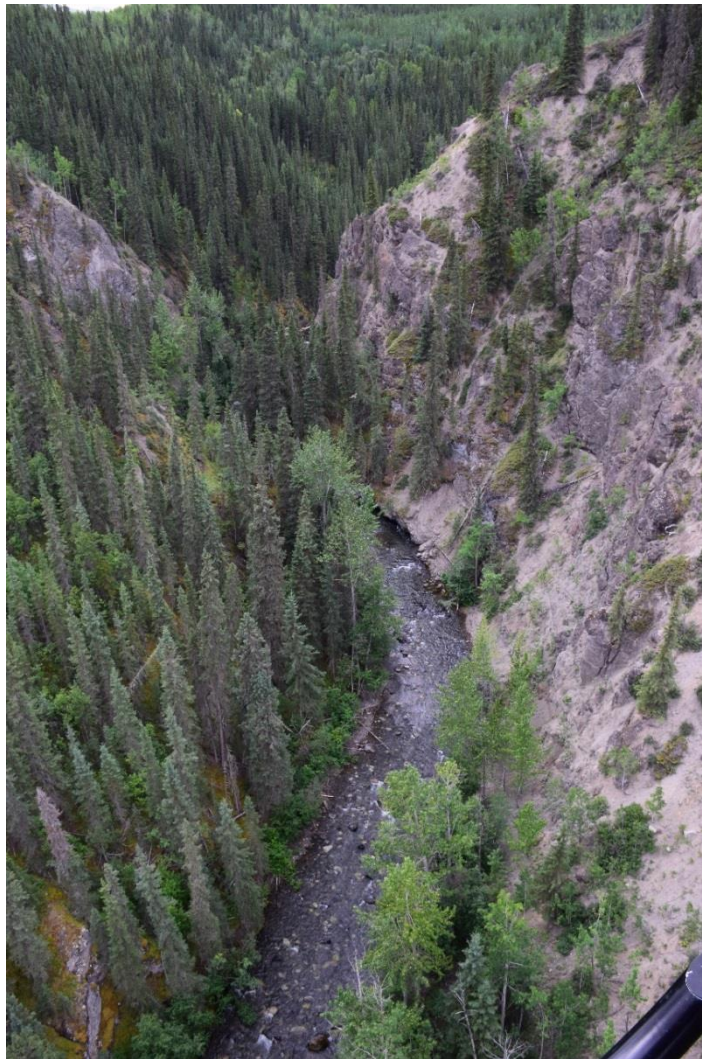
*Photo 4: Reach 2 from the air. This reach is confined in a bedrock canyon.*

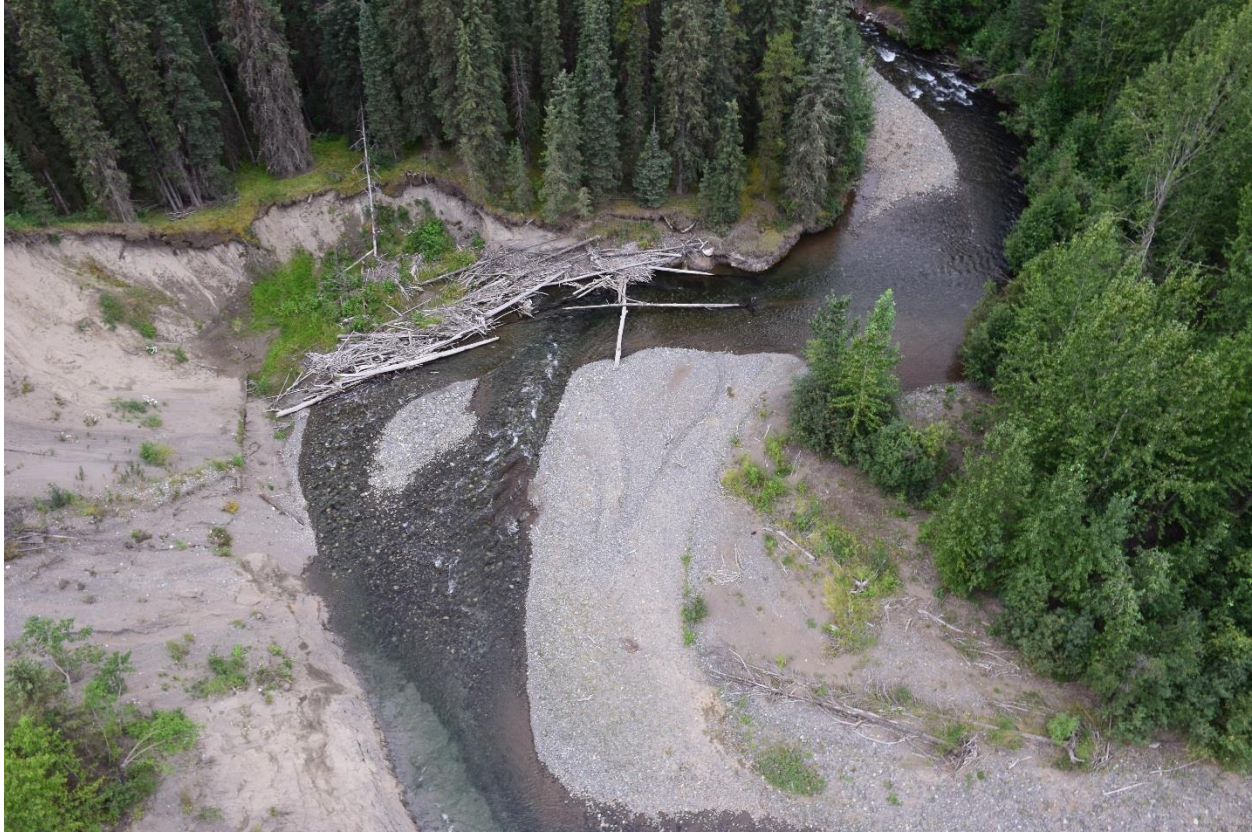
*Photo 5: The top end of Reach 2 where the channel is confined by alluvial deposits and bedrock outcrops. There is good channel complexity, bedload sources and deep holding water.*

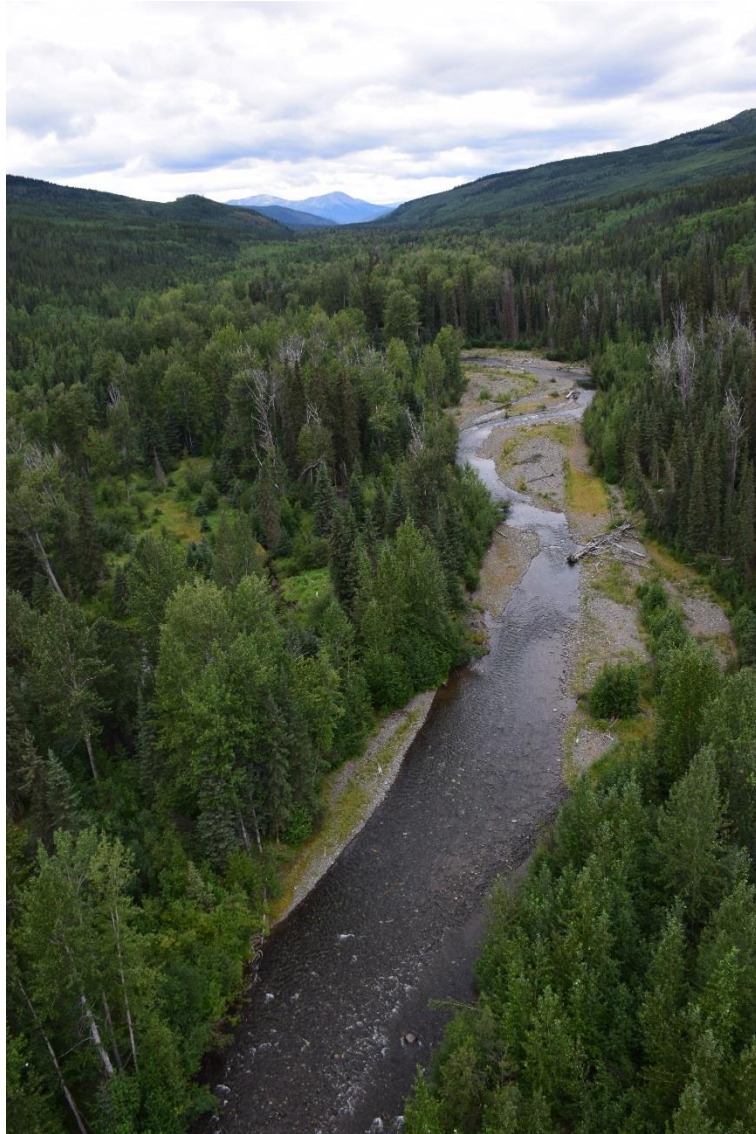
*Photo 6: Looking upstream from the Bottom of Reach 3. The wide valley flat is a paleo-channel emanating from Meszah Peak.*

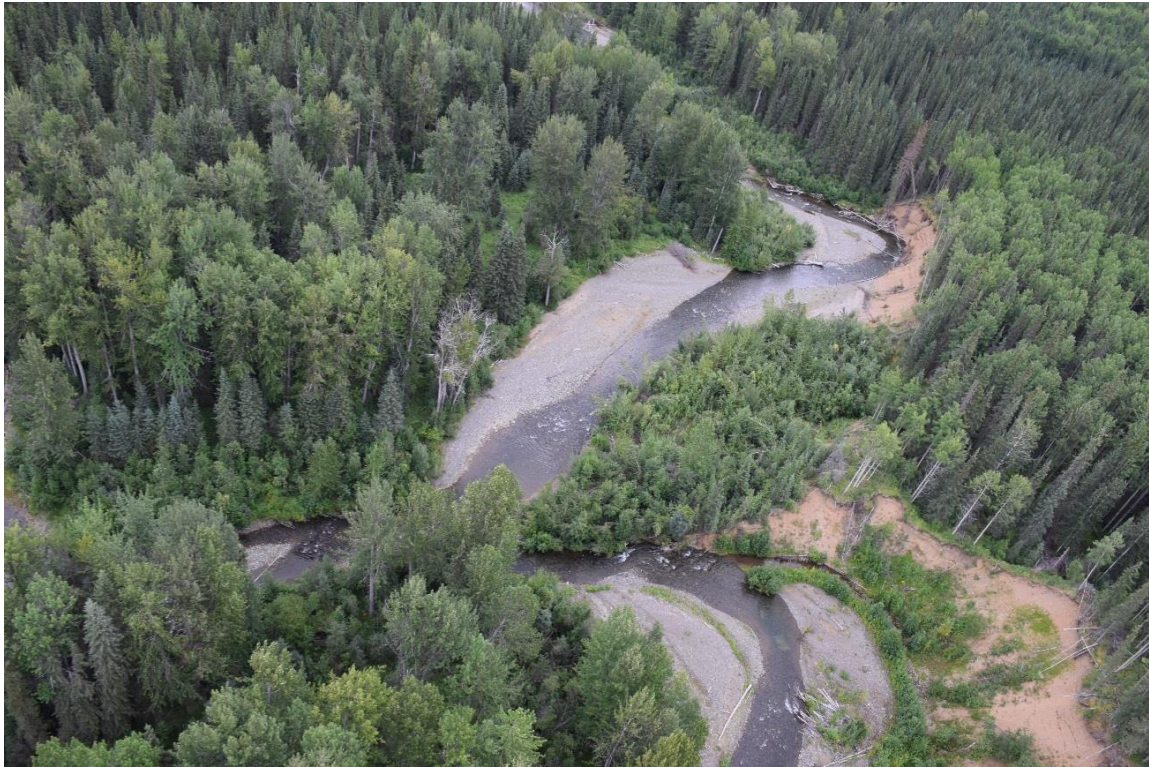
The recon overflight revealed that the braided reach has considerable off-channel habitat in abandoned channel scrolls, back channels and riparian wetlands (See photos 7 and 8 below.) Despite the fact that the photo was taken during extreme low flow there is still considerable wetted area and good holding pool structure and channel complexity. The lower half of Reach 3 had the greatest density of spawning activity at the time of the overflight. Photo 8 was taken in the lower half of Reach 3 and shows the braided channel morphology and extensive active gravel sources. The floodplain / meander plain showed areas of surface ponding and forested wetlands indicative of a high water table and groundwater discharge.

*Photo 7: Aerial photo at the middle of Reach 3. The photo shows a braided section of the channel with active sediment sources.*

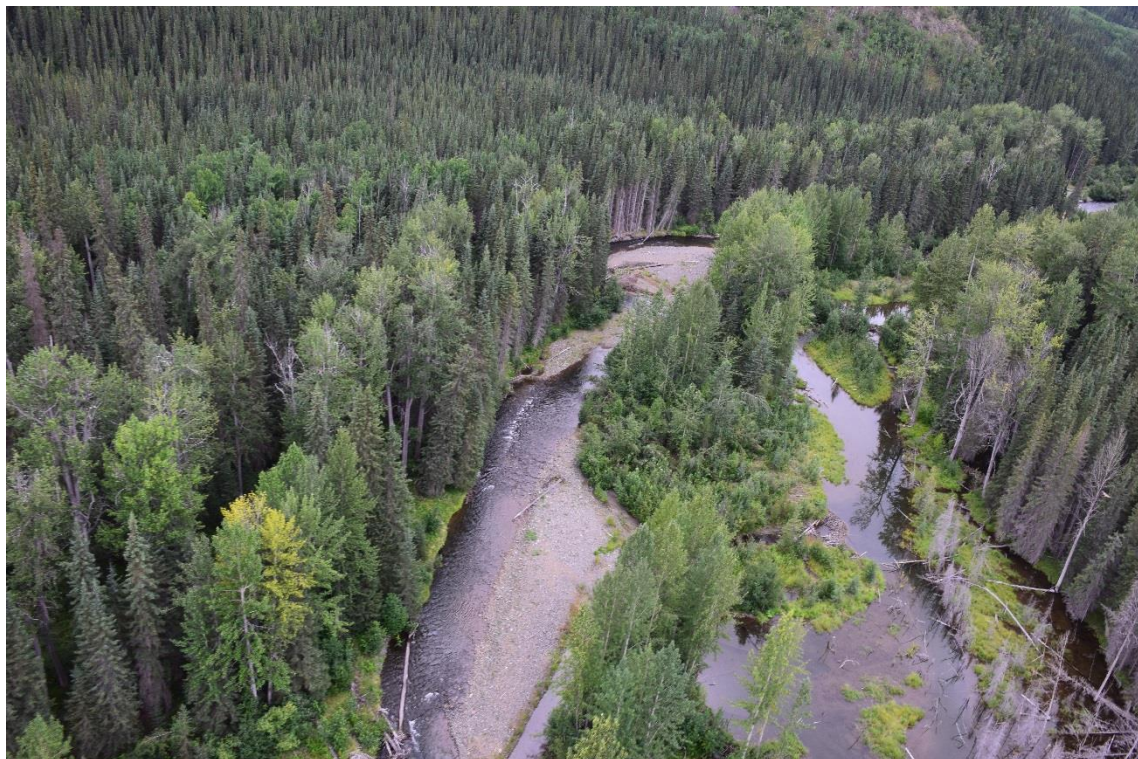
*Photo 8: View of forested wetlands and side channels in the lower half of Reach 3. It is noteworthy that the picture was taken at a near 10 year recurrence interval low flow).*

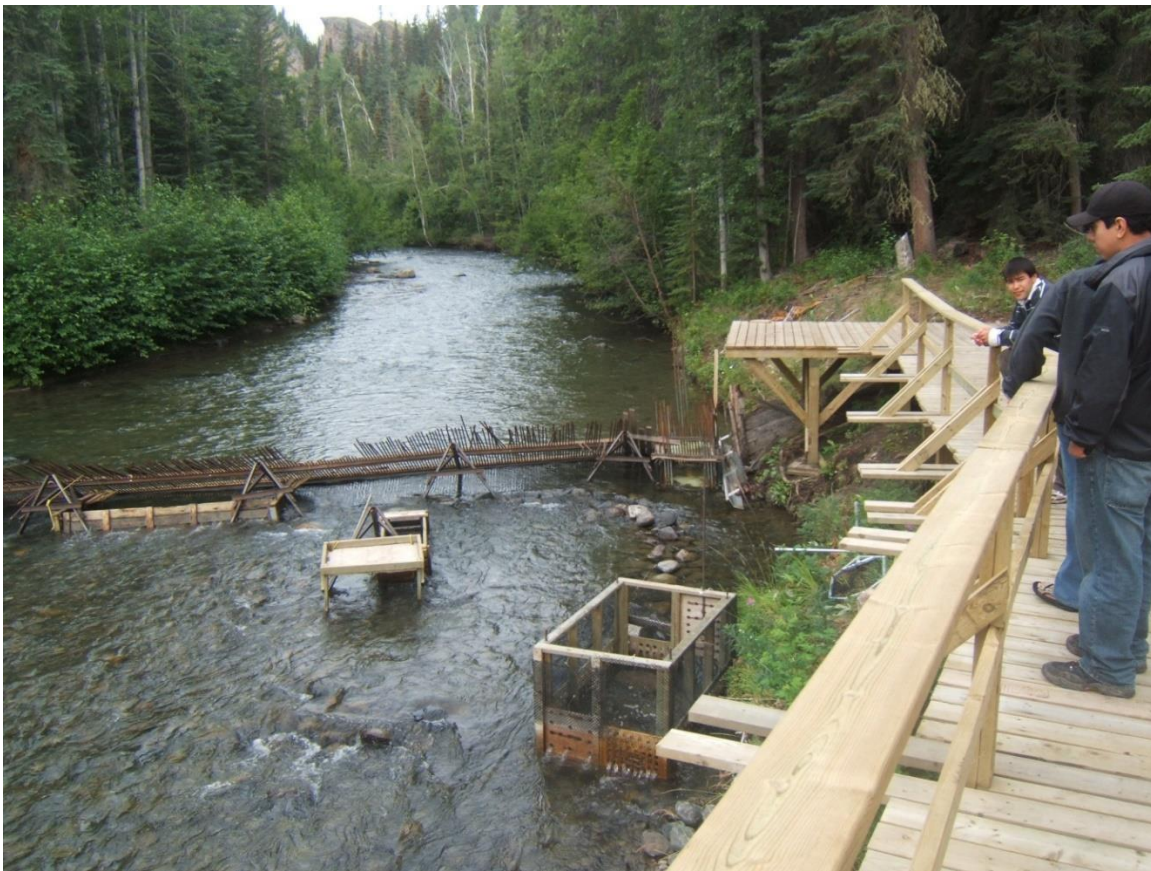
**Photo 9: Little Tahltan weir July, 2006.**

- Having all capture structures for sampling on the downstream side. This included a back out trap and trough below the weir. (See Photo 9 below);
- A lack of water depth and attraction flow thru the counting area on left bank;
- Highly apparent grizzly bear fishing activity in and around the weir structure;
- Some Chinook holding behind the weir area and at times returning downstream.

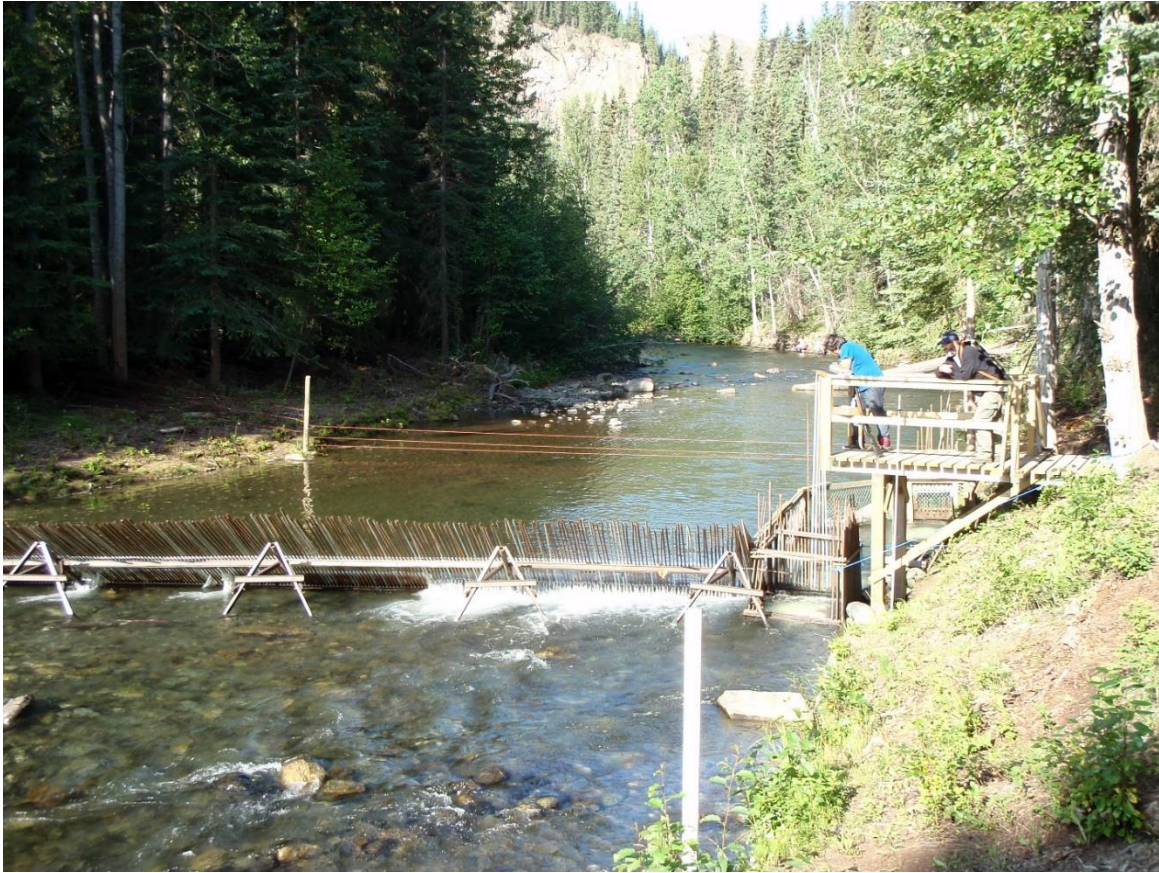
**Photo 10: Little Tahltan weir July, 2016.**

In 2016, after discussions at the TTC and between DFO and Tahltan Fisheries, multiple aspects of the weir configuration and operations were implemented. (See Photo 10 above.) These changes included:

- Installation of the sampling trap upstream of the fence, on the left bank;
- Movement of the weir placement upstream somewhat, into deeper water;
- Directing water to increase attracting flows;
- Setting up a lighting system to allow counting and sampling of fish during dark time periods;
- Installation of an electric fence around the weir perimeter to keep bears out, (which has been done for a number of previous years).

During the site visit in late July 2016, with the above adjustments made, both the weir configuration and operations appeared to move Chinook thru quite efficiently. As well, the weir staff was clearly diligent in efforts to move Chinook thru in an efficient manner. Chinook tended to move into the upstream trap relatively quickly, bear observations were minimal and outside of the weir perimeter. The 2016 weir count was 923 (large fish).
