Kuthai Lake sockeye review -2015

Final Report

March 22, 2016

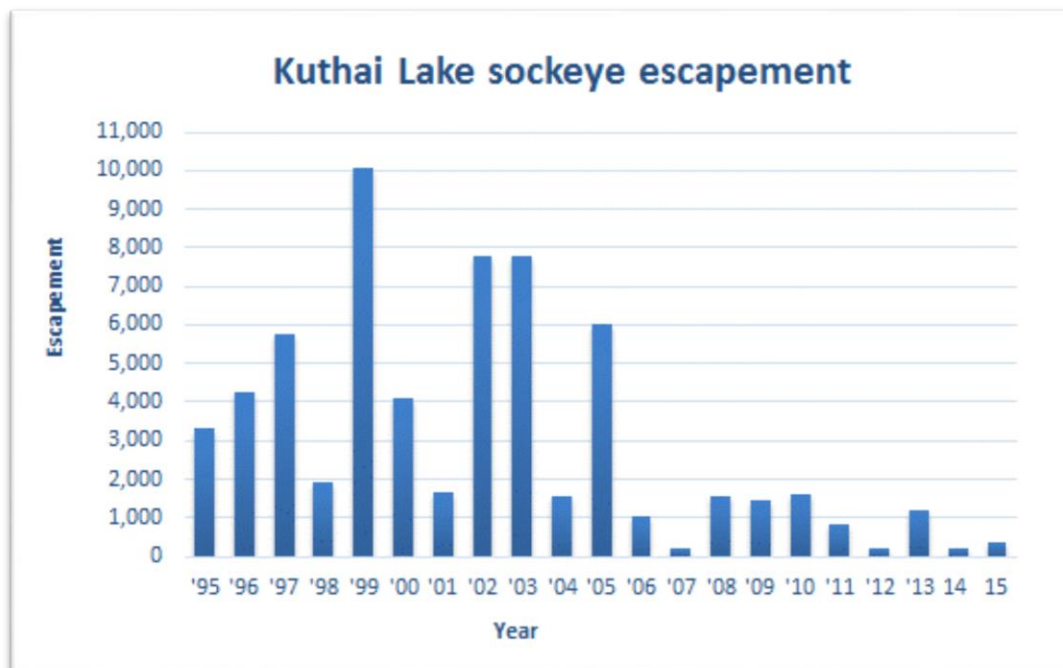
Figure 1: Yearly Kuthai Lake sockeye escapement

Kuthai sockeye escapement has been low for numerous years and does not seem to be recovering. The 10-year average escapement from 2005-2014 was 1,423 while the previous period from 1995-2004 it was 4,818. Sockeye escapement to the lake in 2015 was 341. Although run-sizes and escapements are known to fluctuate over the longer-term, during the last 9 years we have not seen a rebound in the cycle. Also, within that period there have been 3 years of escapements in the range of about 200 fish. Such a low level of escapement has not been observed prior to 2007.

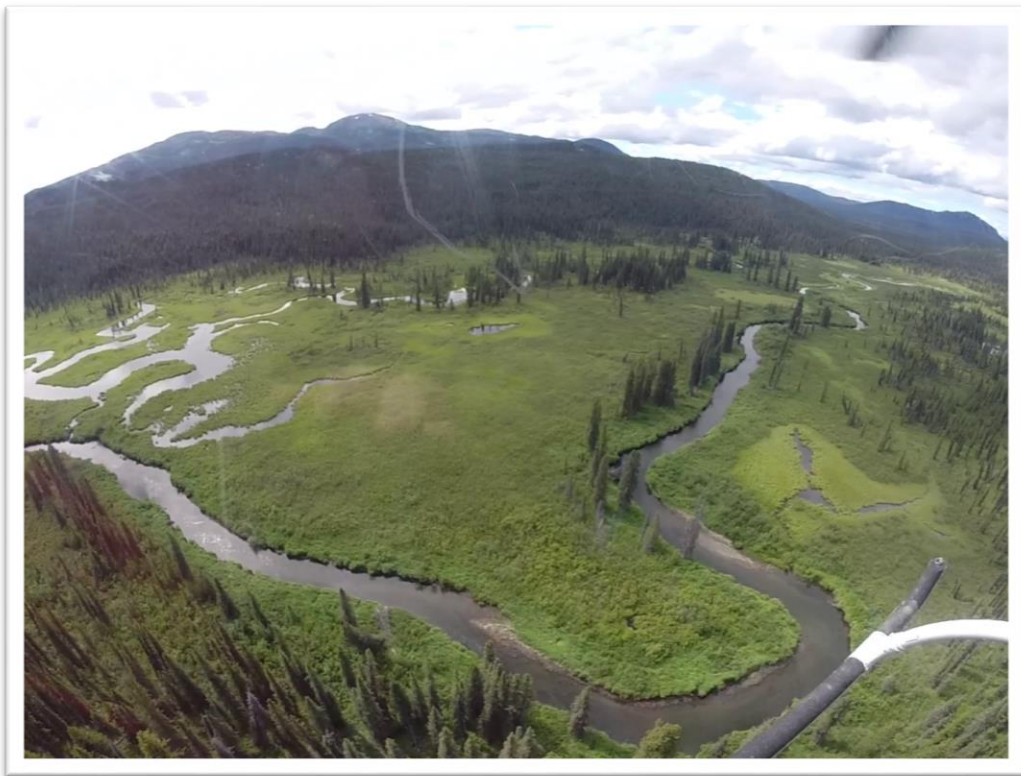
- **Reach 3:** This is the 13 km meandering riffle / pool section of Silver Salmon River channel that traverses the plateau area in the center of the watershed. Lower gradient and abundant glacial fluvial sediments create a channel with sinuous meanders, oxbow cutoff channels, and extensive areas of riparian wetlands. This reach provides excellent beaver habitat as evidenced by the series of main stem and off channel beaver dams and lodges in various stages of repair. Although fairly numerous beaver dams were observed in Reach 3, all but one appeared to be open or breached, and no sockeye salmon were observed holding below the dams.

Photo 3: Aerial view of Reach 3.

(Showing the meandering channel and riparian wetlands characteristic of this reach.)

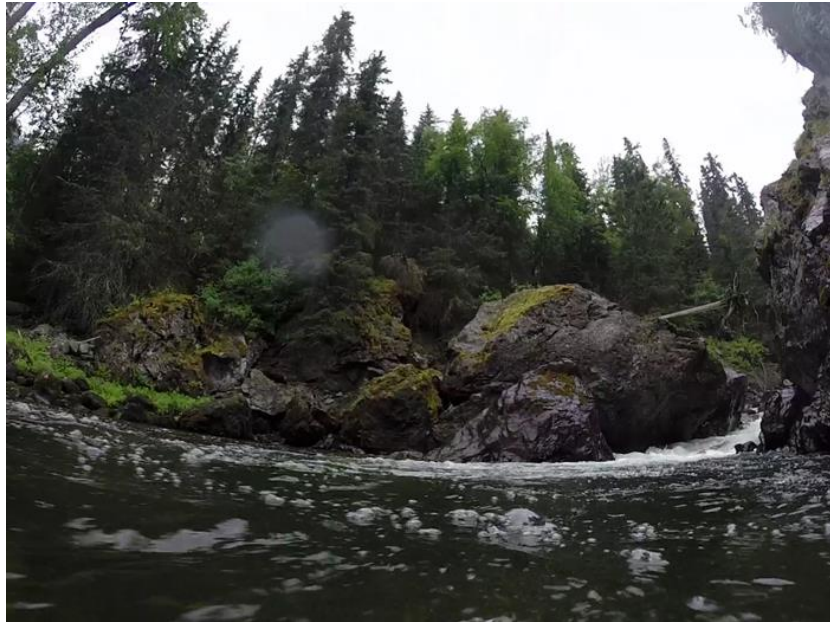
The crew hiked to the two most problematic jump height obstacles at the top and bottom of Reach 1 for inspection. The first of those is immediately above the Nakina River and consists of a boulder cluster jump height obstacle. This obstacle was complex with jump height, turbulence and staging pool depth issues.

Photo 5: Migration obstacle immediately above the Nakina confluence.
(View from water level.)

1. The highest priority should be clearing of staging pool clasts that may be impeding the pool hydraulics and limiting achievable jump heights. This could be a staged process starting with the obstacle at the Silver Salmon / Nakina confluence and progressing upstream. Performance criteria would rely on the escapement results. Boulders removed from the staging pool could be placed to enhance the backwater effect at the tail-spill of the pool which would reduce jump heights and improve staging pool hydraulics;
2. Investigate the potential for implementation of a steep pass fishway at the Nakina / Silver Salmon confluence obstacle that could be put in place during the migration

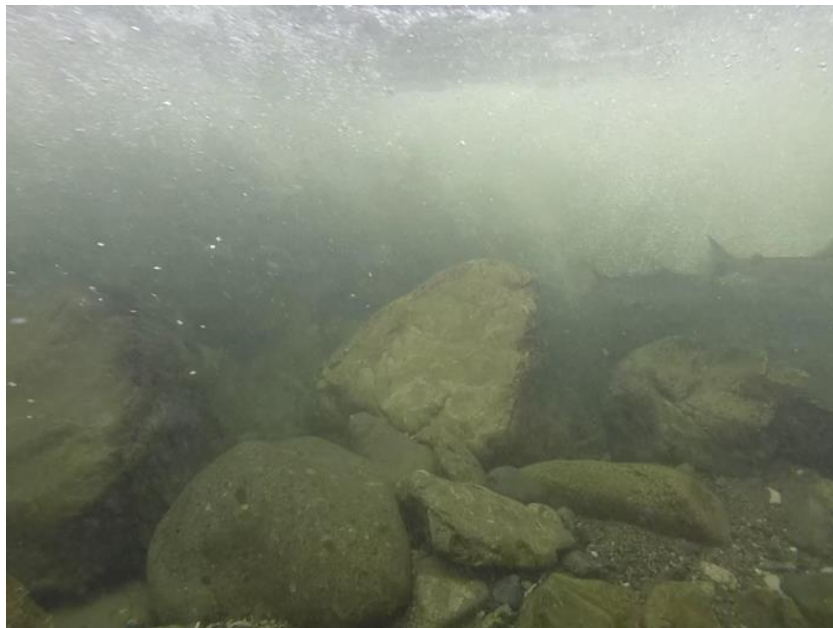
It was difficult to see into the pools due to depth and turbulence. However, some sockeye salmon were observed visually or by underwater camera.

Photo 6: Staging pool underwater view with holding sockeye.
