Slamgeesh Camp Infrastructure Improvements

Northern Fund Project NF-2012-I-14

Gitksan Watershed Authorities

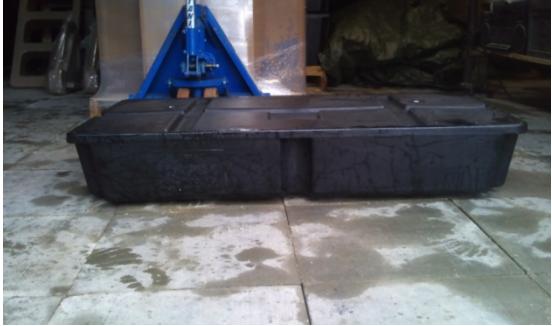
Figure 1. The Western Dock AP8 polystyrene floats used for the new dock, each measuring 24"x48"x8".

The new main dock on Slamgeesh Lake was rebuilt at the same location at the edge of the camp. The dock was enlarged to 12' x 16' compared to the old 8' x 12' structure. The frame was framed with 2x8" pressure treated lumber and covered with 2x6" pressure treated lumber. Galvanized carriage bolts, lag bolts and Simson Strong-Tie GA2 galvanized reinforcing angles were used to secure the frame. There are 16 floats supporting the main dock. The polystyrene floats are Western Dock AP8 Units, each measuring 24"x48"x8" and each supporting up to 250 pounds (Figure 1). The smaller T-section leading to the main dock is approximately 6' by 12', framed with 2x8" pressure treated lumbers and supported by four floats. Heavy duty galvanized hinges (Figure 2) were used to connect the two sections so that they could be disassembled and the smaller section loaded onto the larger float for winter storage. Skids were attached to the bottom of the floats of the smaller section to enable this maneuver. The decking throughout is 2x6" pressure treated lumber, secured with screws and spaced approximately one half inch apart. A walkway was later installed to provide easy access to the dock from the uneven shoreline.

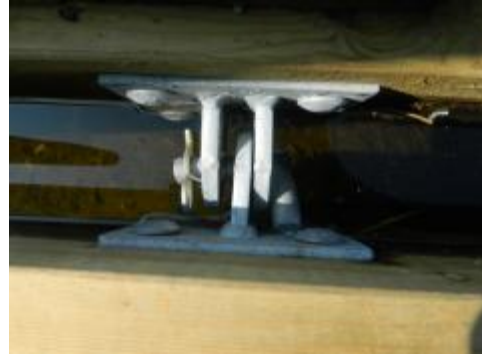
Figure 2. One of two heavy-duty hinges joining the two sections of the dock.

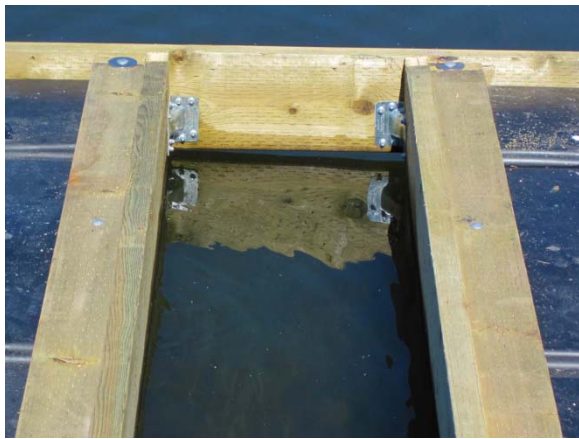
Figure 3. Simpson Strong-Tie galvanized reinforcing angles were used to connect the structural members. Note attachment of float units on right and left.

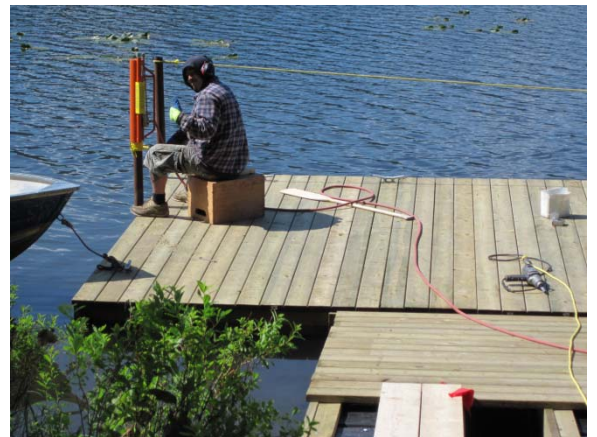
Figure 4. Instalation of drill pipe protection around dock.

Docks in this region need to survive wind-driven ice movement during spring melt. Since the adjacent shore is too steep to store the dock on land, we designed the dock to withstand the pressure of ice flows in the spring. The new dock perimeter is secured with 2" metal drill pipe. An air compressor driven pile driver was used to pound four pipes on each side of the main dock (Figures 4,5). The pipe are in the lake bottom about four feet and were cut off so that they remain approximately two feet above the dock to allow for changes in lake water level. The tops were covered with foam to avoid staff injury. To protect the sides of the boat and airplane pontoons, 8.5" inflatable vinyl fenders were used along the outer edge of the dock (Figure 6). Where the float protection required more depth, used tires were secured. Cleats were positioned on the deck edge to which boats and float planes can be secured. Dock plans are included attached as an Appendix to this report. When the existing dock was removed, the scraps were burned or moved to high ground.

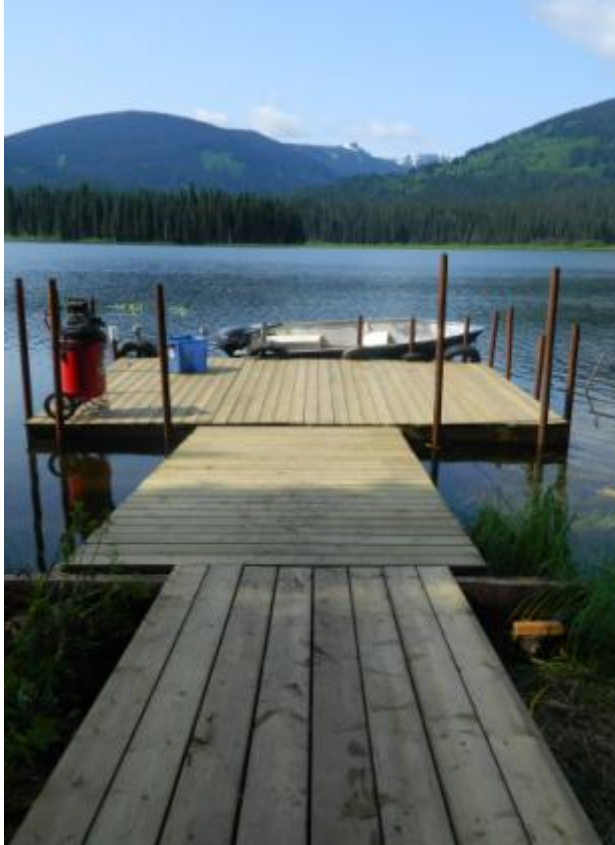
Figure 5. A photo of the new walkway leading to the two part dock during the pile driving of the 2 inch drill stem that secures the main 12'by16'platform.

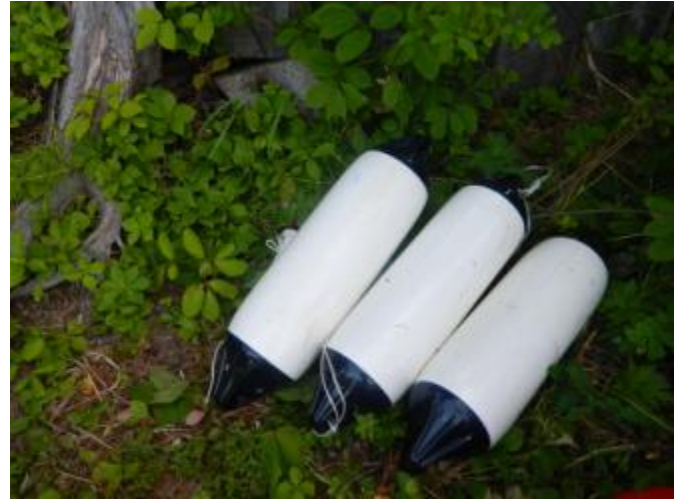
Figure 6. 8.5" x 48" Fender floats used along outer edge of main dock

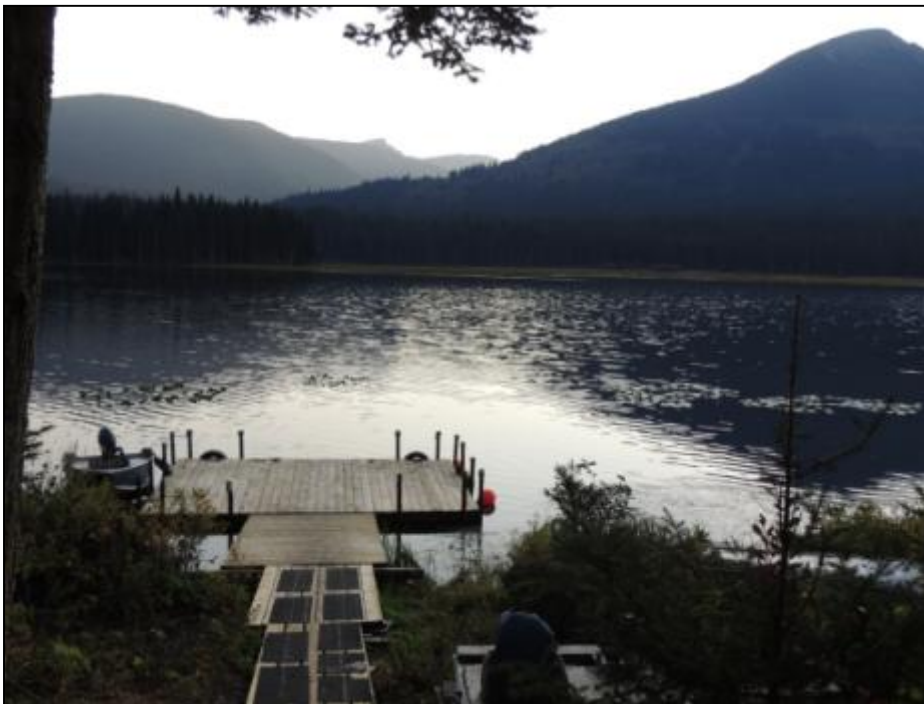
Figure 7. The newly completed dock at Slamegeesh camp in July 2012 prior to attachment of fender floats.

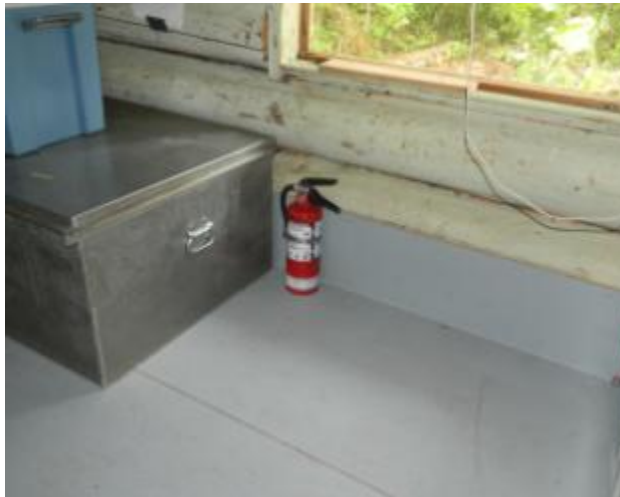
Figure 8. A section of the new floor in the main cabin at Slamgeesh camp in July 2012.

The existing rotted floor of the main log cabin was removed by the field crew on the final shift of the smolt trapping season. The site was prepped and ready for the new materials and construction crew to arrive. The old joists were mainly logs lying on earth or log posts which had for the majority rotted. The floor level was raised slightly to enable concrete footing installation and bracing to make the floor level. New tongue and groove $\frac{3}{4}$ " plywood was used and properly joined with the walls to avoid gaps which allow easy *Peromyscus* mouse entry into the cabin. The floor is approximately 18' by 18' and is now level with even joints. Two coats of paint were applied before the construction crew left and technical field staff resumed work.

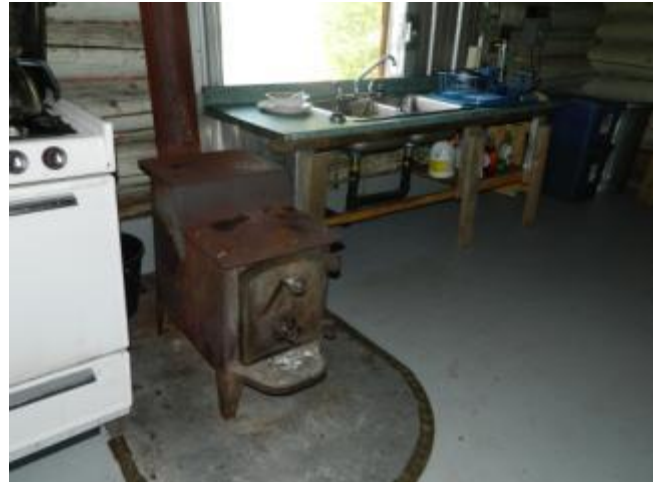
Figure 9. Lake side section of the new floor with appliances re-installed.

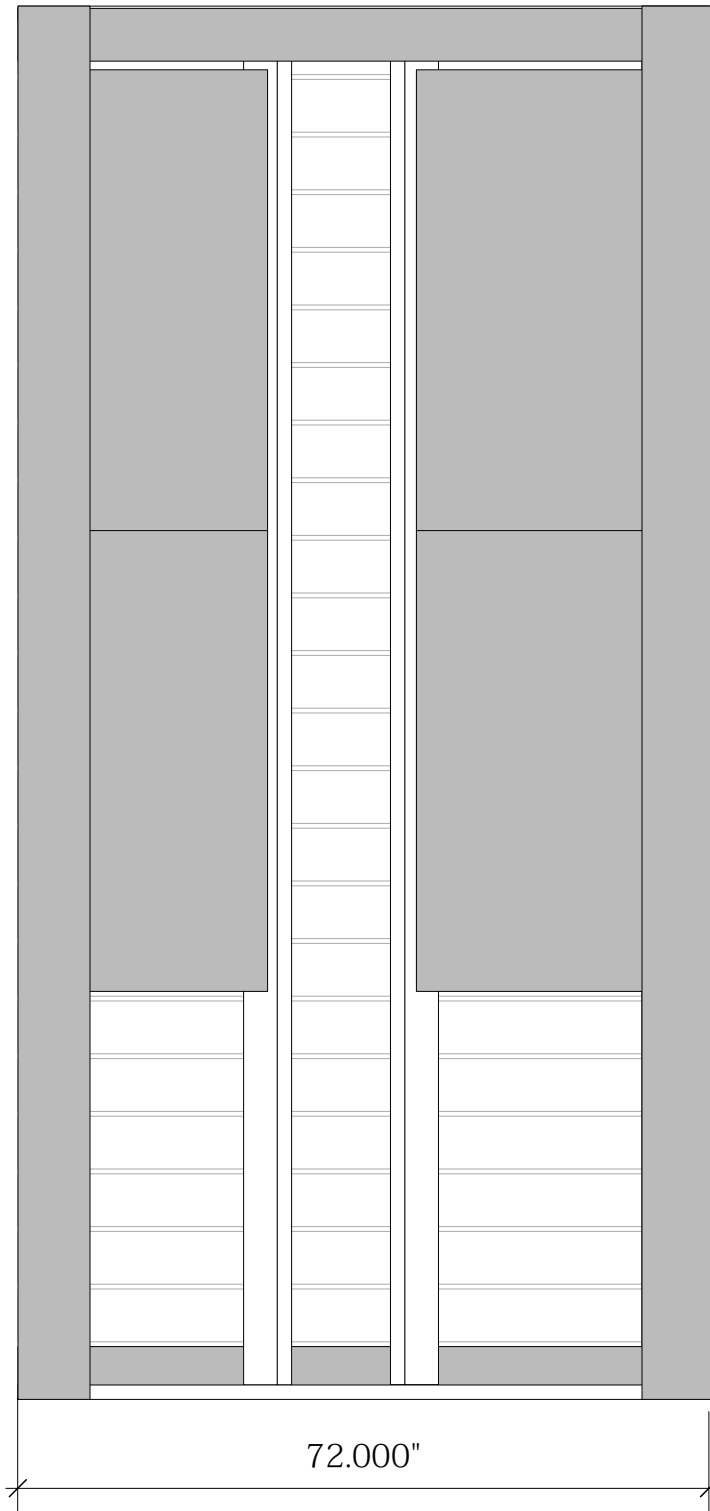
1 to 20 scale
Note 2x6 cross-wise
spacers and 2x8
skids beneath float
units
