Slamgeesh Smolt Fence 2008

Pacific Salmon Commission

Northern Fund Project NF-2008-I-31

**Gitksan Watershed
Authorities**

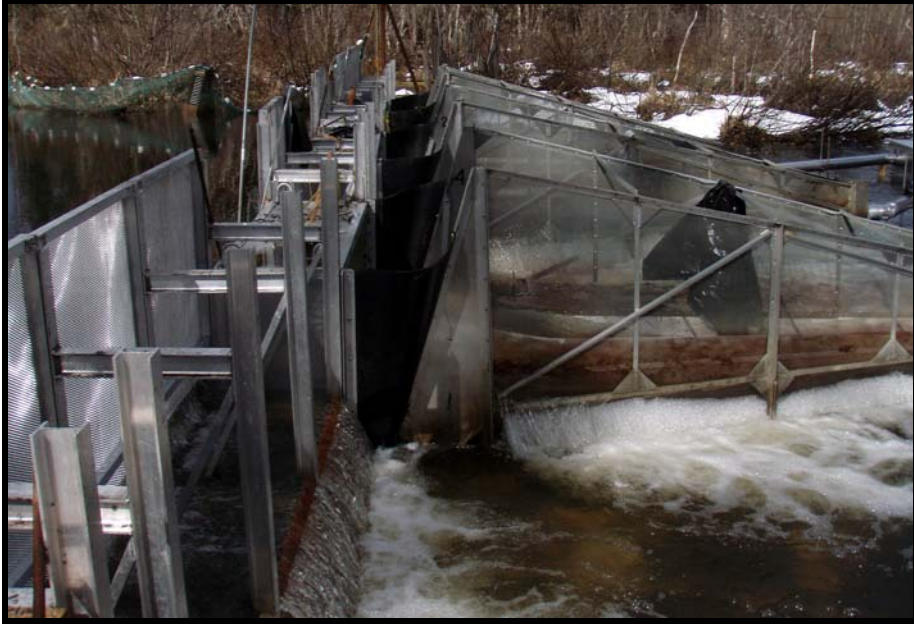
Figure 1. Fence structure shows screens in upstream position and traps mounted with adaptors.

The foundation of the weir consists of 2 large cement piers, each about 4 m³, and a series of 18 interlocking 0.8 m² concrete slabs crossing the stream. Each slab has a pair of clevises that attach aluminum trusses to form the framework of the fence. Adult fence panels can be slid into the spaces between the truss assemblies. Smolt panels were fabricated to block juvenile movement. These screens fit upright in the upstream H-beam channels of the weir trusses. They are simple screens, 36"x 72" (91 x 182 cm), made with a frame of 1½" (38 mm) aluminum channel and are filled with ¼" (3/8" stagger) perforated 18 gauge sheeting. The bottom edge was ensured to fit closely along the cement sill. In use, the upstream panels were backwatered by a dam constructed of red cedar blocks set in the downstream channel position of the trusses (Figure 1). The height of block layers could be adjusted by 3" intervals.

A set of used fan traps was acquired from the Fulton River sockeye spawning channel facility that was used on the pilot scale Spawning Channel A in the 1970s and 1980s. Three of these fan traps were adapted and mounted in the base structure of the weir (Figure 1, 2). The trap entrances were slightly wider than two of the weir units so we needed to design and fabricate adaptors to fit into the double weir spacing on the upstream side (Figure 3) and to have a hinge and gusset structure on the downstream side to mount the trap and provide vertical adjustment (Figure 1). The fan traps worked by controlling flow on perforated incline planes. Stainless steel turn jacks were custom fabricated and mounted to the traps ends for altering trap slope and height (Figure 3).

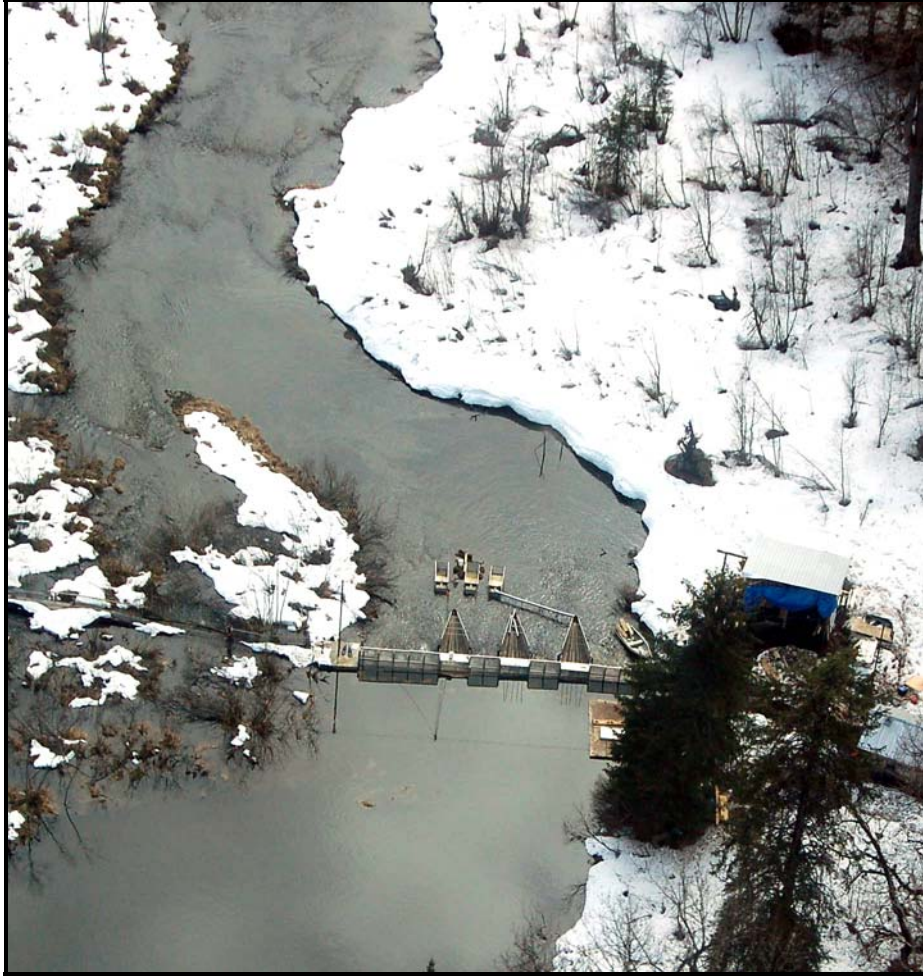
Figure 2. Three fan traps in position mounted in the Slamgeesh Weir.

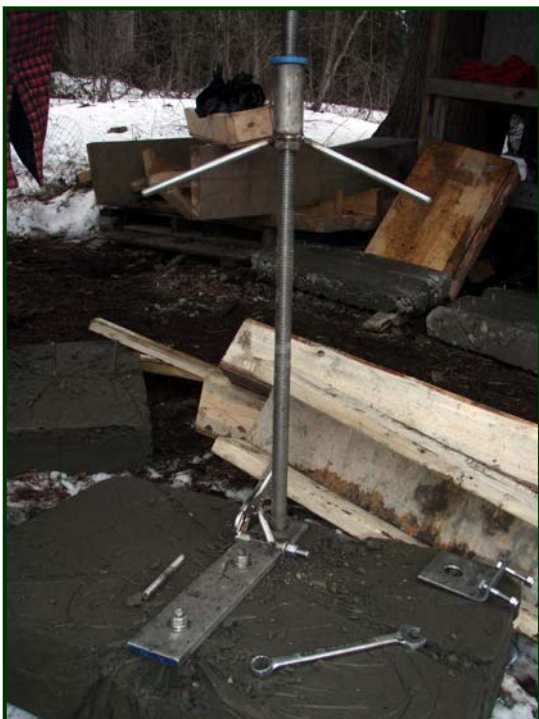
Figure 3. Screw jack mechanism to adjust downstream trap height.

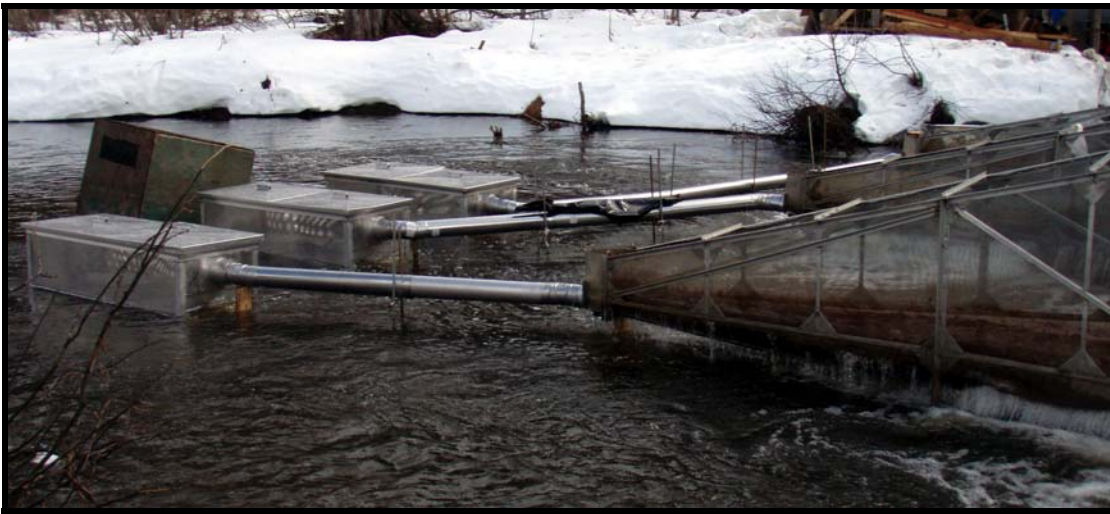
Figure 4. Smolt system assembled May 7th with three separate capture units.

The three fan traps were connected to separate live boxes via 6” stainless steel tubing. The tubing had adjustable sleeves and elbows to compensate for jack movement of the trap ends (Figure 4). The live boxes were made of aluminum sheeting and perforated plate, approximately 72” long, 30” high and 30” wide (Figure 4). The footings were bolted onto cement blocks which were dug into the stream bed on the up and downstream ends. Each had two aluminum lids for easy access.

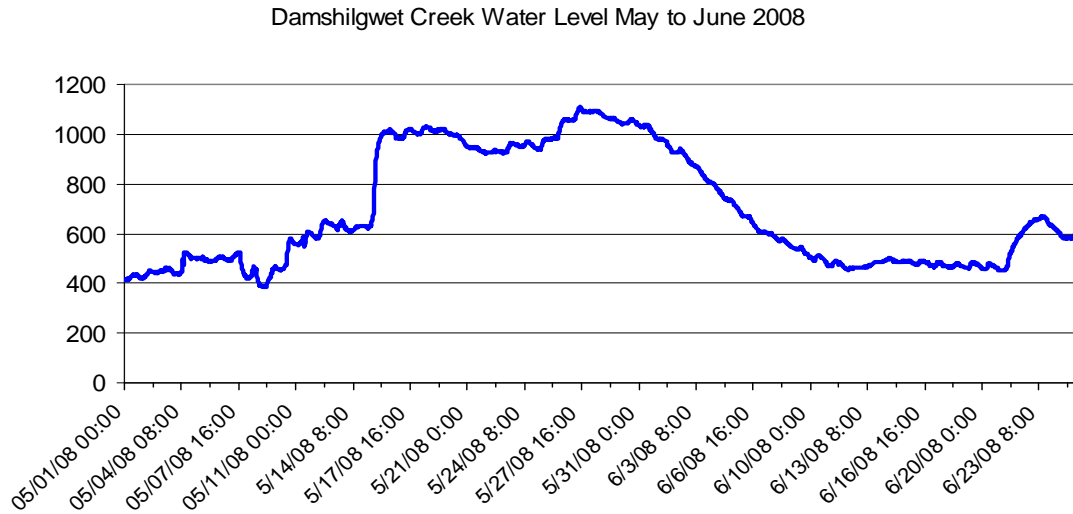
Figure 5. Damshilgwet Creek water level in mm from May 1st to June 25th, 2008. Weir failure occurred on May 15 about 15:00. The vertical scale is in millimetres.

The cold late spring weather abruptly changed on May 14 and temperatures reached 30° C. The stream level at the Slangeesh weir responded rapidly and by May 15 the water levels were rising several cm per hour (Figure 5). The weir structure failed. At the time of failure the discharge was approximately 8 m³ /sec. The stream stage was 0.808, a typical spring peak flow level. The stage reached its highest level of 1.099 m on May 27th, 2008. This was a high spring flood level but not extraordinarily so. It was exceeded three times in the past nine years.

The weir failure occurred near the top of the 200 mm vertical rise section on May 15 (Figure 5). We observed the weir structure failure. The overall structure bowed downstream over a few seconds and the weir components separated with many of them being washed downstream short distances. About 50,000 m³ of water was released by the collapse of the weir. At the time of failure, the stream flow was increasing so fast that the weir failure did not result in a drop in stream level and high stages persisted for about two weeks.

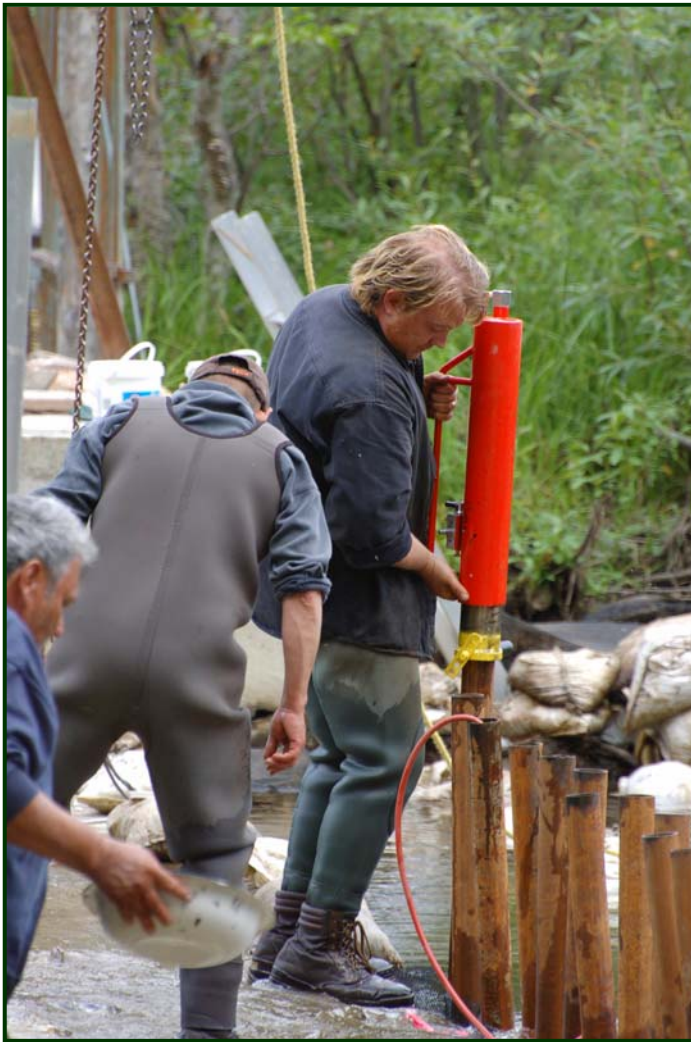
Figure 6. Placement of steel drill pipe sections along the downstream edge of the weir, August 2008.

Our weir reconstruction was undertaken in July 2008. We drove 1.5 m lengths of 2 inch drill pipe (63 mm ϕ) into the stream bed at the downstream edge of the weir on 30 cm spacing. (Figure 6) This provides three support points downstream of each weir block and should make translation failure of the sort we experienced on May 15 2008 much more unlikely. The weir was used to support an adult fence in August through November 2008 and performed flawlessly. No adult salmon passed the fence uncounted as verified by mark and recapture experiments.

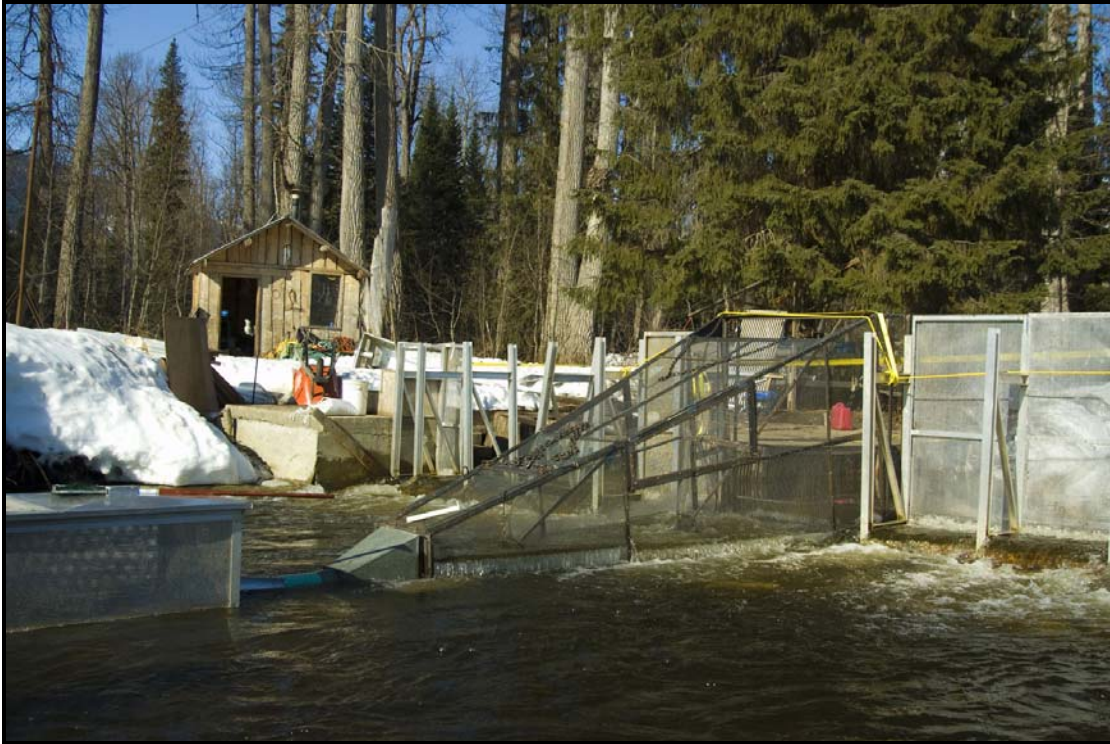
Figure 7. Fyke trap installed at Slamgeesh Weir in May 2009.

In 2009 we installed a more modest smolt fence design, one that did not require backing up the Slangeesh Lake system nor did it attempt to filter all of the flood flows through perforated plate. This trap is a 6x6 ft fyke trap with two fykes (Figure 7). It functions in water 15 cm deep. High velocities in the intake area prevent smolts from leaving the trap. Problems with floating vegetation and debris were avoided by building a barrier upstream with 5 cm mesh that captures most of the debris. The trap was set up in the position used by the rightmost fan trap in 2008.

The fyke trap seems to be more efficient at catching sockeye than the traps used in previous years. Preliminary analysis suggests that the catch rate is more stable at various stages than in previous trap designs. The simple fyke trap functioned during a prolonged spring snowmelt flood with peak stage over 1000 mm for seven days. We used mark and recapture experiments to calibrate the trap. Preliminary efficiency calculations suggest the trap fishes at about 20% efficiency for sockeye and 2 to 10% for coho.

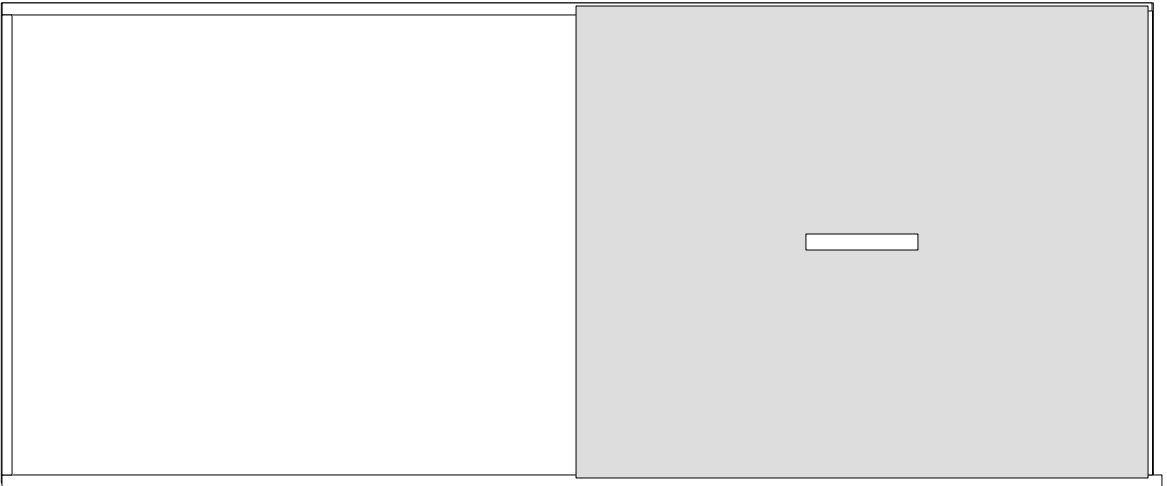
Live Box Drawing Page 1 of 2

3/4" angle x 3/16" inside 18 ga sides, 1/2" down

Add Detail of recessed lid
