# Pacific Salmon Commission

## Coquille River Watershed Habitat Enhancement Project

### FINAL REPORT

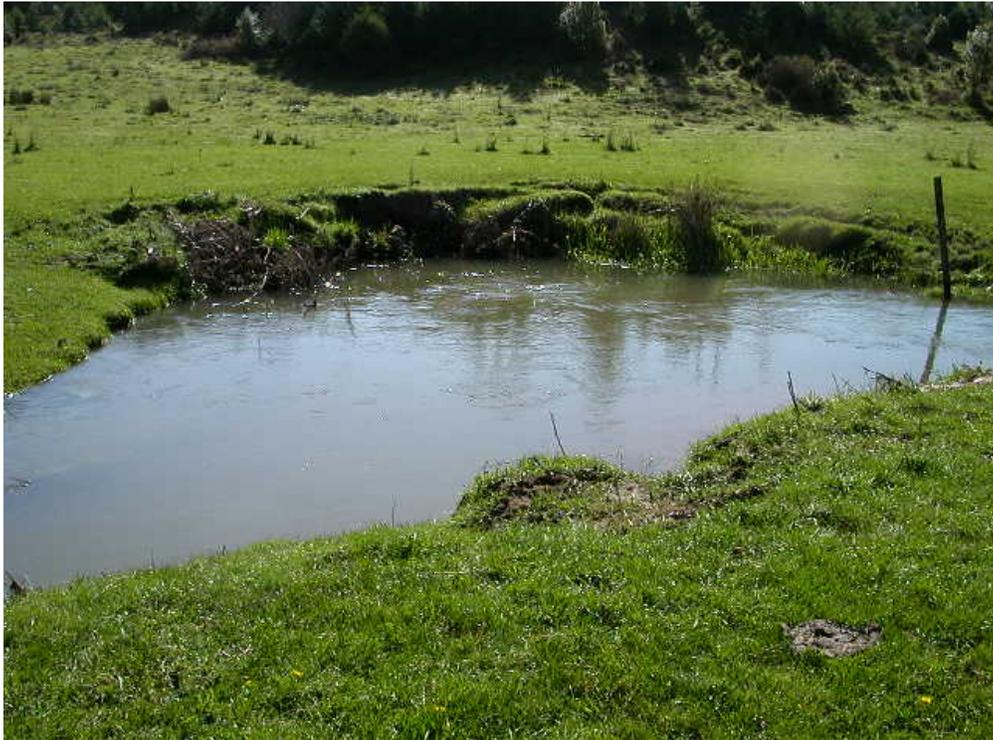
Hall Creek at the project site is approximately 15 feet wide (bankfull width) and has very little riparian vegetation other than pasture grasses. This slightly meandering stream has no wood or rock structure throughout the project reach and lacks stream complexity. The gradient of the stream at the project site is less than 2% and the habitat is almost entirely a glide/pool complex. According to the landowner, Hall Creek was not splash-dammed but was used as log storage and transport during the 1930's and 40's.

The stream was also “cleaned” (wood was removed because it was believed to impede fish passage) in the 1970’s which effectively removed any remaining structure within the channel. The stream substrate is mostly sand and silt with no spawning gravel at the project site. Agricultural practices removed any riparian vegetation to maximize grazing on the property, so there is no wood available for future LWD recruitment. The stream banks are very eroded and bare and contributing fine sediments to the stream.

Photo taken from west side of bank (before)

For this project, the CWA crew installed logs and boulders in Hall Creek to create complexity and cover for fish. The project consisted of placing logs in the creek and anchoring with rock and existing trees in the riparian area. Log sizes were 18” DBH to 24” by 30’ long. Rocks and logs were placed using an excavator from the bank. A total of 10 sites were constructed. Rock size was ½ to 1 and ½ cubic yard. The project was completed on 7-30-07.

All disturbed sites were re-vegetated with a seed mix and mulch. The project sites were barren of instream woody debris, prior to the project activity.

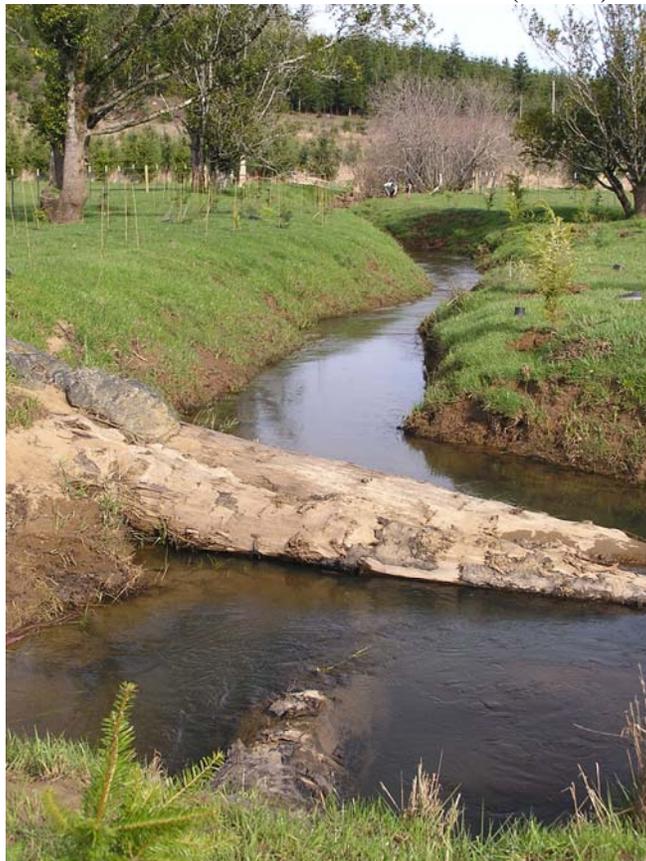
To date noticeable changes are apparent in stream depth and stream bed complexity below the log/boulder structures. The logs and boulders placed in the stream have increased specific scouring patterns and have created very deep pools in the sand and gravel substrate, which will provide a source of cover and refuge for aquatic life.

Photo taken from west side of bank looking north (after).

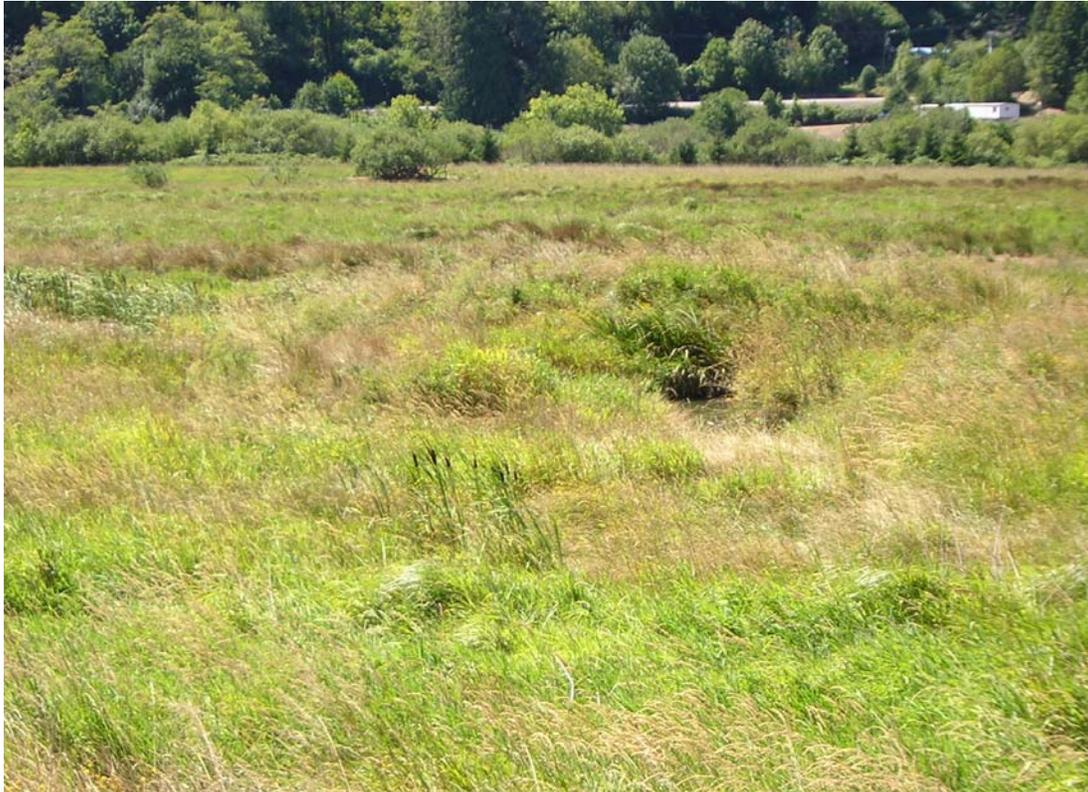
The site consists of about 95 acres of bottomland. Bisecting the upper end of the property is a 20-30 foot wide slough that was shallow, stagnant and serviced by a tide-gate. About 40 acres of this area are jurisdictional wetlands.

Snyder Wetlands- Before – note white house in background as reference

This project involved excavating new pond areas and channels that connect to the previous wetland work completed on this property. The pond depth will retain water at all phases of the tidal flows. The water control structures also maintain flows in the channel at low tide, preventing fish from being trapped or stranded. The berms and dikes were planted with native species.

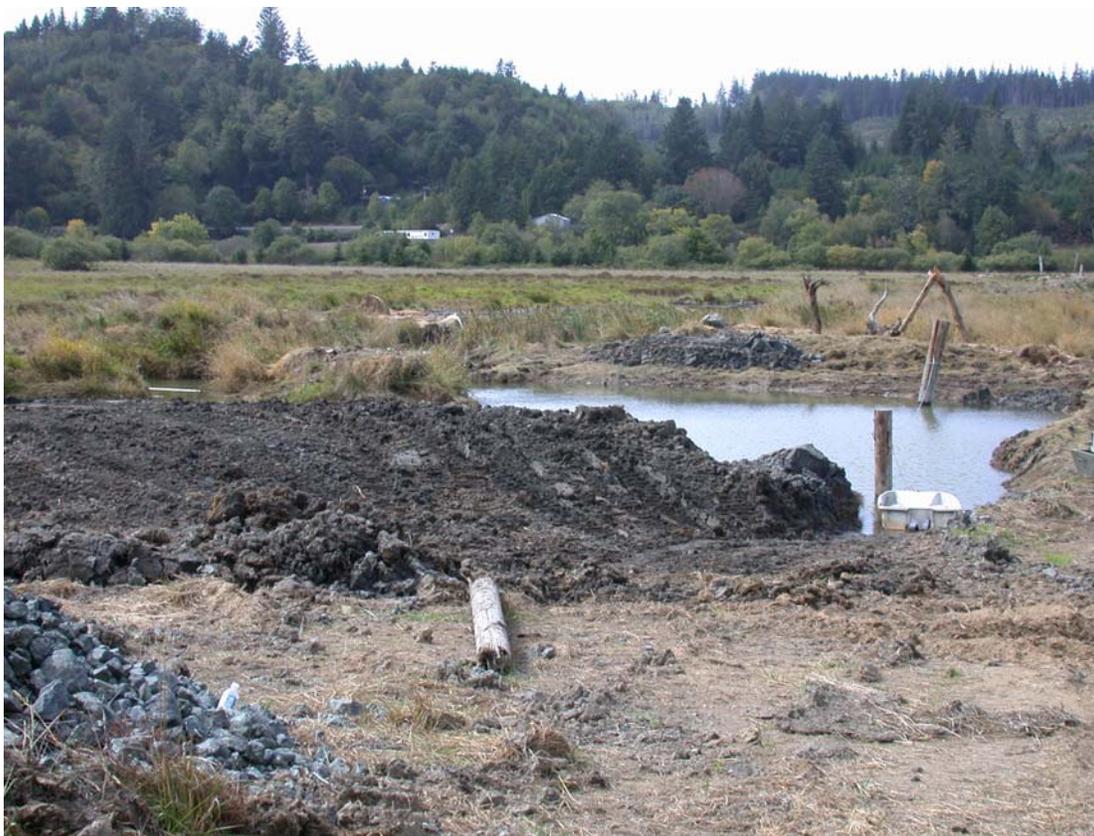
Juvenile fish surveys have documented juvenile salmonids using the ponds as off-channel refuge and over-wintering habitat.

Snyder Wetlands- After Construction

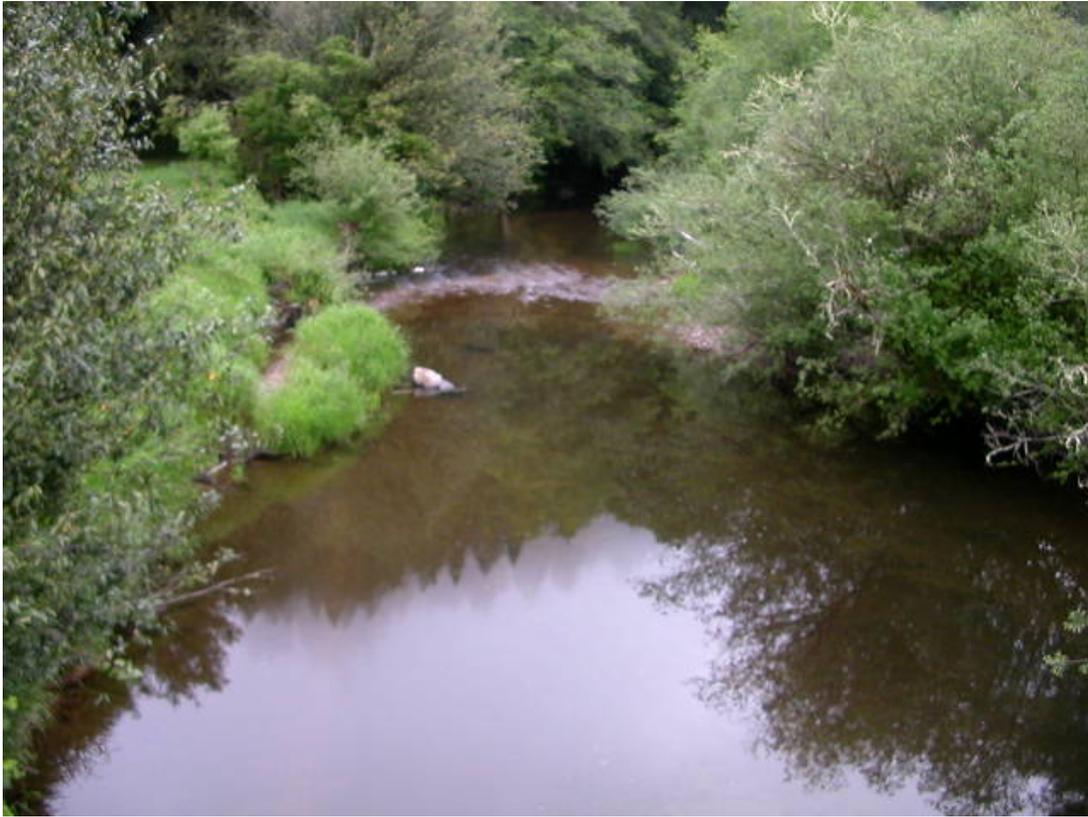
The North Fork Coquille Watershed drains 154 square miles. This tributary of the Coquille was splash dammed in the 1930's, which scoured out much of the instream structure such as large boulders and wood during the release of the impounded water and logs. Large sections of bedrock remain within these systems.

Limiting factors of this area are lack of spawning gravel, over-wintering habitat and stream complexity. Bankfull width is 50-60 feet at the project site. Currently, substrate in the project area is 30% sand/silt, 40% gravel/cobble and 30% bedrock. Each winter due to the lack of instream structure, the substrate deposition sites change. The site has future potential for large woody debris (LWD) recruitment. This site had a riparian enhancement project completed on it in 1998 by the Coquille Watershed Association. A fence was constructed along the riparian area to exclude livestock and a mixture of native trees was planted. The trees are free to grow at the height of 6-8 feet. The east side of the stream has good tree cover and vegetation which could also contribute future LWD.

Williams/North Fork Instream- Before Construction

This small stretch of stream had two full spanning boulder weirs constructed at 30 degree angles to the banks. The banks at each end of the weirs have been heavily armored to minimize erosion of the banks.

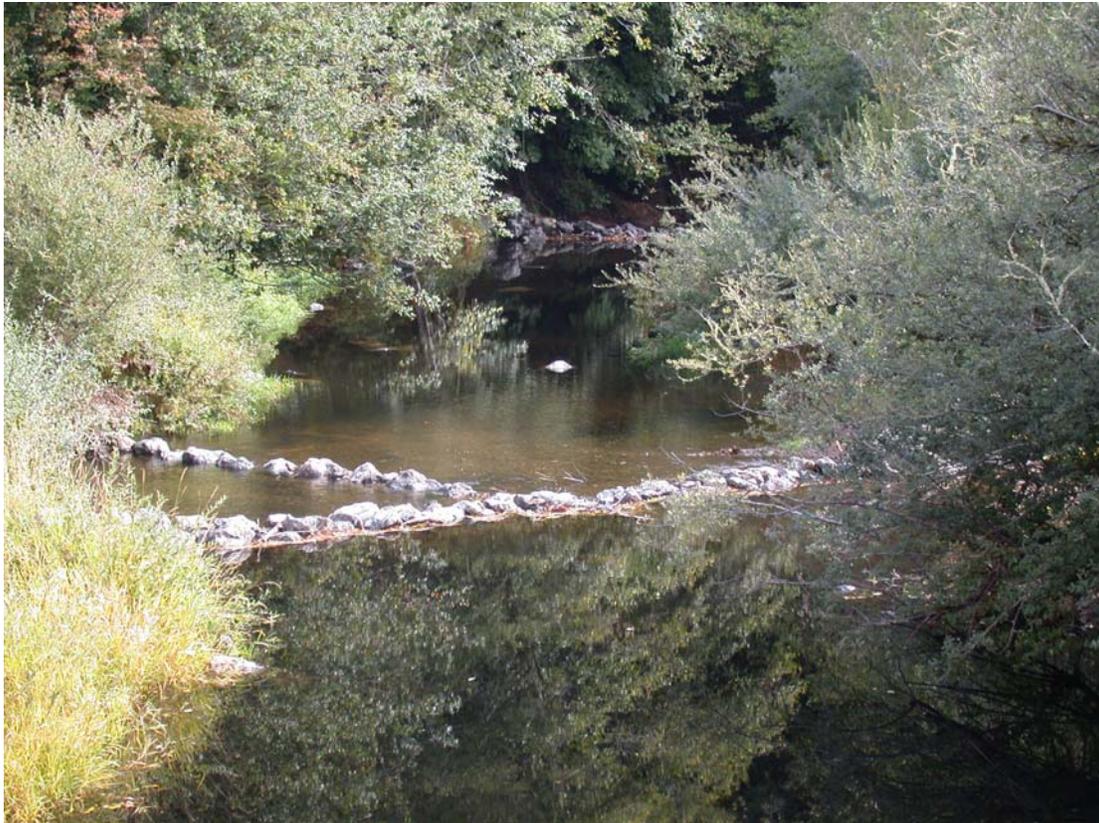
Each weir has a downstream jump pool, shown in Attachment A. The jump pools are an innovative design used by the Coquille Watershed Association, instream work crew to provide easier access for fish during lower flows. The pools provide an extra step, which can also be used as a resting place.

Benefits to the Williams project site include an increase in complexity and stream bed gravel and other organic accumulation. A post-project survey will be conducted this summer using the ODFW protocol to determine and compare pre and post conditions. Spawning surveys during the winter of 2007/2008 found salmonids utilizing the boulder weir substrate. Natural recruitment of woody debris has occurred from stream side vegetation falling into the stream near the boulder weirs.

Williams/North Fork Instream- After Construction
