# Creighton Creek Streamflow Recovery Project – Phase II

Prepared by:  
Thomas Minor, BSc, CET

Prepared for:  
Whitevalley Community Resource Centre Society

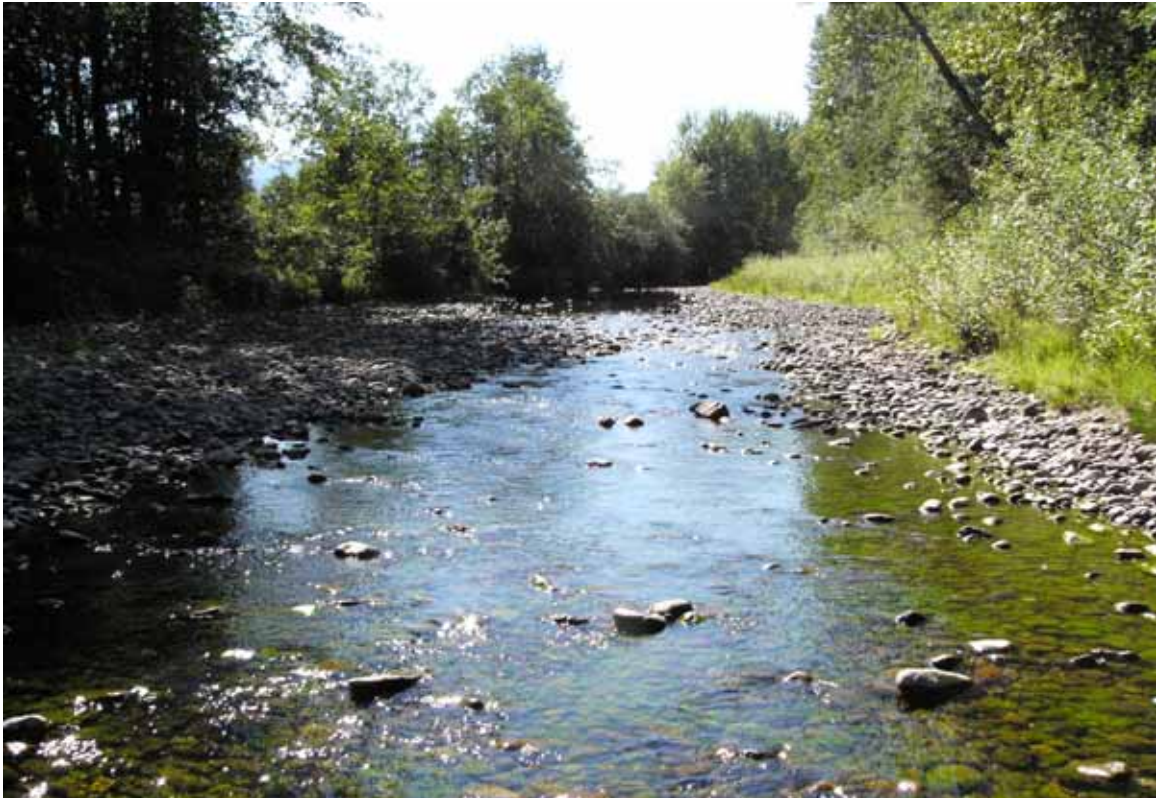
Figure 6: an upstream view of Bessette Creek at Cross section #1 near the Smit/Headington Property line. This is the downstream limit of the severe deposition.

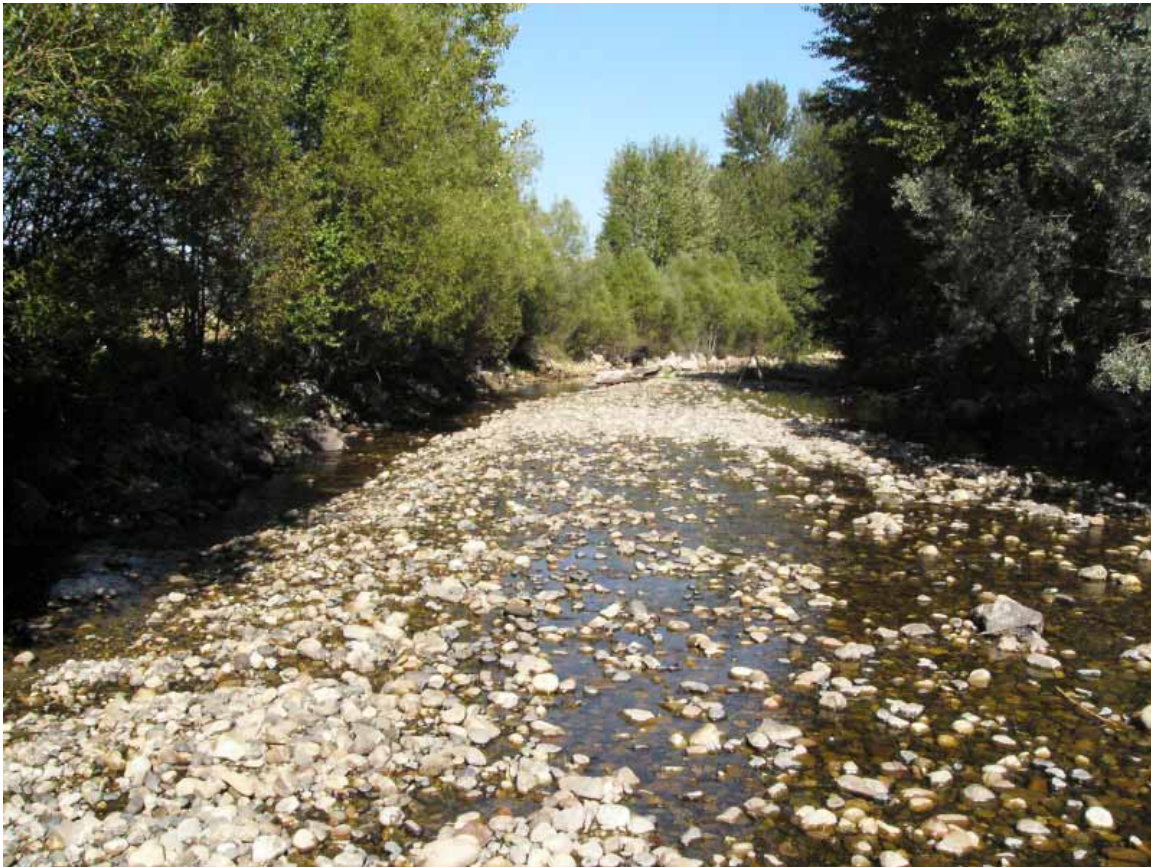
Figure 8: Cross section #2 and a downstream view at the second cross section on Bessette Creek. This cross section had the smallest area, about half the area of the first cross section at the end of the deposition zone.

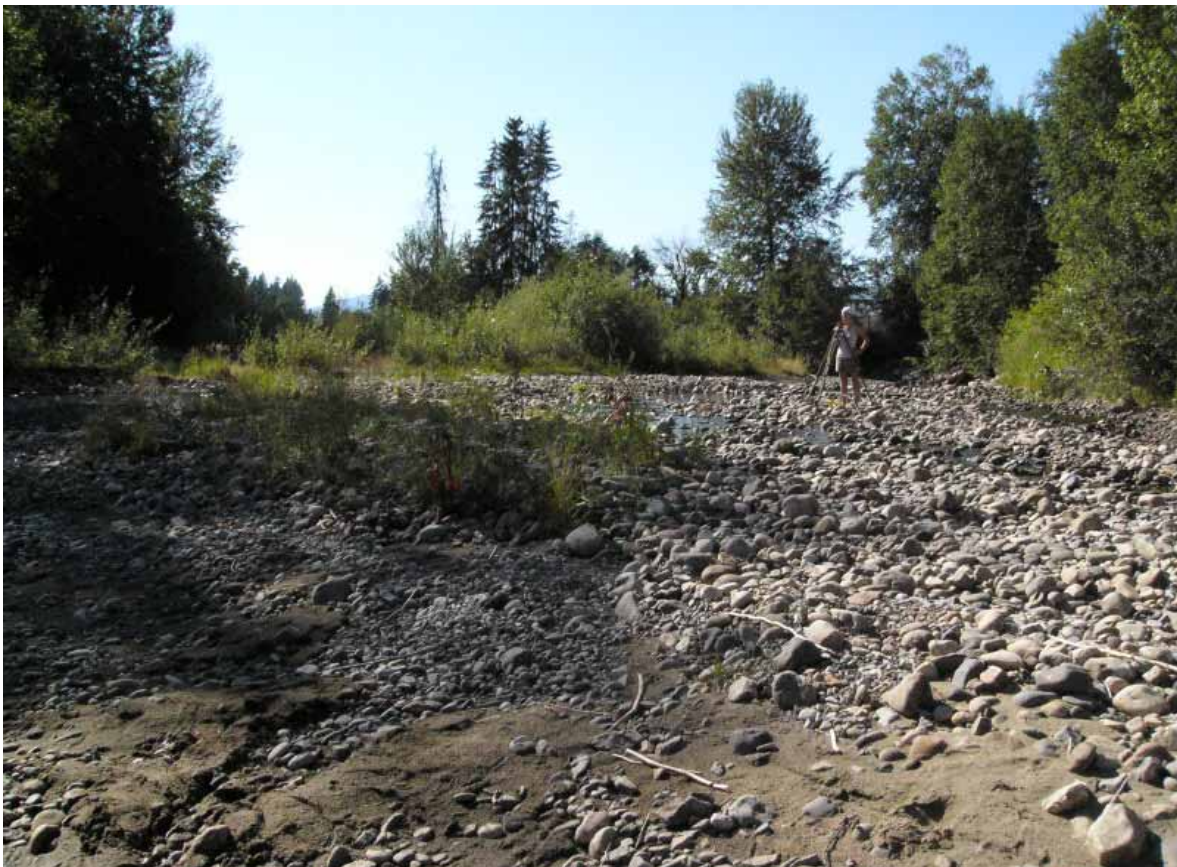
Figure 10: Cross section # 3 and an upstream view of Bessette Creek at the third cross section.

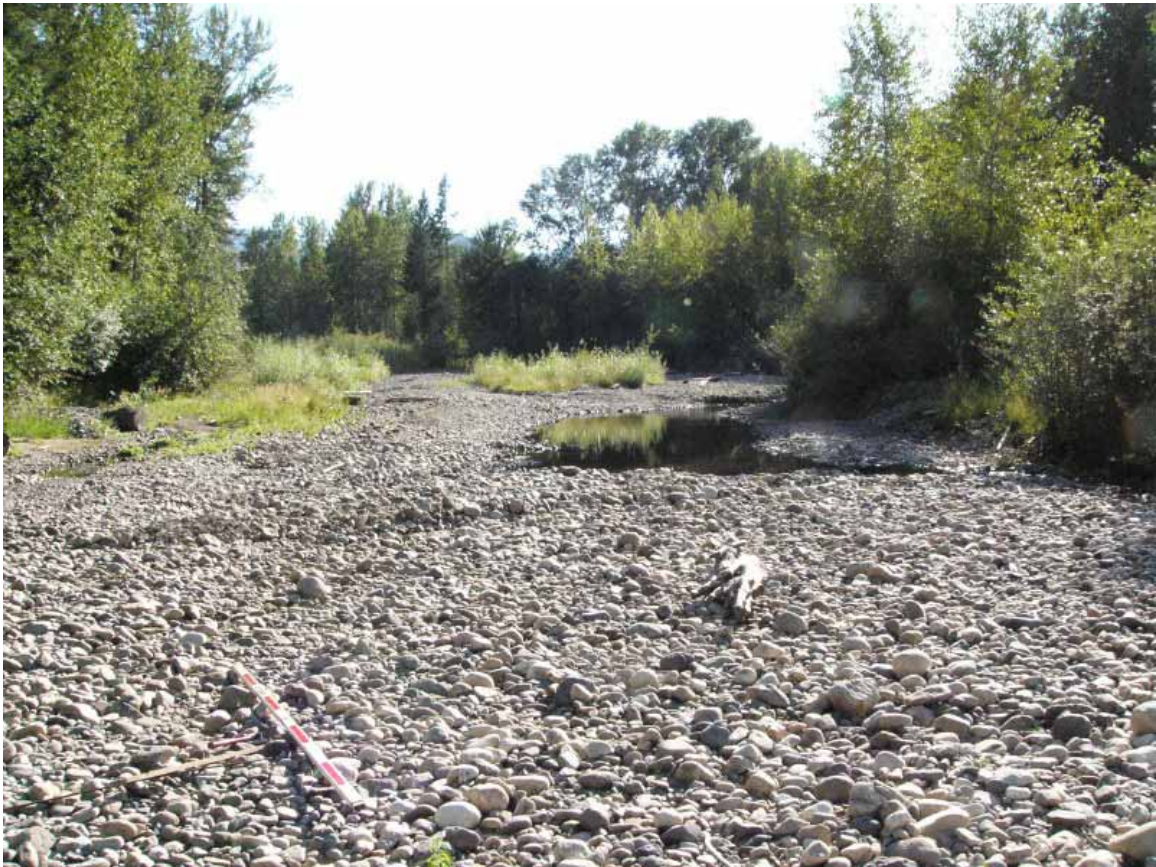
Figure 12: Upstream view of Bessette Creek at the fourth cross-section. During July and August there is often no continuous flow through the cobble substrate between cross-sections three and four.

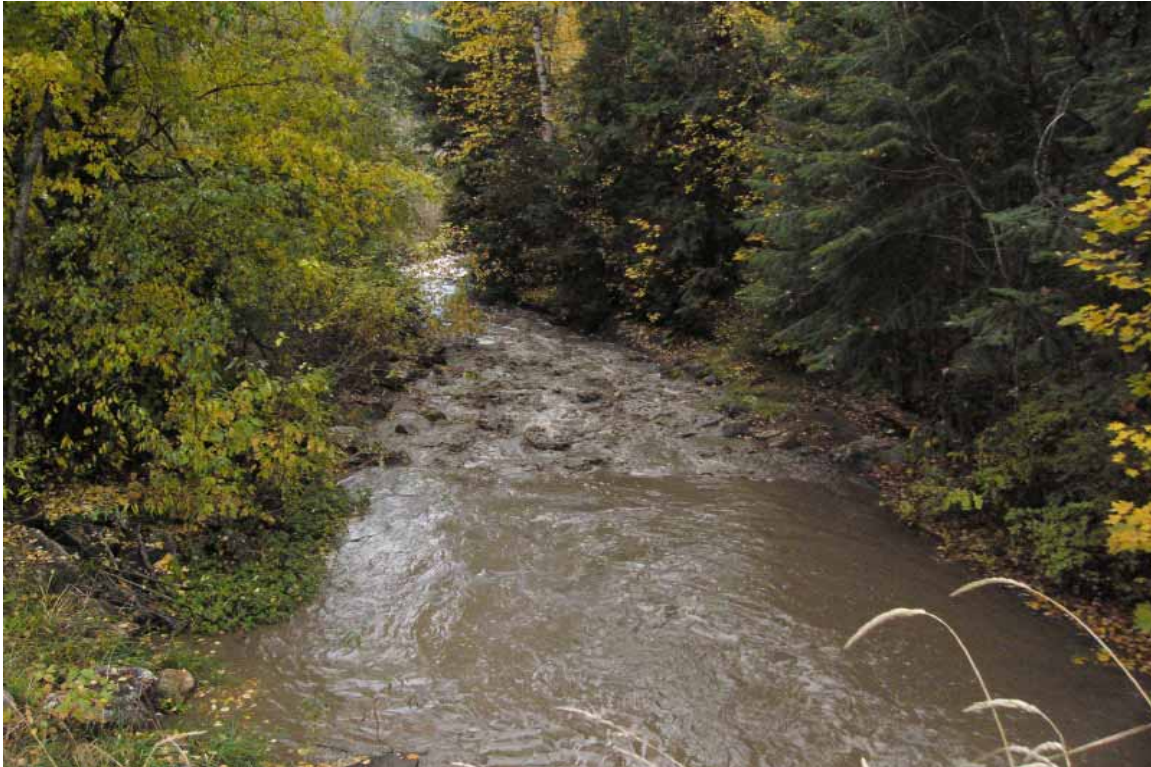
Figure 15: Vance Creek at Mabel Lake Road 560 m upstream of Bessette Creek on October 7, 2005.

With the rainfall in June, there was no opportunity to measure low flows in the lower section of Vance Creek below the withdrawal points. The wetter 2005 weather however, did call attention to other concerns with Vance Creek. Vance Creek headwaters are in Silver Star ski resort. Silver Star has been expanding for the past decade with growth in both the residential area and the development of new ski runs. The exposed ground, especially the steep ski runs, can lead to sedimentation of the creek. Rain in early October, for example, led to extremely turbid creek conditions in Vance Creek and consequentially in Bessette Creek during salmon spawning season. Figure 15 shows Vance Creek at Mabel Lake Road on October 7, 2005, the day after a 38.2 mm rain was measured at Silver Star Mountain Resort (Environment Canada, 2005).

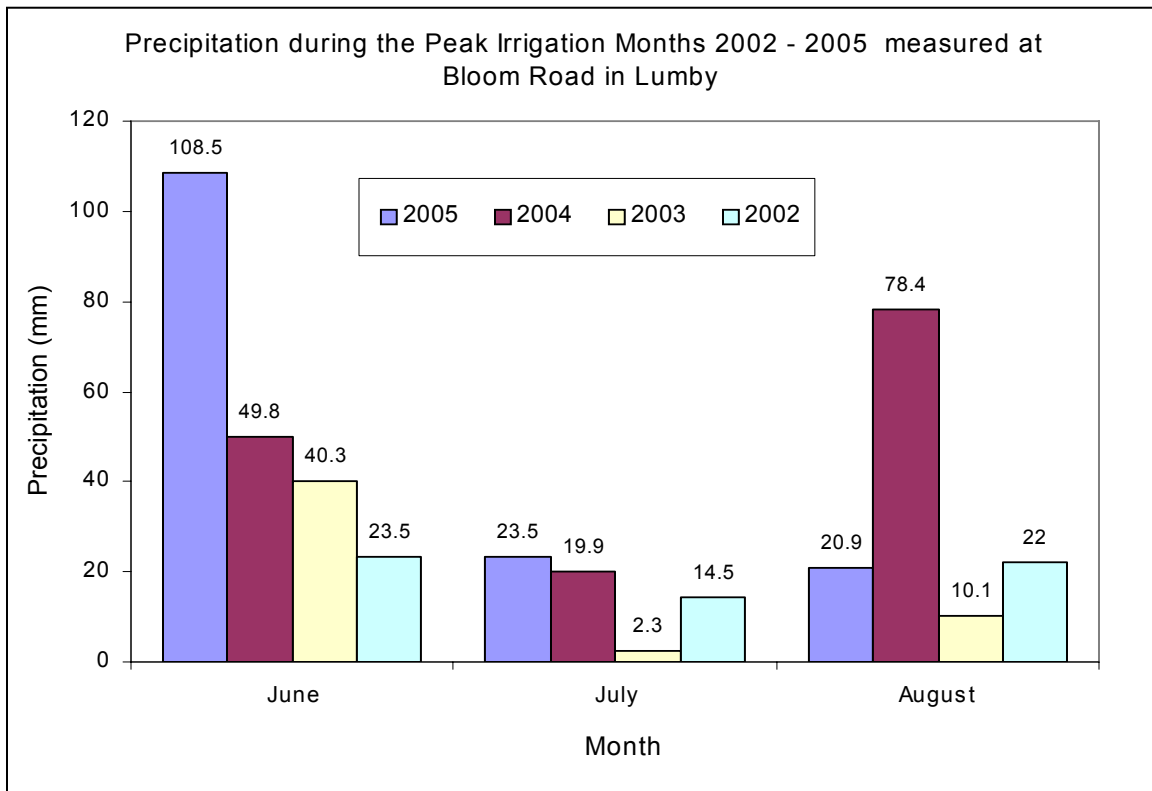
Figure 16: The summer precipitation increased during the two years that this project took place. Both 2004 and 2005 had almost three times the amount of rain (152.9 mm and 148.1 mm respectively) during the irrigation season as 2002 and 2001 (52.7 mm and 60.0 mm). Most of the rain in 2004 fell during the later half of August, while in 2005 most

the rain fell in June. The June rain of 2005 dissuaded most farmers from irrigating well into July. The June rain also charged the Bessette watershed so that the summer creek levels were the highest in four years.

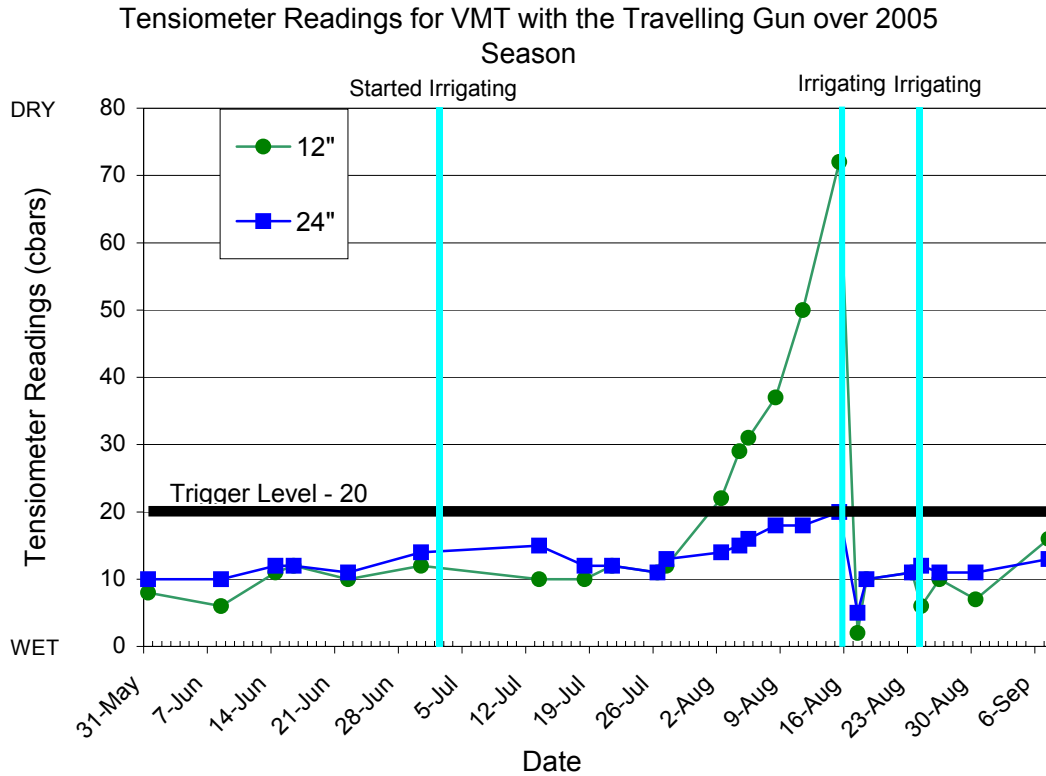
Figure 19: The tensiometer readings in the VTM field where the traveling gun was used indicate that the first pass in early July was not necessary yet. The trigger level for this field is 20 centibars and was hit in the end of July though the gun did not pass again until the 16<sup>th</sup> of August.

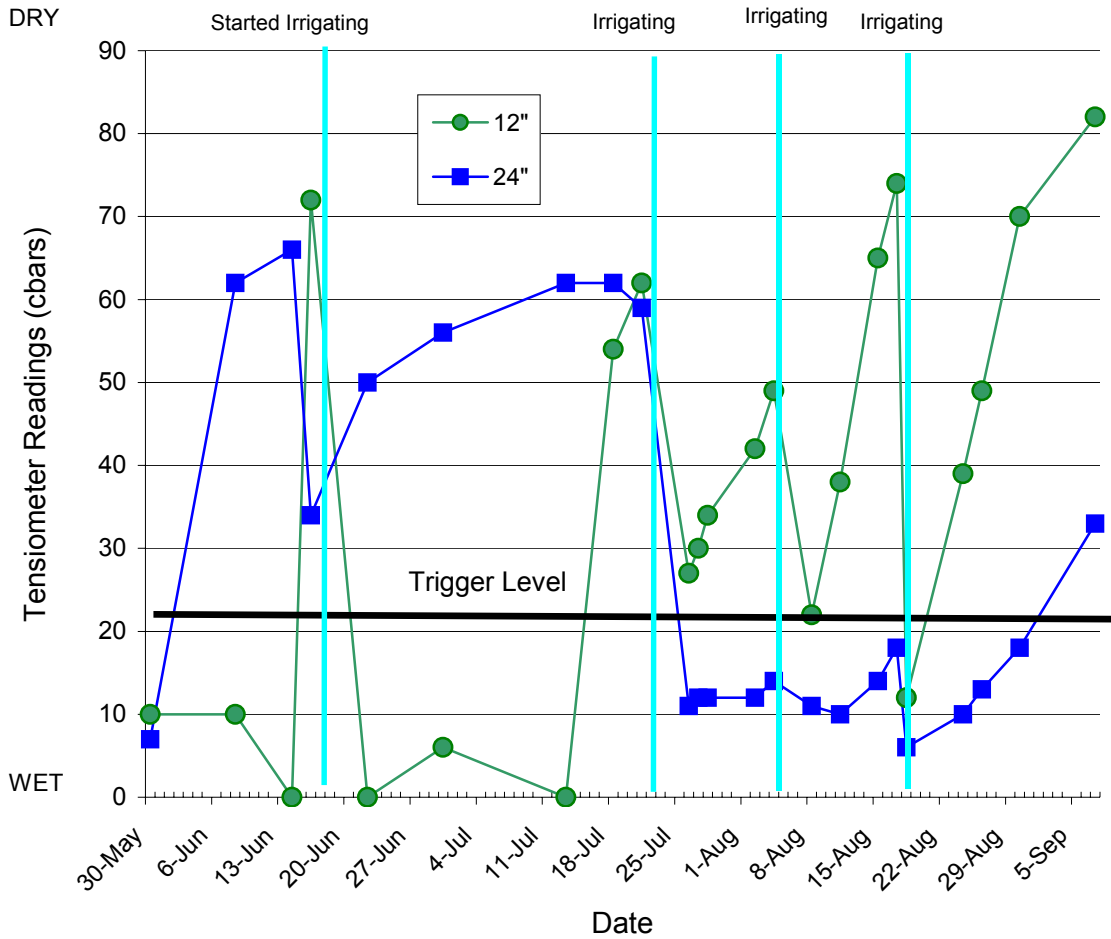
### Tensiometer Readings For the StationaryGun (V3) Over 2005 Season

Figure 20: Tensiometer readings for the V3 field. This field is on the valley bottom and closer to the water table than the upper fields. The fields were used for pasture with a high percentage of alfalfa. The topsoil was a sandy loam with silty gravel from 11 – 14“. The trigger level was 20 cbars. The tensiometers at this site continuously crashed and had to be reinstalled twice in the first two months. Only after July 26<sup>th</sup> 2005 did the tensiometers provide consistent readings.

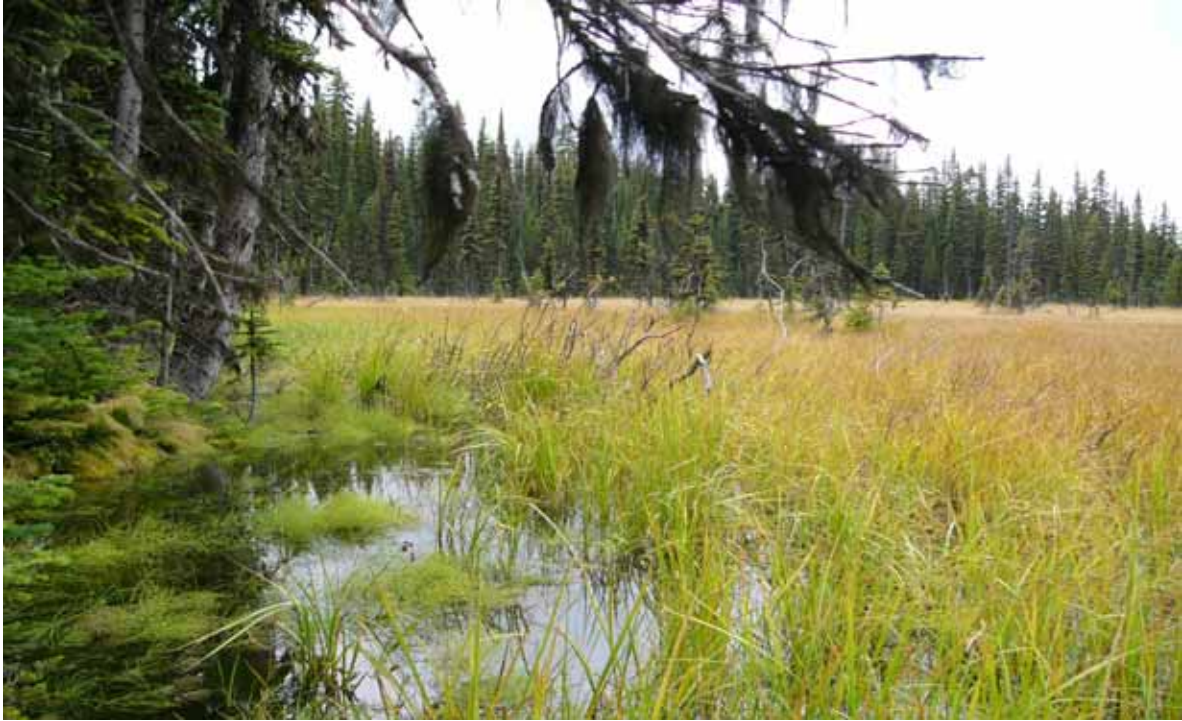
Figure 22: The east meadows in September 2004. The standing water is a result of a wet fall.

After site visits to all the areas suggested by licensees at various meetings and areas picked out from orthophotos, two sites were thought to have enough potential to merit further investigation: the meadows in the northeastern corner of the upper watershed and Bonneau Lake. A cross section of the potential dam site at the east meadows and a level circuit of the area upstream of the dam site were conducted (Figures 22- 23).

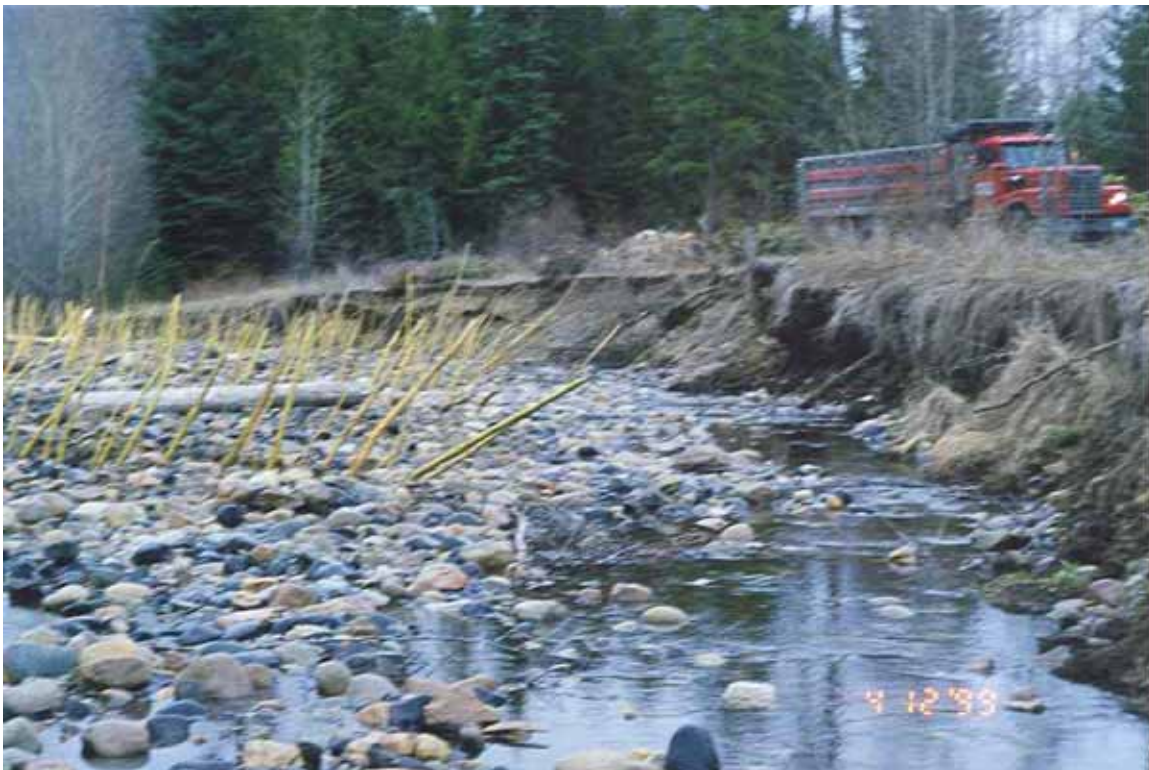
Figure 27: Willows stakes were planted in this gravel bar during the winter of 1999 on Besette Creek to help stabilize the bar and to eventually concentrate the high flow to the other (left) side of the creek.

There is still the problem of the bedload that is reducing stream capacity and creating significant loss of surface flow to groundwater in the deposition zone below Horner Road. In areas where the creek is wide, the gravel bars could be planted with willows. This is an inexpensive treatment that was done on several properties farther upstream on Besette Creek. The willows stakes are planted in a series of rows that concentrate high flows in the channel while slowing flow across the bars. This causes the channel to deepen while finer sediment accumulates on the bars. As finer sediment collects on the bars, the bars become populated with first cottonwood then conifers volunteers.

This method works only where the area between the berms is wide enough and where livestock don't have access to the creek and riparian area. In areas where the creek width is narrow, like the second cross section, there is only enough room to pass high flows and another method would have to be used.

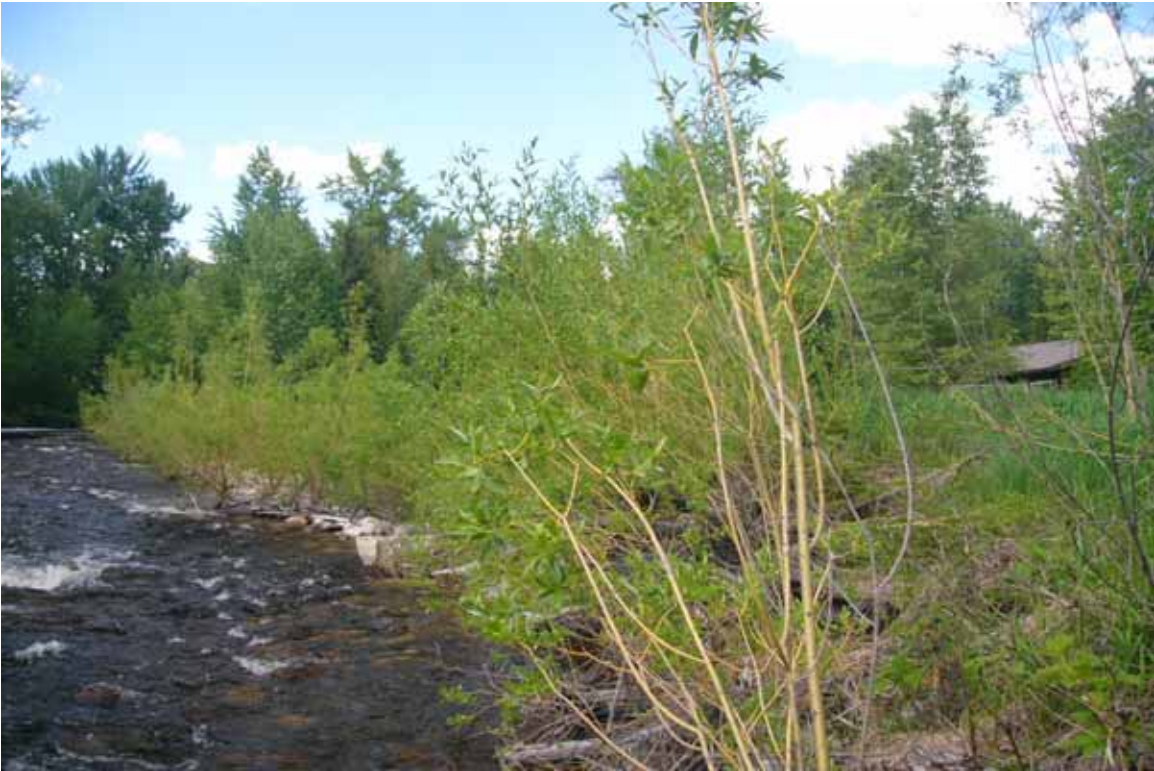
Figure 28: A picture of the same site as above taken during the freshet of 2004 from a vantage point 30 m farther upstream. The willows have grown several meters. The bar has collected enough fine material that cottonwood volunteers are more numerous than the willows originally planted. The high flow has become concentrated to the right side of the creek. Some of the streamside edges of the bar have eroded as the stream became concentrated on the left side of the channel.
