# Kennedy Watershed Restoration Project 2005 Compendium

The objectives of the Kennedy Watershed Restoration Project (1994-present) are to restore the hydrological, biological, riparian and ecological functions of creeks and terrestrial areas in the Kennedy Flats Area that have been negatively impacted by historical logging practices.

Kennedy Flats - Watershed No.249  
Kootowis Creek, Staghorn Creek  
Lostshoe Creek, Twin Rivers, Sandhill Creek

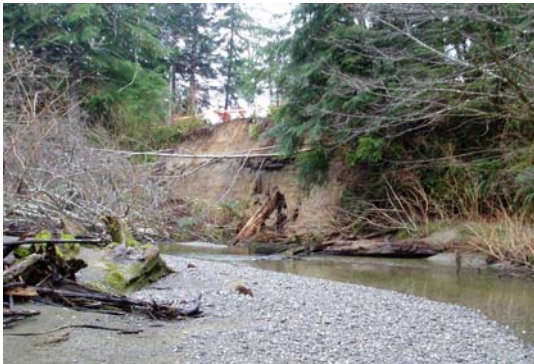
Most restoration work focused on a section of Lost Shoe Creek within Pacific Rim National Park Reserve which had been badly eroded by high flows in January of 2005 (Figure 2). Non-embedded small woody debris (SWD) was removed and placed in debris piles located above the high water mark. Existing large woody debris (LWD) was re-positioned and anchored. Additional LWD and ballast rocks were flown into several sites by helicopter and used to create in-stream structures designed to provide cover and scour (Figure 3).

**Figure 2.** Site LS2-1 before restoration.

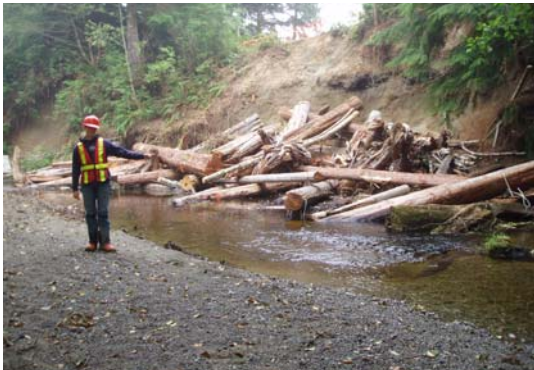
**Figure 3.** Site LS2-1 after restoration.
