2018 Summary Report for the Silver Salmon River Sockeye Access Improvement Project

Prepared For:
Taku Tlingit Fisheries
Atlin BC

March 2019

Plan, Profile and Sections
As-built Survey of Passage
Remediation Works
Silver Salmon Creek
Site SR3-3

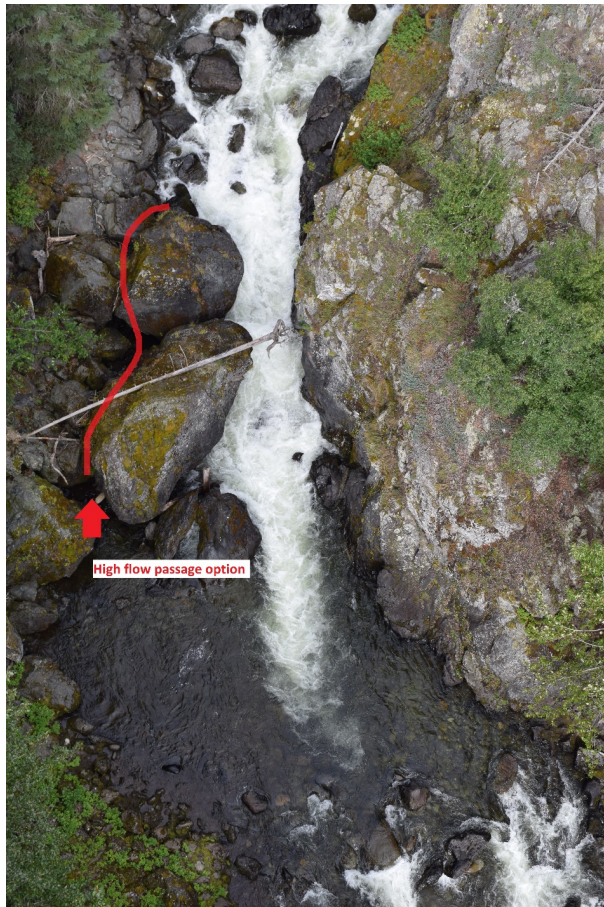
Photo 1: Site SR1-1 high stage passage was opened by removing small woody debris.

site visit. At SR1-1, the lowermost challenge immediately above the confluence pool the high flow alternate passage option through the boulder pile was cleared of small woody debris. This should provide a high flow passage option and reduce high stage flow volume through the main channel. Photo 1, below, indicates the high flow route through the boulder pile.

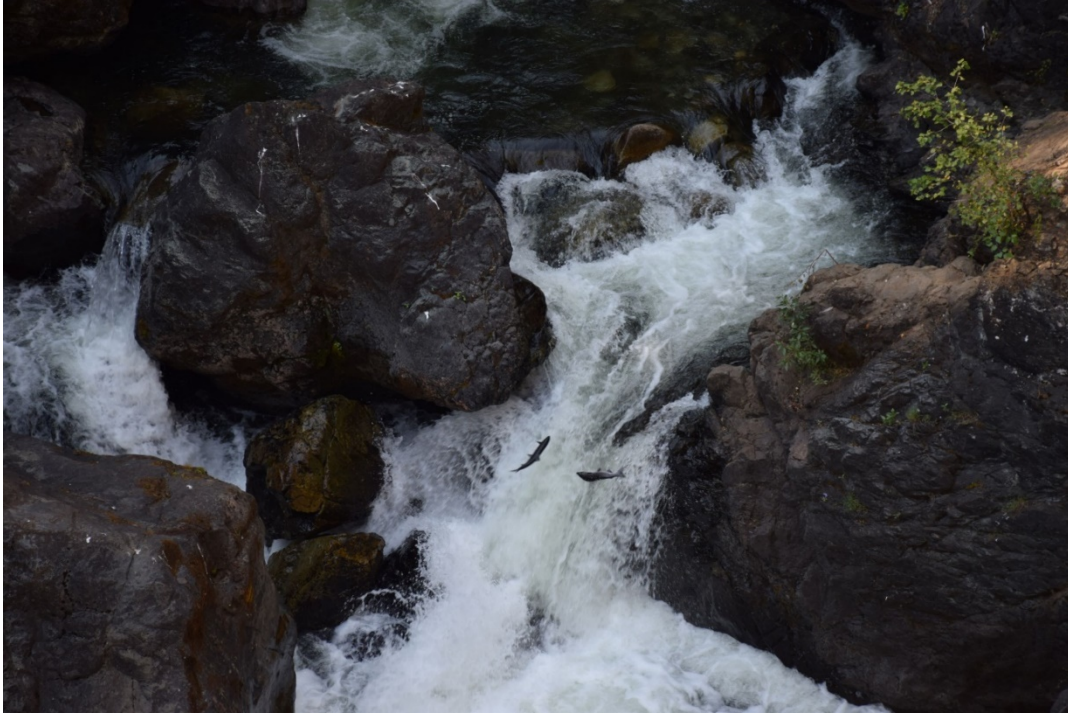
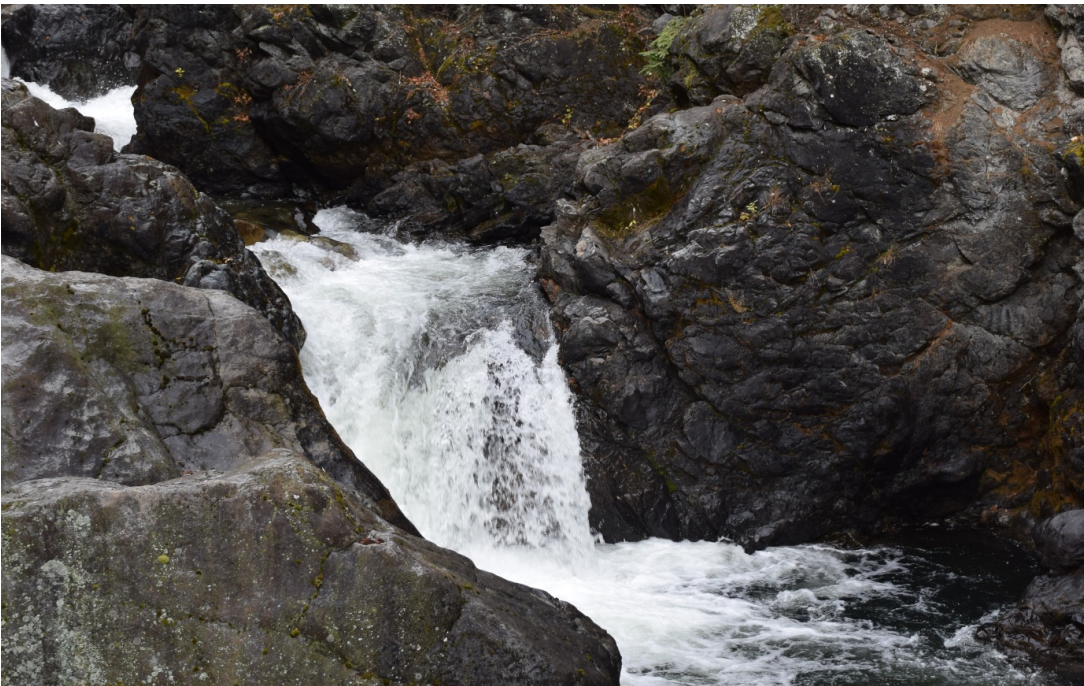
Photos 2 and 3: View of the site before and after mitigation at SR3-3.

A fall site visit was conducted between October 10th and 15th. The main objective of the 2018 mitigation implementation works program was to address the hydraulic issues at site SR3-3 by widening the spill crest at the channel step that has been a migration bottle-neck. The original plan was to drill a series of holes and blast a small notch in the river left bedrock outcrop that forms the step. A drill and blast plan was developed, a certified blaster was put on standby in Whitehorse and the crew proceeded to the site to conduct the work. Once the initial drilling was underway it became apparent that the bedrock sidewall was not as stable as was originally thought and a weak layer was detected. This posed risks associated with blasting as it appeared that controlling the blast might be problematic and an “over-achievement” may have been possible. Uncertainty around blast control raised the risk of producing too much blast rock and potentially creating a more problematic hydraulic outcome. Because of this the team decided to forgo blasting and create the rock notch by a combination of rock drilling, rock sawing and sledge hammer removal. This resulted in a much smaller volume of rock removal under much more controlled conditions. The majority of the rock removed was achieved manually by sledge hammer. A basic as-built survey was conducted once the work was complete and an as-built diagram produced from the survey data, overhead photo-mosaic and professional judgement. The SR3-3 as built survey diagram (Appendix 1) enabled the estimation of total material removed and the resulting hydraulics of the step. The figure shows that approximately 1.1 cubic meters of material was removed to create the notch, which is considerably less than 3 to 5 cubic meters projected with the blasting plan. Mitigation of the step is being achieved by creating a rock notch on river left that achieves the following;

1. Migrants are now able to stage from directly below the plunge and are thus approaching the crest head-on to the flow;
2. The new staging area has a surveyed depth of 2.7 meters which should result in much better staging velocities and better jump performance;

3. The crest of the step spill point has been widened by approximately 0.75 of a meter which should create better overall hydraulics. Widening the crest has resulted in a “landing pad” with low aeration (see picture 1) which should improve swimming performance by increasing traction. Excessive aeration can reduce flow density and thus reduce burst swimming performance which is critical for fish passing high jump height obstacles. One of the main recommendations of the design engineer was to assure that the “landing pad” was minimally aerated and hydraulically laminar.

4. The final alignment of the notch includes a narrow low flow notch (LFN) that will assure that the “landing pad” does not dewater under low flow conditions.

Photos 1 and 2, below, show the pre and post-mitigation conditions.

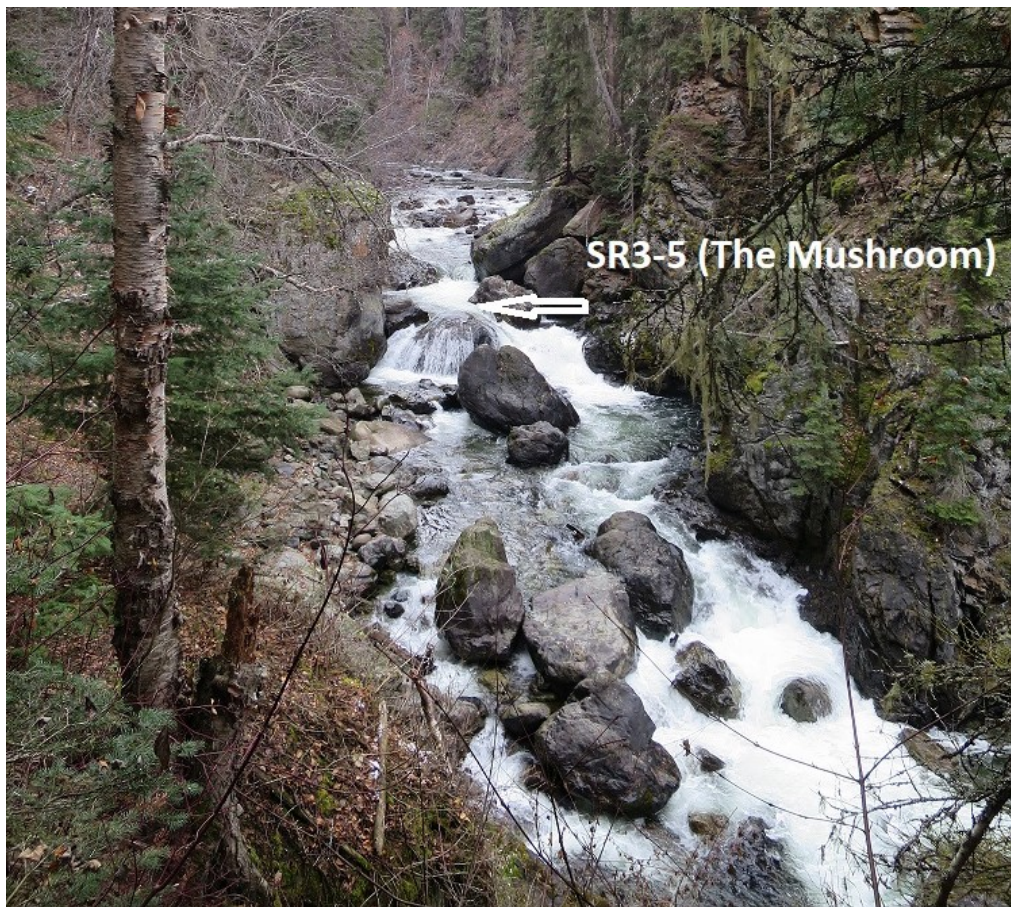
Photo 3: Upstream view to obstacle SR3-5. SR3-4 is cluster of boulders in the foreground and SR3-3 is just out of frame on the right side of the picture. This picture was taken at low flow.

The proposed work for 2019 involves a continuation of the work to the last upstream migration obstacle, SR3-5. This obstacle is formed as flow passes over a rounded boulder that causes flow dispersion resulting in a mushroom shaped cascade (thus the obstacle is called the “Mushroom”). An overview of Sub reach 3 (SR3) is included in Appendix 2. Previous assessments and jump attempt monitoring indicates that this is the preferred migratory path, likely because the river left channel is a velocity barrier at typical summer flow levels (during the migration period) and there is a cluster of small boulders obstructing the staging area.

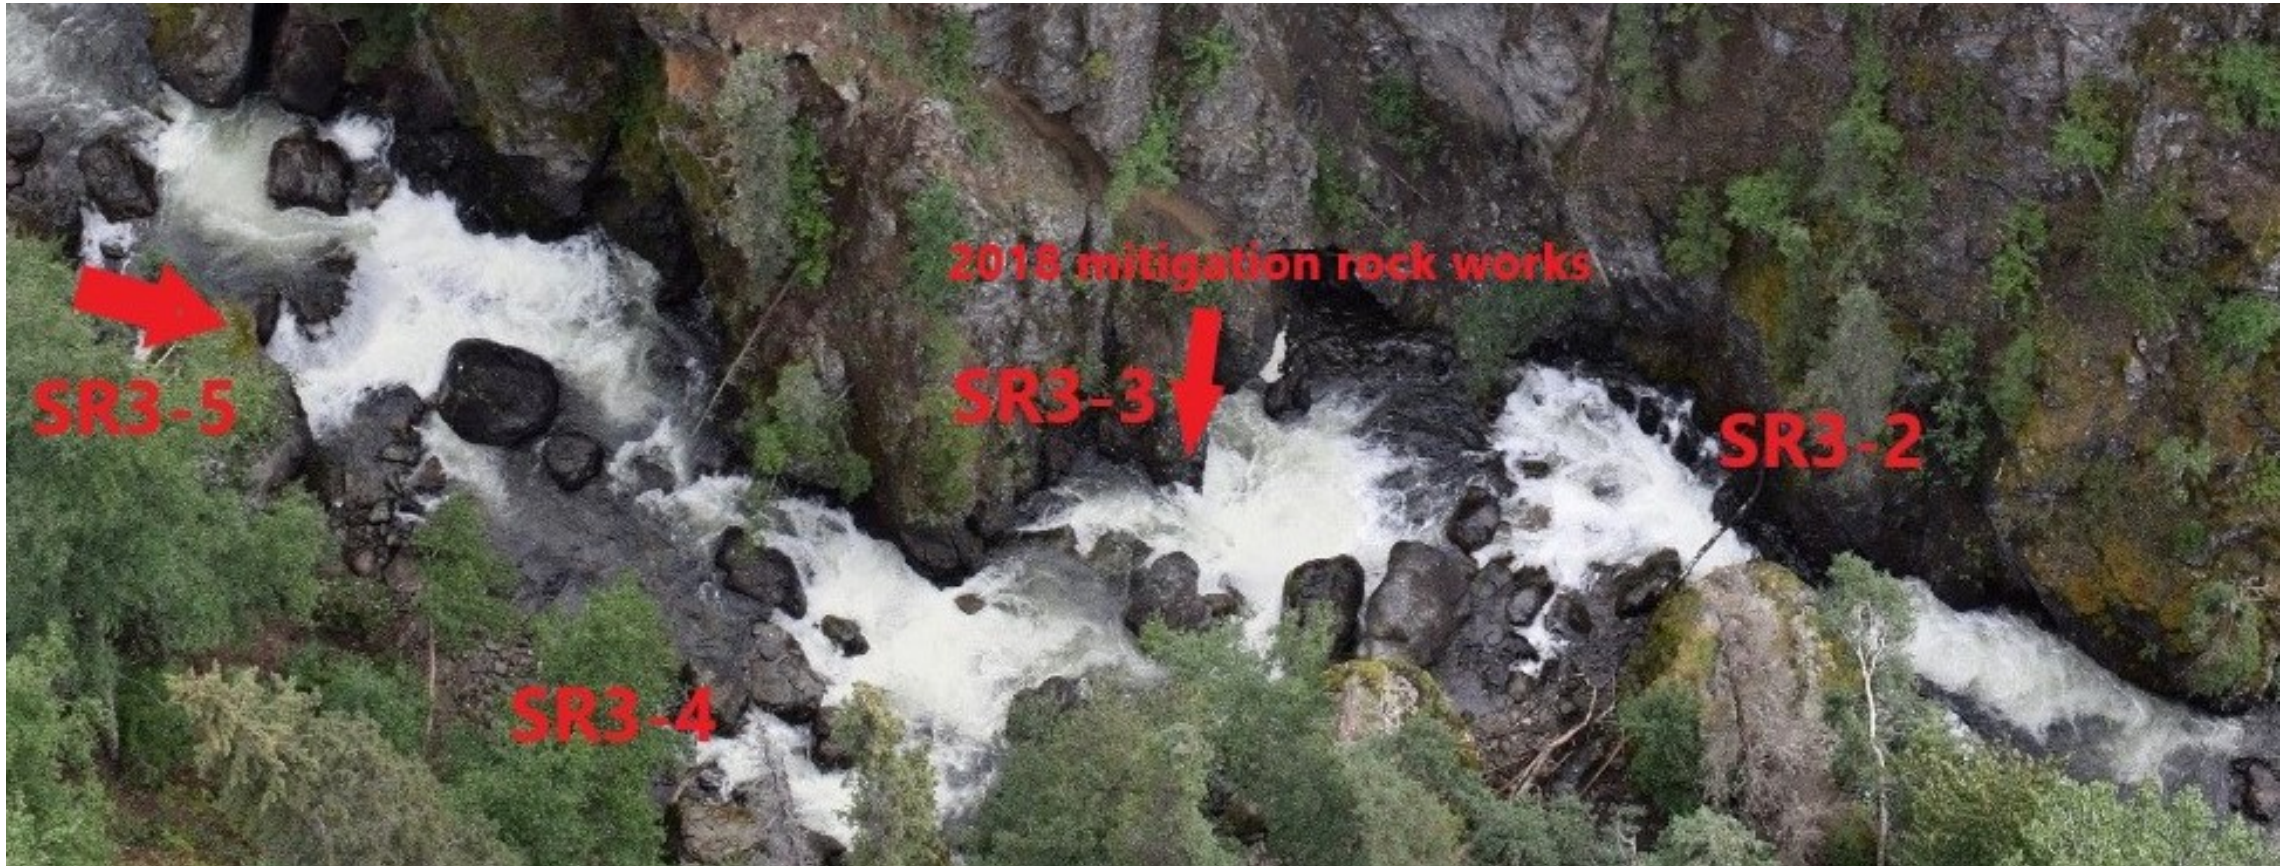
Appendix 2: Overview Mosaic of Sub Reach 3, Silver Salmon canyon.
