## Site Assessment of Lillooet River for Use of Imaging Sonar to Estimate Coho Salmon Escapement

# Site Assessment of Lillooet River for Use of Imaging Sonar to Estimate Coho Salmon Escapement

14 January, 2019

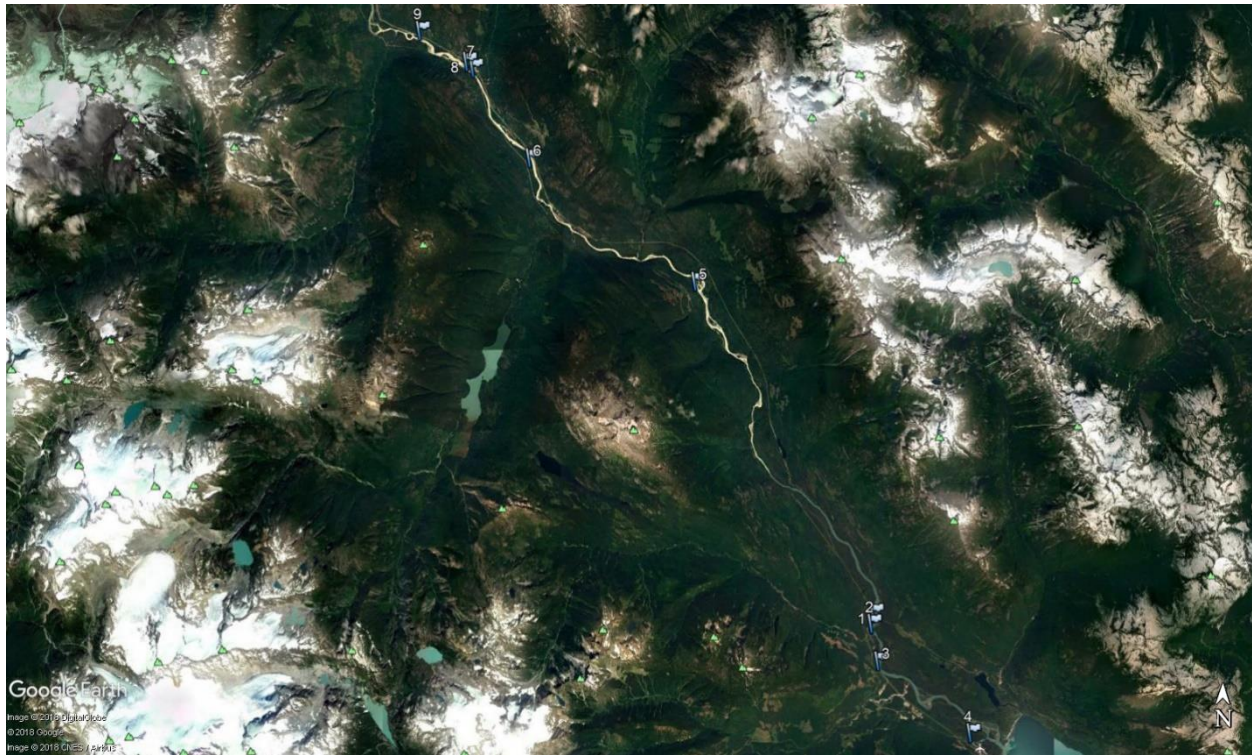
Figure 1. Image from Google Earth showing the locations of each site surveyed on the Lower Lillooet River on 8 August 2018.

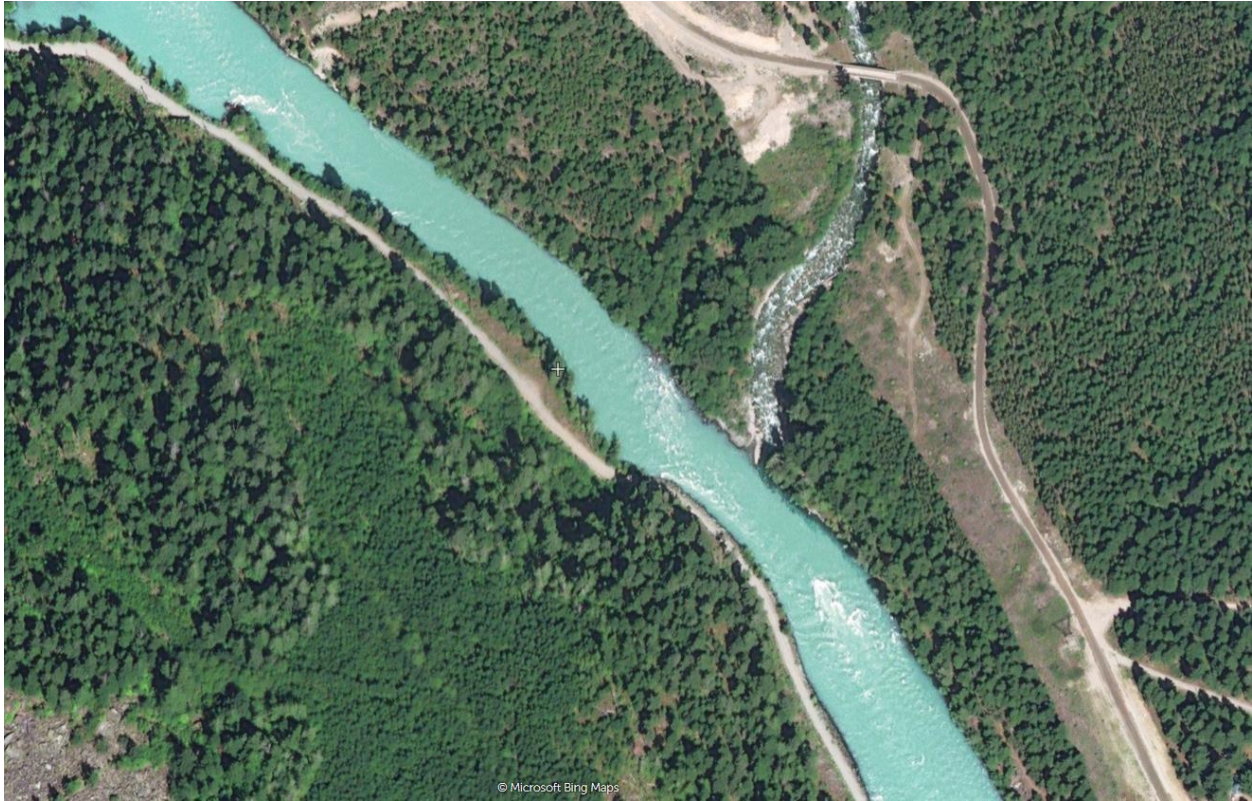
*Figure 2. Image from Zoom Earth of the Lillooet River at Rogers Creek showing a potentially suitable location for using imaging sonar to estimate the number of Coho salmon migrants.*

Located near the mouth of Rogers Creek (Figure 2), site 7 stood out as a suitable location for use of imaging sonar to estimate the number of Coho salmon migrating up the Lillooet River and provide a census-style assessment of the entire Lillooet CU. This site features a relatively narrow wetted width

(approximately 50 m), absence of rapids or highly turbulent areas, absence of large boulders that would obstruct the ability to image across the river, ease of access from West Lillooet Lake Road, and presence of a community gathering structure that may be used to house electronic equipment and on-site technicians.

- Setup a monitoring station at the Rogers Creek site using an ARIS 1200 system to assess Coho salmon migration up the Lillooet River;
- Monitor Coho salmon migration throughout a five to six week time frame that encompasses the typical peak period of Coho salmon movement up the Lillooet River; and
- Use sonar counts from the monitoring period to develop best estimates to characterize Coho salmon escapement on the Lillooet River.

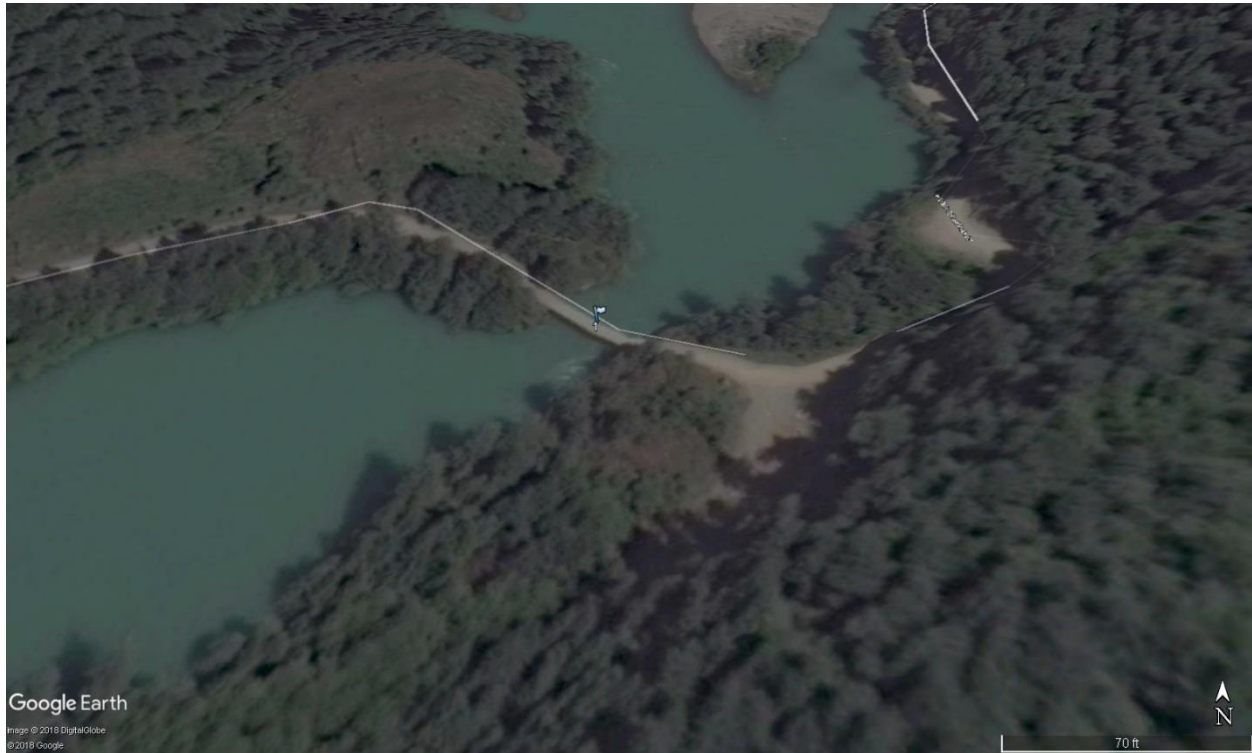
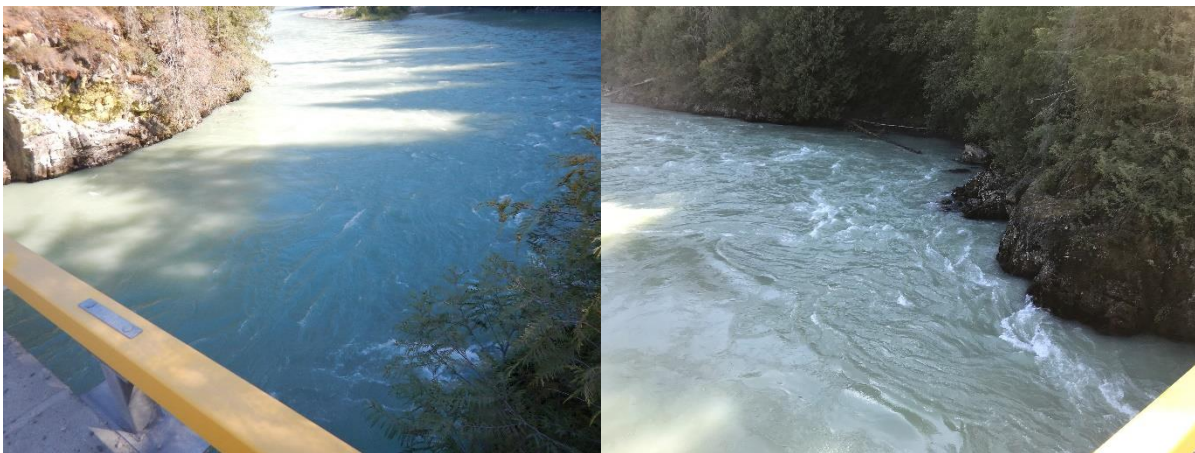
### Site 1

- Upper bridge crossing on In-Shuck-ch Forest Service Rd at km 72
- Access from bridge to river difficult and dangerous
- Flows were high and turbulent
- Width of 35 m estimated from Google Earth imagery
- Site deemed unsuitable

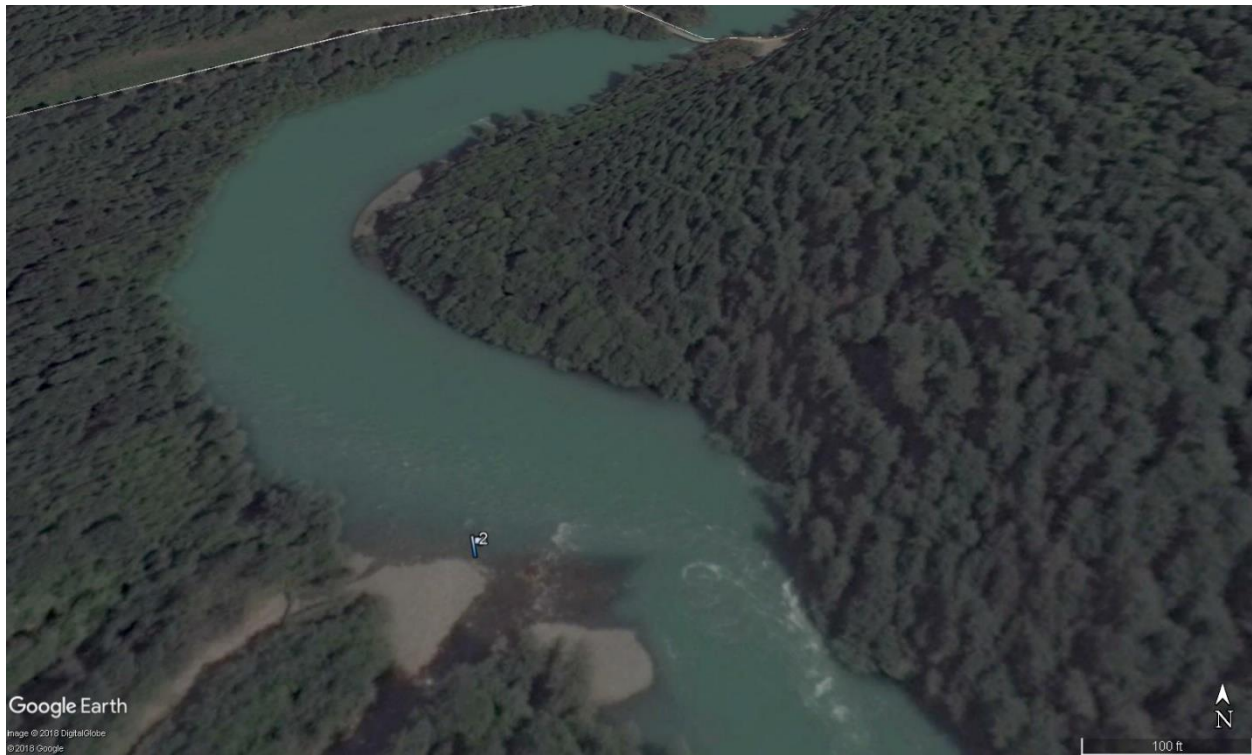
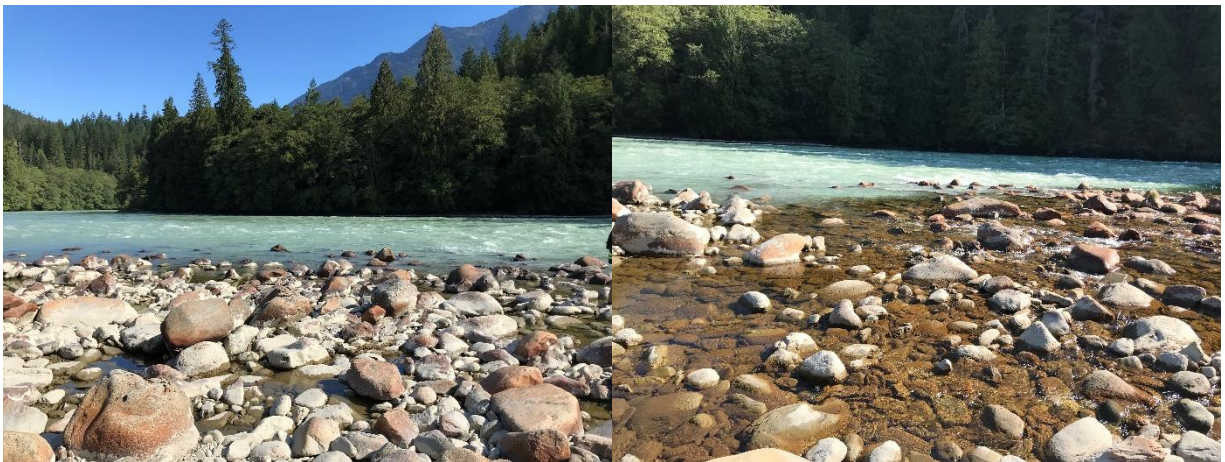
## Site 2

- Mouth of Fire Creek
- Easy access along dirt path near abandoned house on In-Shuck-ch Forest Service Rd at km 72.2
- Flows were high and turbulent, with abundant rapids
- Large cobble and boulder fan along creek mouth
- Width of 90 m estimated from Google Earth imagery
- Site deemed unsuitable

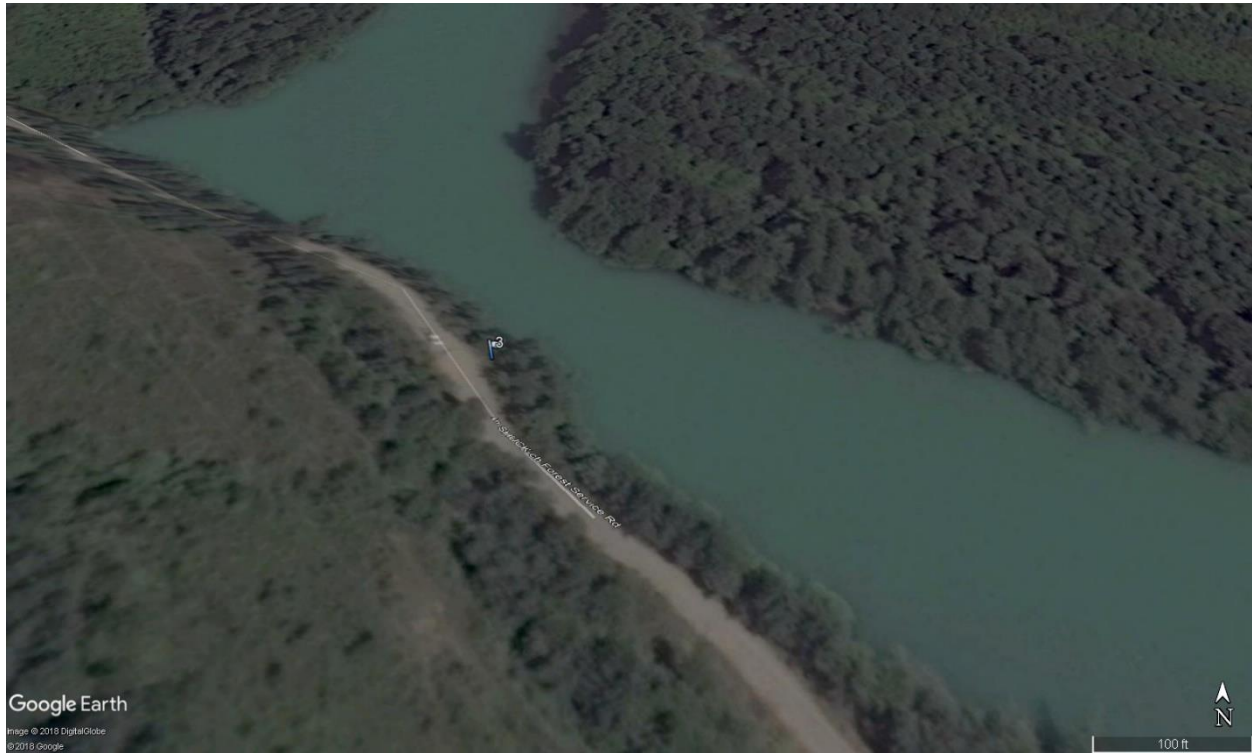
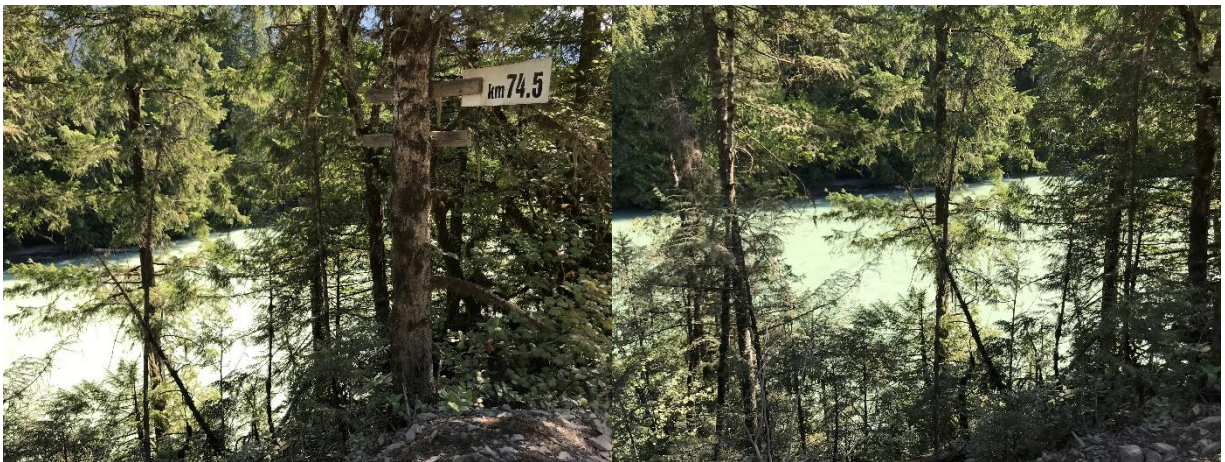
### Site 3

- Km 74 on In-Shuck-ch Forest Service Rd
- Access extremely difficult with river much lower in elevation than road
- Flows were not turbulent, with no rapids
- Width of 55 m estimated from Google Earth imagery
- Site deemed unsuitable

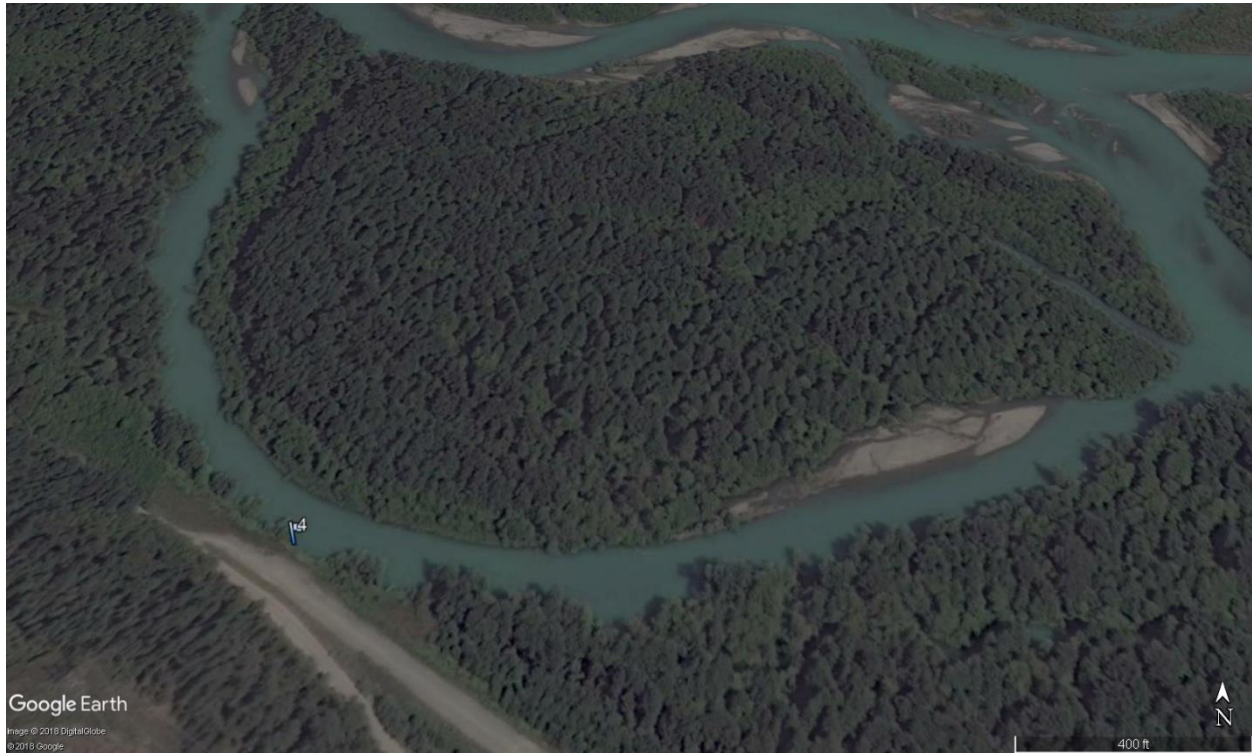
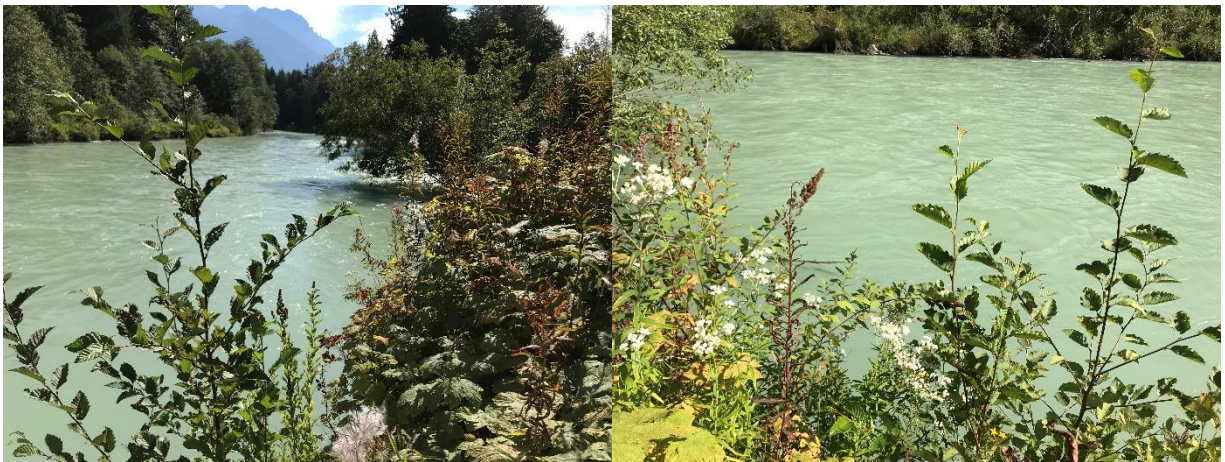
## Site 4

- Near old airstrip south of community of Tipella
- Side channel of mainstem Lillooet River
- Gravel lot access from In-Shuck-ch Forest Service Rd at km 80
- Flows were not turbulent, with no rapids
- Width of 41 m estimated with range finder, width of 35 m estimated from Google Earth imagery
- Site deemed suitable but inferior given it is a side channel

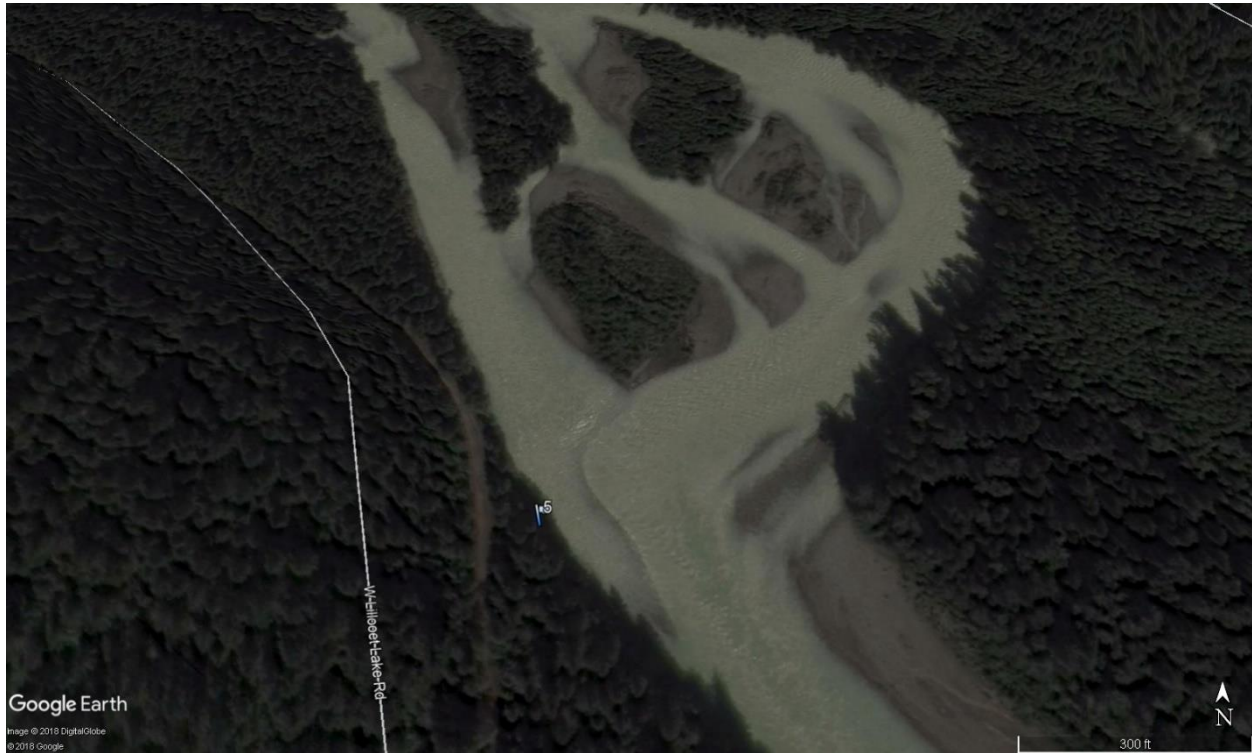
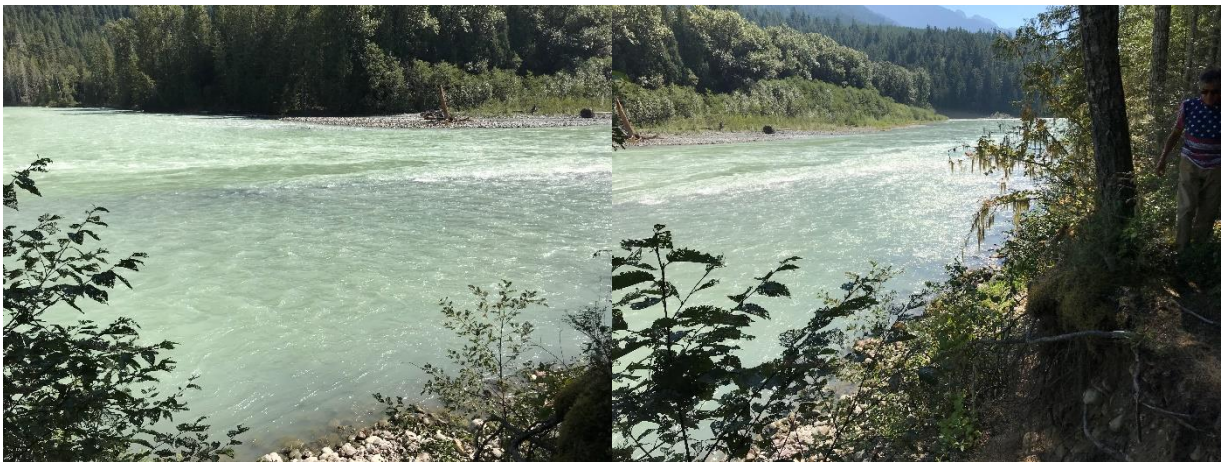
## Site 5

- Km 60 on West Lillooet Lake Rd
- Easy access down short path from road
- Just below series of islands; gravel/cobble bar 20 m from west bank
- Flows with light turbulence, no rapids
- Width of 100 m estimated from Google Earth imagery
- Site deemed potentially suitable at low water when channel is assumed to be substantially more constricted

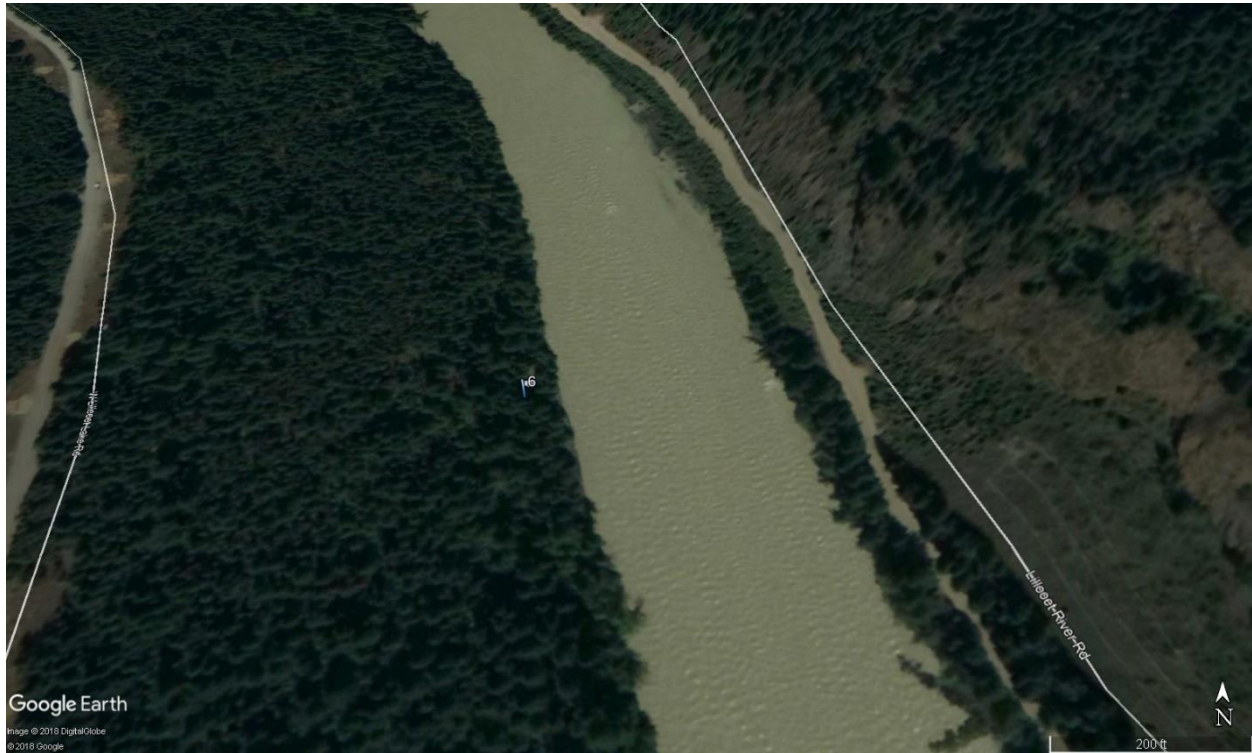
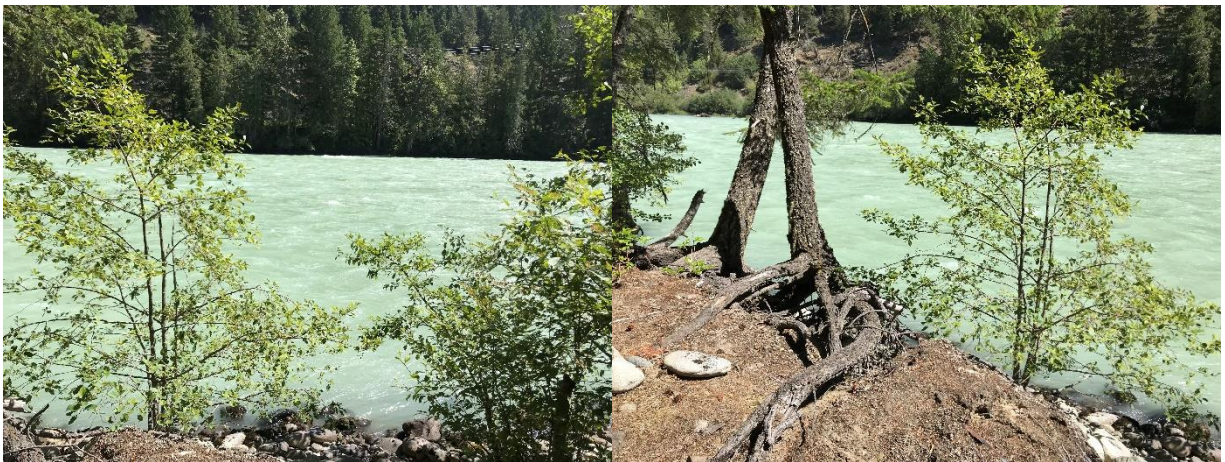
## Site 6

- Km 48 on West Lillooet Lake Rd
- Easy access down short dirt road to campsite on river's edge
- Flows with light turbulence, no rapids
- Width > 100 m estimated with range finder, width of 90 m estimated from Google Earth imagery
- Site deemed unsuitable due to great width

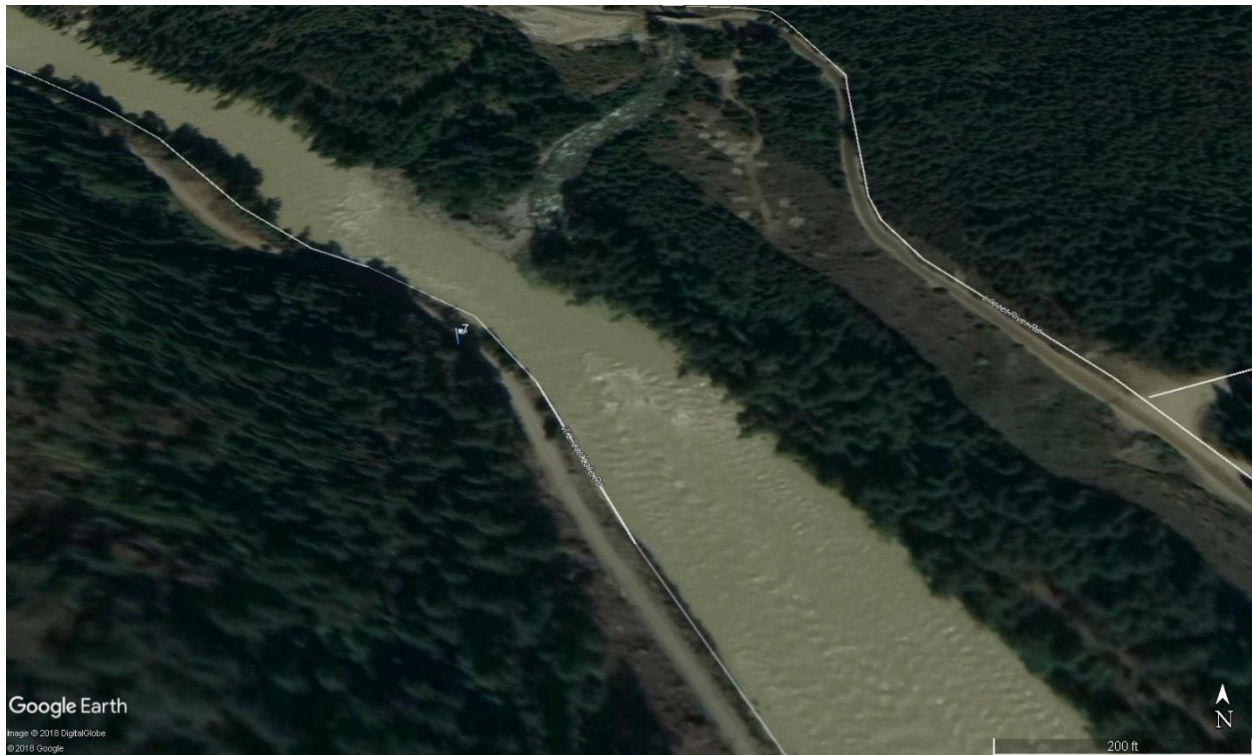
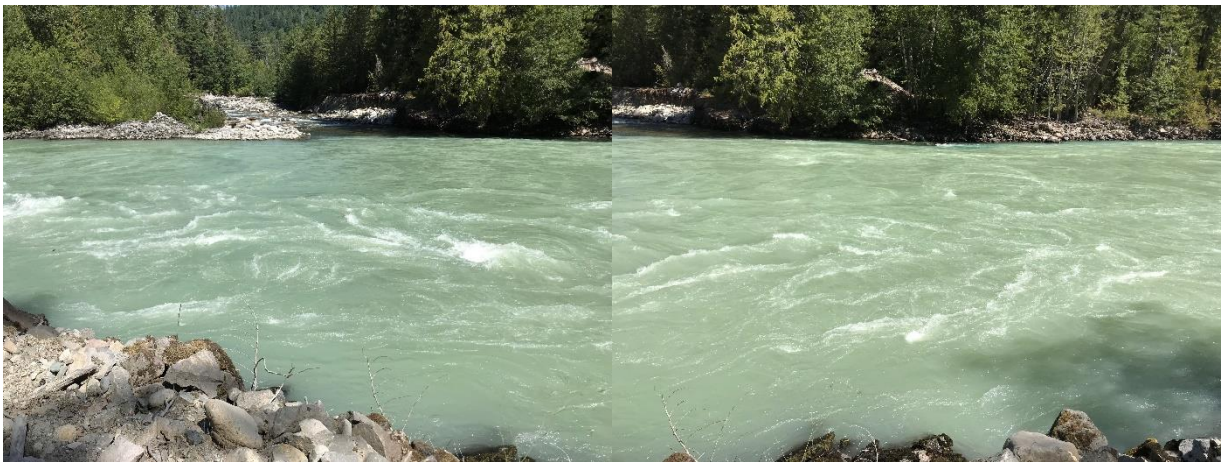
## Site 7

- Just below Rogers Creek
- Site assessed from km 44 on West Lillooet Lake Rd
- Easy access to site from Lillooet River Rd; cultural gathering hut located below creek mouth
- Flows with light turbulence on west side, no rapids
- Width 51 m estimated with range finder, width of 42 m estimated from Google Earth imagery
- Site deemed suitable

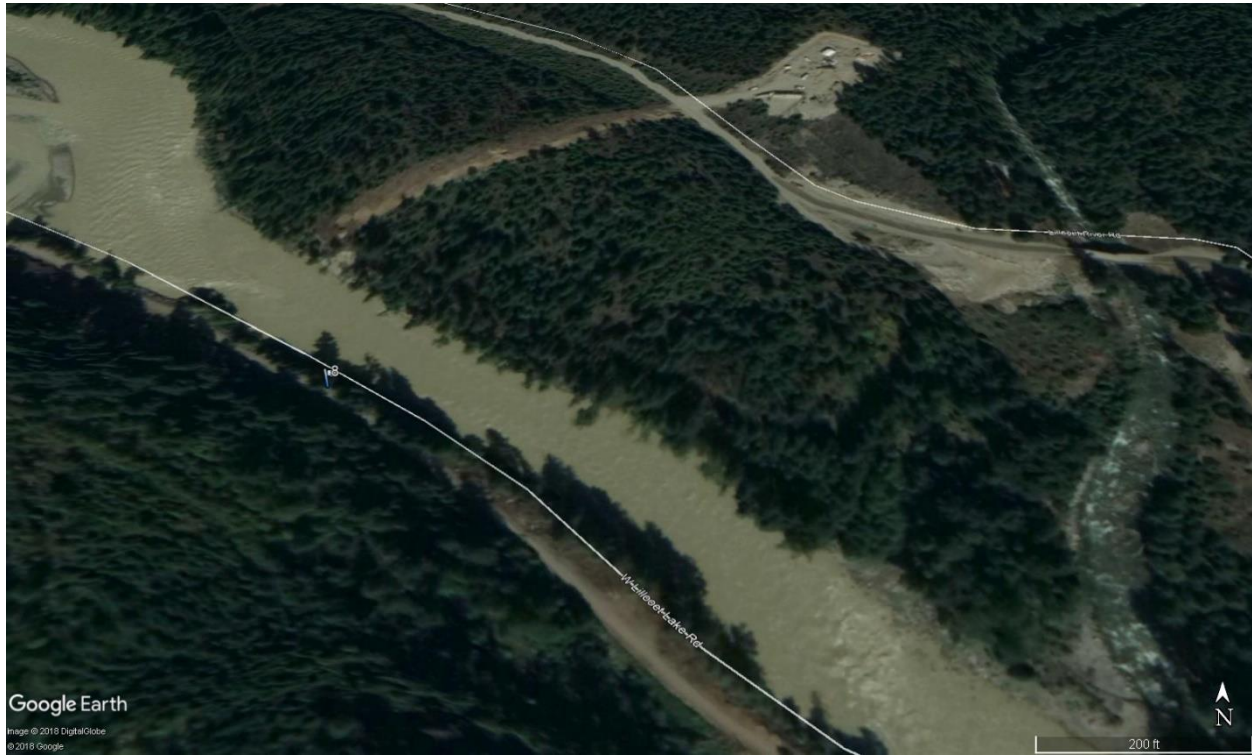
## Site 8

- Near km 44, 300 m upstream of Site 7
- Site assessed from km 44 on West Lillooet Lake Rd
- Access very difficult down steep hillside to river
- Flows highly turbulent
- Width of 55 m estimated from Google Earth imagery
- No additional photographs taken at Site 8
- Site deemed unsuitable

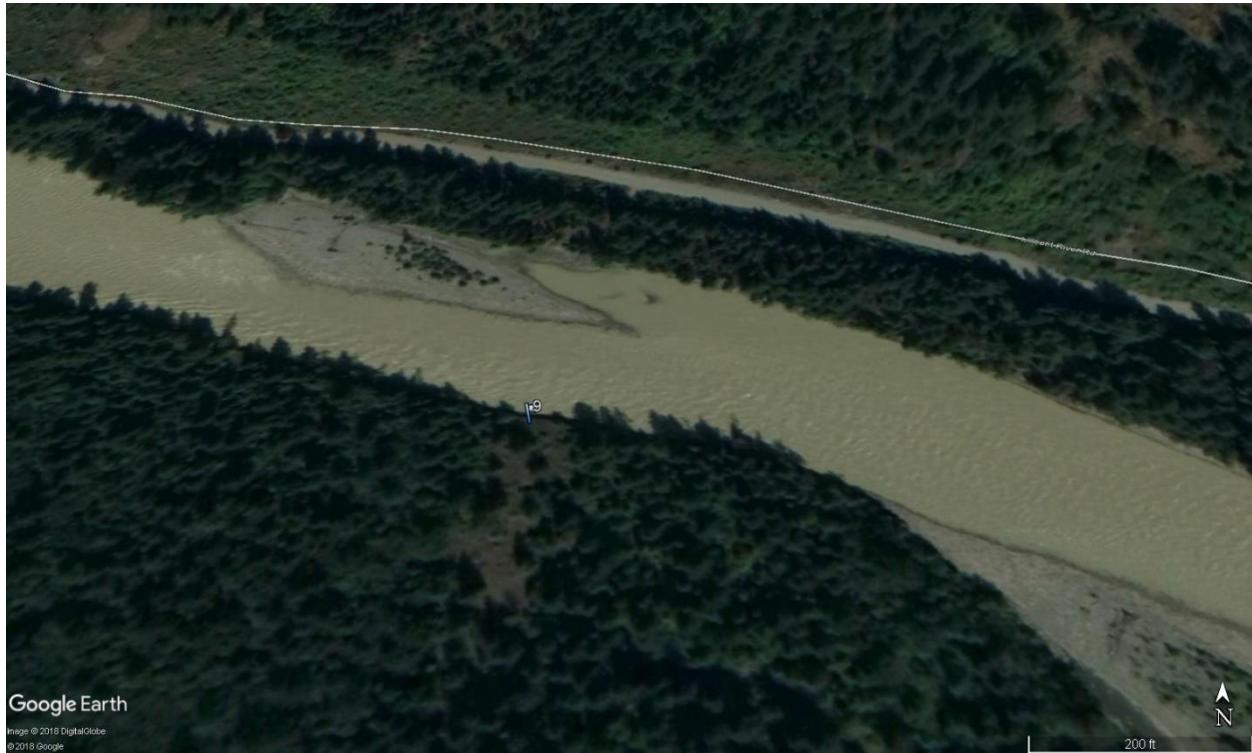
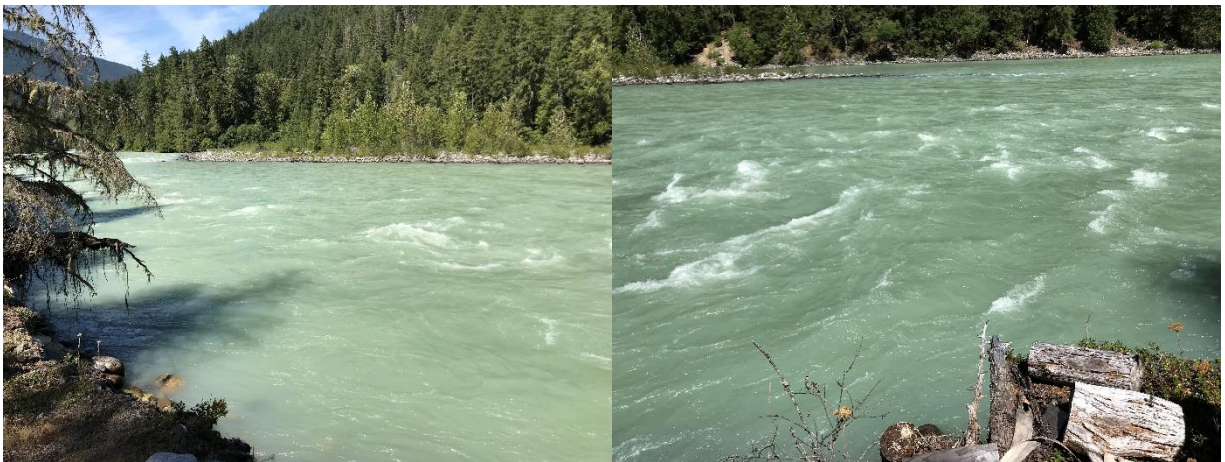
## Site 9

- Km 40 on West Lillooet Lake Rd
- Site includes gravel/cobble bar spit that encloses cove on east side of river
- Access easy after following long dirt path to river
- Flows moderately turbulent
- Width of 76 m estimated with range finder, width of 63 m estimated from Google Earth imagery to downstream tip of spit
- Site deemed unsuitable due to width
