Bessette Creek Coho Enumeration Using a Resistivity Counter (Year 2 of 3)

Brenley Yuan and Skyeler Folks
Okanagan Nation Alliance Fisheries Department, Westbank, BC

Pacific Salmon Commission

March 2019

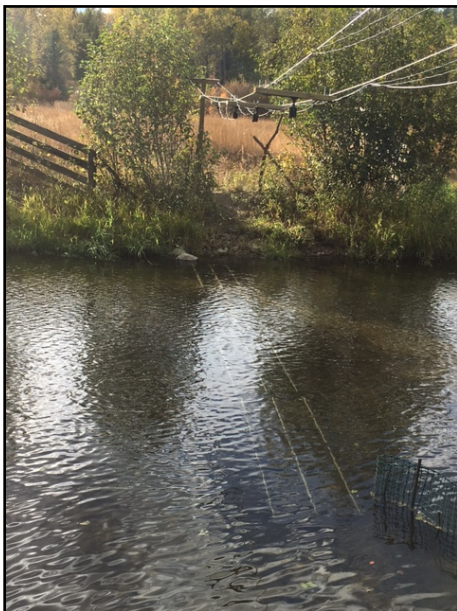
Figure 2: Resistivity counter installed in Bessette Creek, BC.

A resistivity counter and flat pad sensors were installed in Bessette Creek at a location 6 km NE of Lumby, BC (Figure 1) from September 26 to November 30 in 2017, and September 26 to December 5 in 2018. At this site, the stream is approximately 12 m wide with a mean depth of 0.3 m (Figure 2). This location is situated downstream of the majority of Coho spawning areas, ensuring that most of the spawners migrating into the system would be enumerated. In 2015, the counter was successfully operated on a trial basis at this location. At the site, the stream consists of a relatively wide and shallow glide with a uniform channel suitable for counter installation.

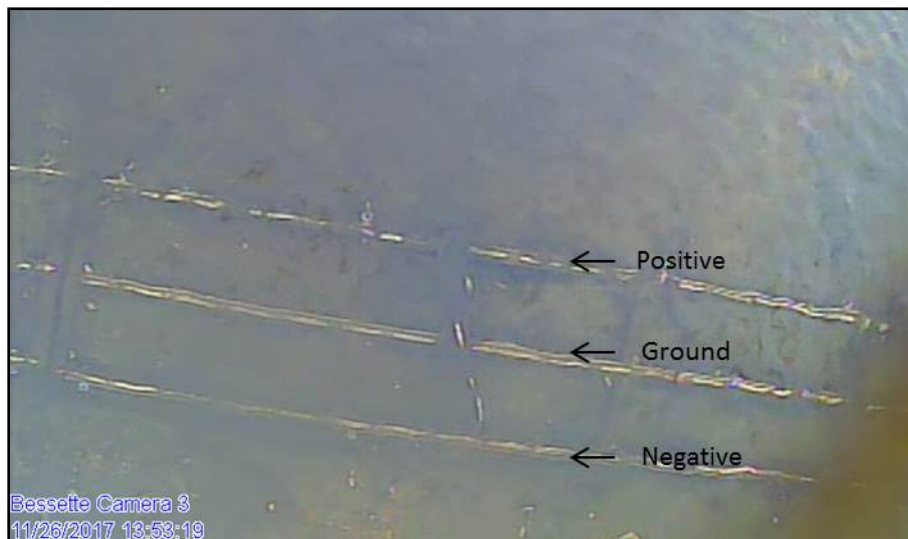
Figure 3: Video screenshot of upstream migrating Coho salmon over resistivity panel in Bessette Creek, BC.

The Logie 2100C resistivity counter consists of two components. The electronic unit (computer that contains the algorithm) that is deployed onshore and the flat pad sensors (2.44 m by 0.635 m), which each house three electrodes, that are deployed in the river. The electrodes are spaced 0.3 m apart and run the length of each panel (Figure 3). The bulk resistance of the water column above the flat pad sensors is continuously measured. When an object passes over the electrodes, it displaces water around it and thus a change in resistance is detected. If the object spans two electrodes simultaneously, an event is recorded. Each event record includes the date, time, direction of movement, channel number, and peak signal size (PSS). In addition to the record, trace data (Figure 4) is also stored for each event and can be graphically visualized to help verify counter events and correct for algorithm errors. The counter's internal algorithm was developed to discern a fish passage event (compared to mammals or vegetation) by monitoring the trace data and a change in electrical resistance which exceeds a user defined threshold. When categorized as a fish, the corresponding event is recorded as an up (U) or down (D) fish movement, otherwise it is assigned an "E" for unclassified event. Movement direction is determined by the order in which the fish passes the negative and positive electrodes.

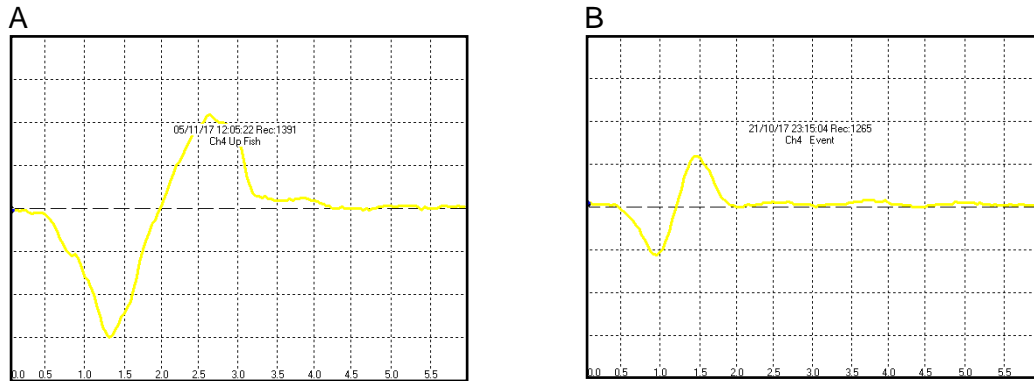
Figure 4: Graphical trace data for resistivity counter at Bessette Creek, BC: A) correct counter assignment of a Coho Salmon upstream movement, and B) incorrect counter assignment of a Coho Salmon upstream movement as unclassified event.

Graphical trace data were visually assessed and compared to the counter algorithm assignment of each record. When trace data indicated the record was incorrectly assigned, a note was made in the event's record. To confirm the validity of each misidentified event, along with all other correctly-assigned fish movement records, targeted video validation was conducted by reviewing video camera footage at the time of these records. Data recorded included channel number, video start and end time, and video duration. If a Coho was present, the direction of movement, the onscreen length of the fish, and the onscreen width of the resistivity panel were also recorded.

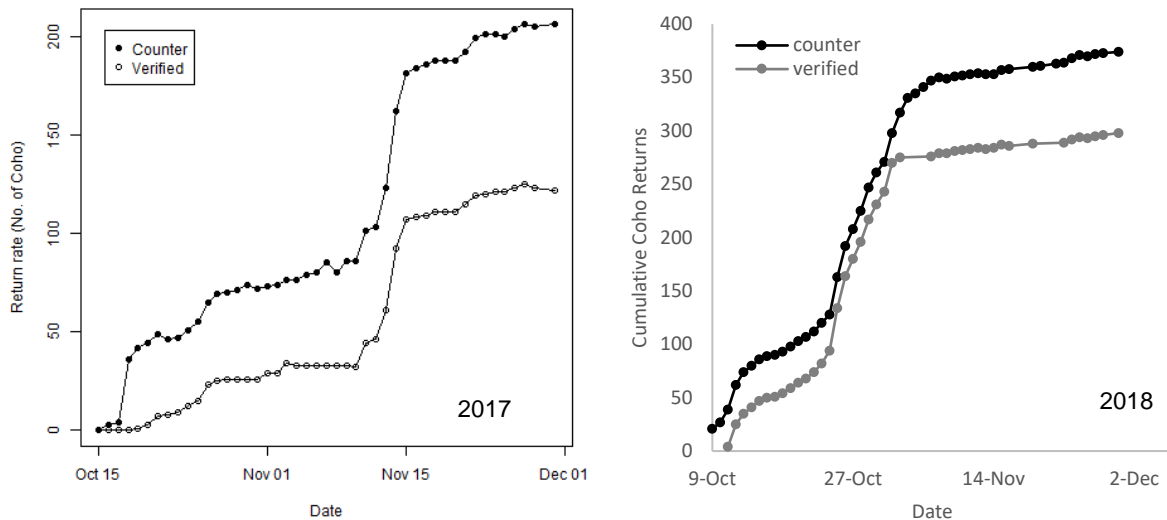
Figure 7: Cumulative Coho returns at Bessette Creek, BC in 2017 (left) and 2018 (right), as net daily upstream movements, estimated by resistivity counter (Counter) and those detections which were verified through video validation (Verified).

In 2017, the overall return of Coho peaked in mid-November, with a large proportion of adults returning from November 11 to 16. A large pulse of fish was also detected on October 18 by the counter (Figure 7). Peak returns in 2018 occurred earlier, with a large proportion of individuals returning between October 24th and November 3. An earlier pulse was also detected in 2018 between October 9 and 13.
