2019 Summary Report for the Silver Salmon River Sockeye Access Improvement Project

Prepared For:
Taku River Tlingit Fisheries
Atlin BC

March 2020

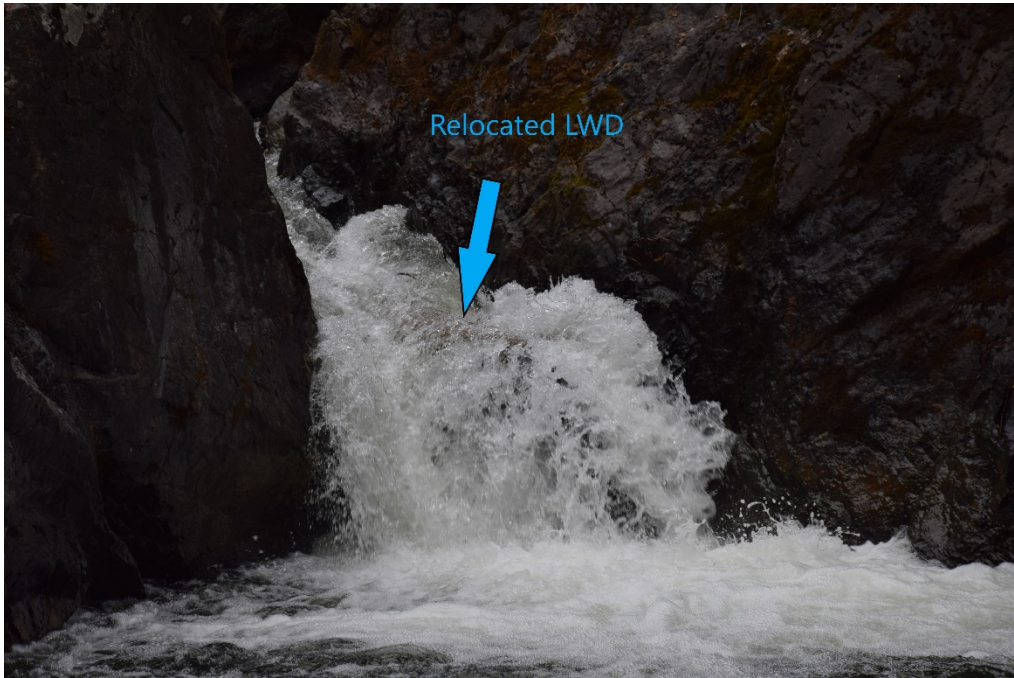
The canyon was traversed from top to bottom to assess the previously identified migration obstacles. Water quality was excellent during this recon which allowed for good visibility in the channel. The reconnaissance of the lower canyon revealed two channel step changes. The changes were the result of the movement of a log from the staging pool in the “Angle Pool” (SR1-3) down to the spill point on the next downstream step, the “foam Pool” (SR1-2). It appears that this change will improve staging conditions in the “Angle Pool” since this log was lodged below the spill there. The log has relocated to the spill point above the “Foam Pool” which may increase the overall jump height but it does not appear to be reducing passage based on a limited number of checks from the top of the canyon during the summer and the fact that fish were making it up to SR3-3. The log appears not significantly lodged in place so we expect it may continue downstream in a stepwise fashion during subsequent high flows.

Photo 1: The relocated LWD at the "Foam Pool" spill point as of April 2019.

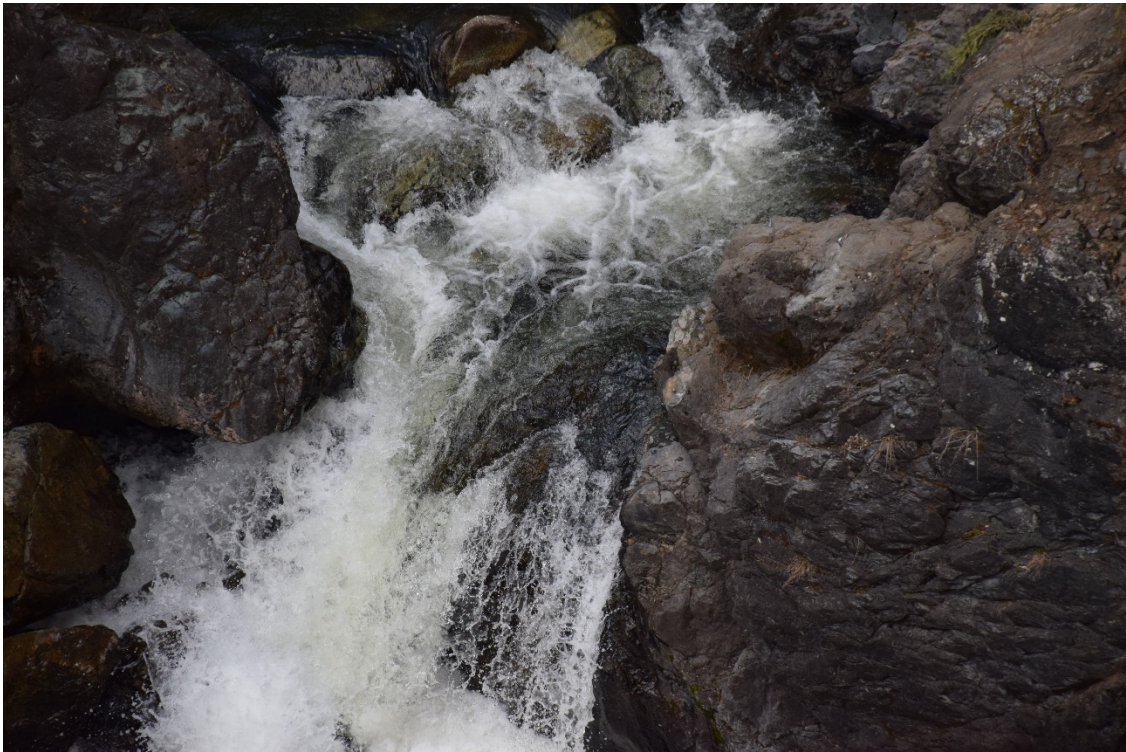
Rock shaping work conducted during the spring site visit included deepening and widening of the river left side of the channel at the lower obstacle (SR3-3, photo 2 below).

Photo 2: The SR3-3 site after the spill point was widened and deepened. (Photo date April 20th, 2019)

The chert bedrock is very hard, with a hardness of 7 on the Mohs scale, (diamond is ranked at 10 on the scale) making the rock shaping rate of progress slow. The hardness resulted in rapid wear of the diamond blades used in the rock saw. Nonetheless the rock shaping both widened and deepened the rock cut and low flow notch.

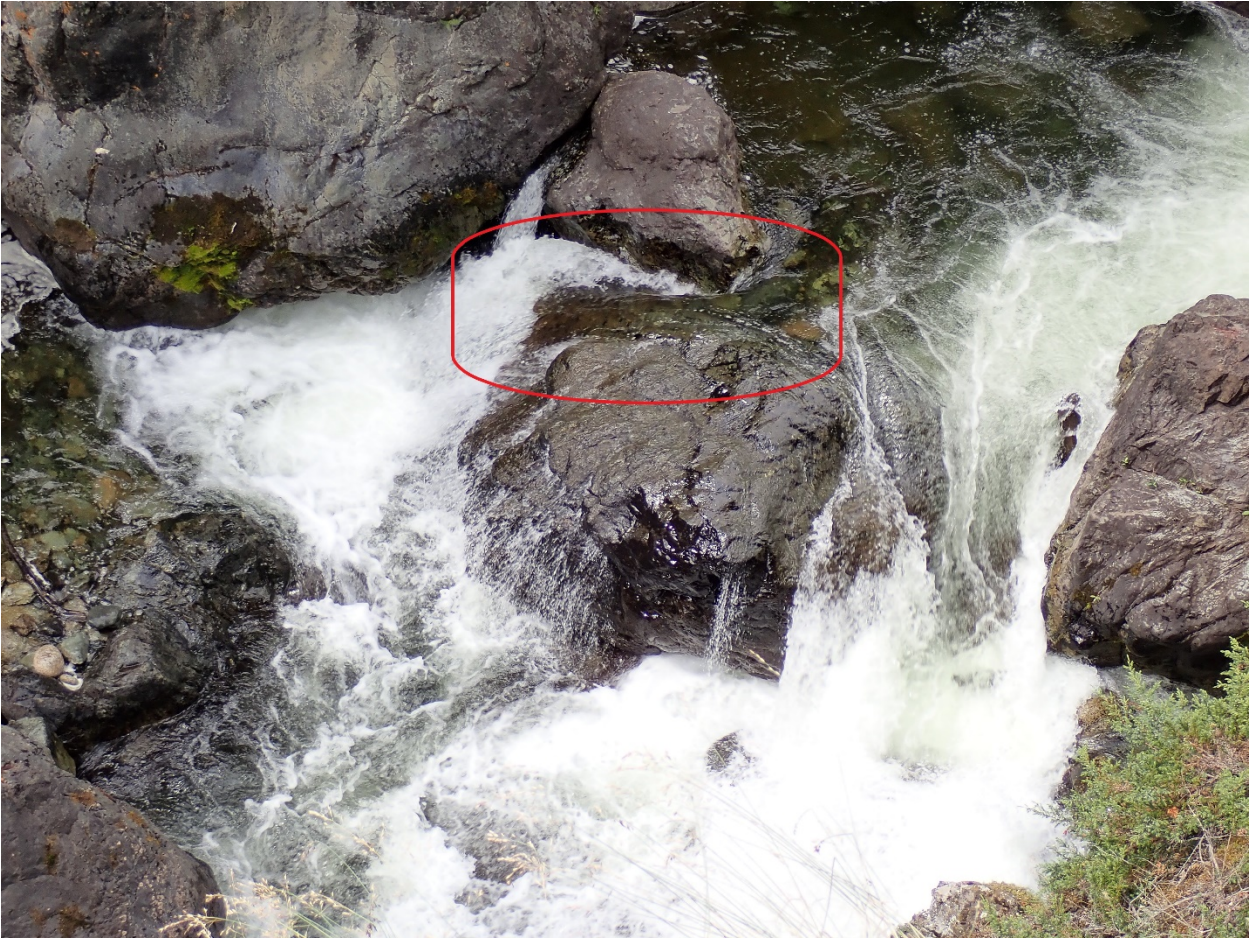
The Mushroom is formed by a large chert boulder lodged at the spill crest of the furthest upstream pool in the canyon. Flows, prior to shaping, were dispersive across the convex surface of the boulder creating poor attraction flows and minimal low flow depth. Rock work at the SR3-5 site involved the following;

- A 25 cm wide, 1.5 meter long notch was cut to increase attraction flows and provide a deeper landing pad for better traction;
- The staging pool was also backwatered by manually infilling the downstream crest of the pool;
- The upstream edge of the boulder, at the notch inlet, was infilled with cobble and small boulders to reduce flow losses.

Photo 3 shows the results of the rock shaping and the new, deeper, laminar flow of the landing pad. The passage dimensions of the spill and staging pool were surveyed post work, Table 1 below details the key passage dimensions;

The resulting alignment provides a more focussed attraction flow, laminar landing pad and slightly deeper staging pool (see photo below).

Photo 3: The Mushroom (SR3-5) during the summer migration period. (Photo Date July 22nd, 2019)

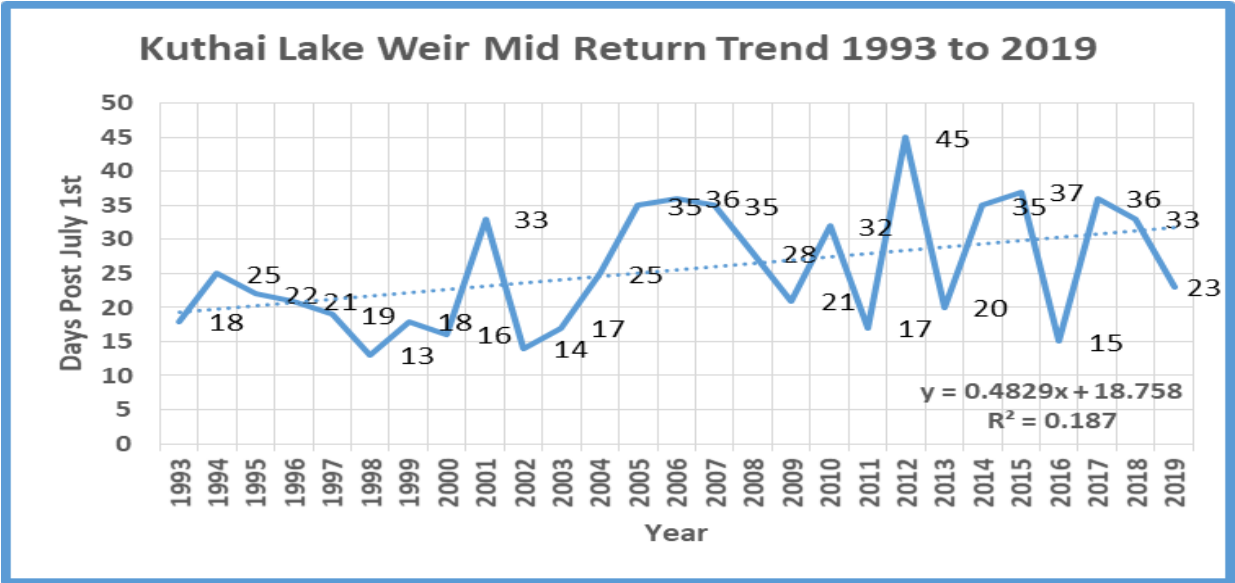
Figure 1: A summary of the mid return dates for Kuthai sockeye passing the weir at Kuthai Lake.

The plot shows a trend line over the data period of increasing mid return date. The mid return date for 2019 is 23 which is the 50th percentile of the dataset indicating that the mid return date is at the average for the data period.

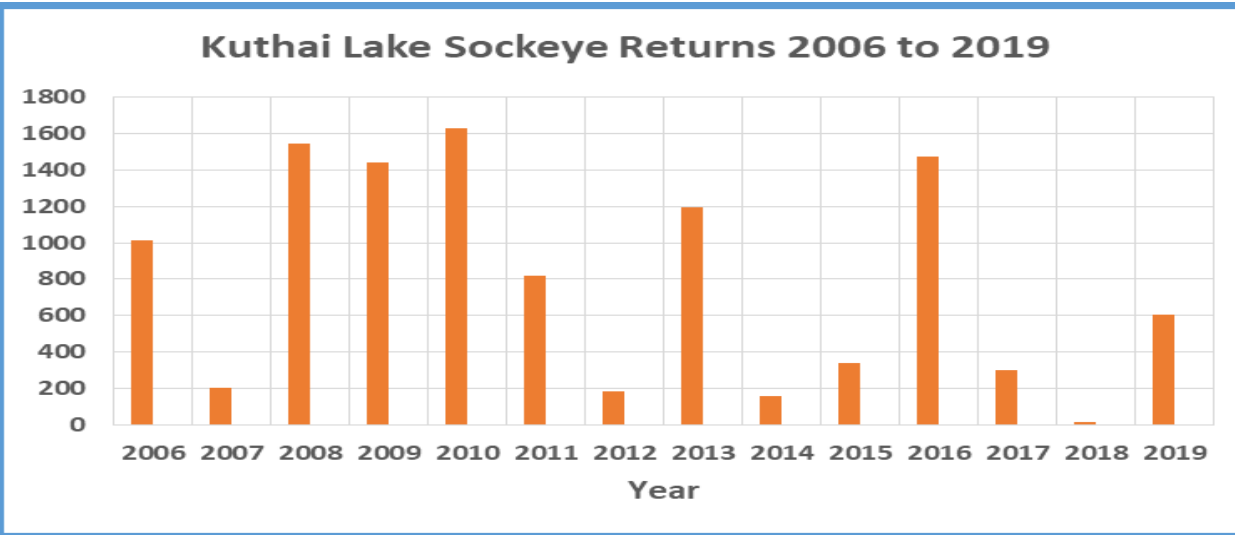
Total Return for the 2019 season was 605 individuals past the weir. This compares to 13 past the weir in 2018 under similar river stage. This suggests some positive results from the rock shaping in 2018 and spring 2019. The 2019 return ranks at the 47th percentile of total returns between 2006 and 2019 making it approximately an average return for the period. The 2019 lake escapement of 605 came primarily from the 2014 brood (parent) year escapement of only 204. However, the 2018 lake escapement of only 13 sockeye came from the 2013 brood (parent) year escapement of 1,195. This provides further indication that the 2019 mitigation works provided improved access.

Figure 2: A plot of total returns to the Kuthai weir between 2006 and 2019. The 2019 total is ranked at the 47th percentile of returns for the period, an average year.

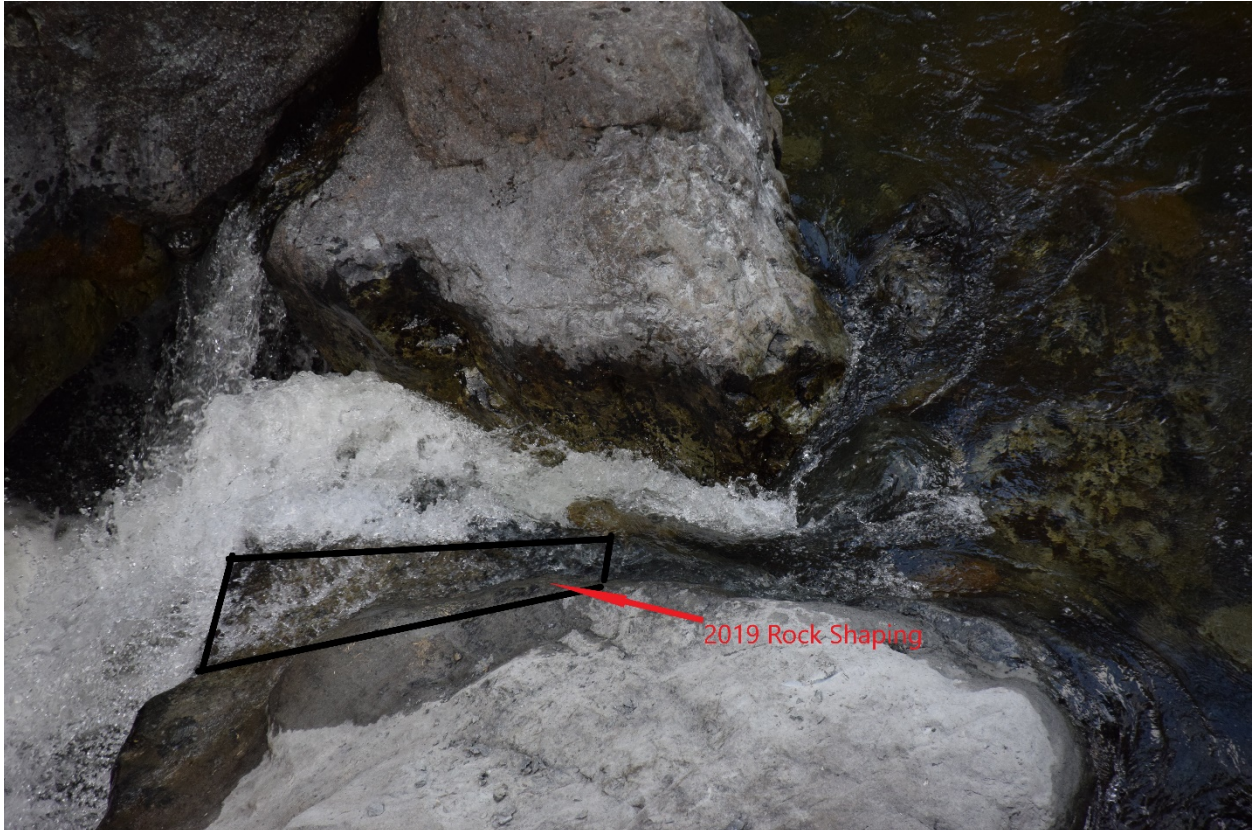
The objective for SR3-5 is decrease the overall jump height and increase the depth of flow for the landing pad. This site is a single boulder so it is risky to attempt blasting or to use expanding epoxy, so we are proposing to use only the rock saw to deepen the landing pad and reduce the overall jump height.

Photo 4: Proposed rock shaping works for site SR3-5.

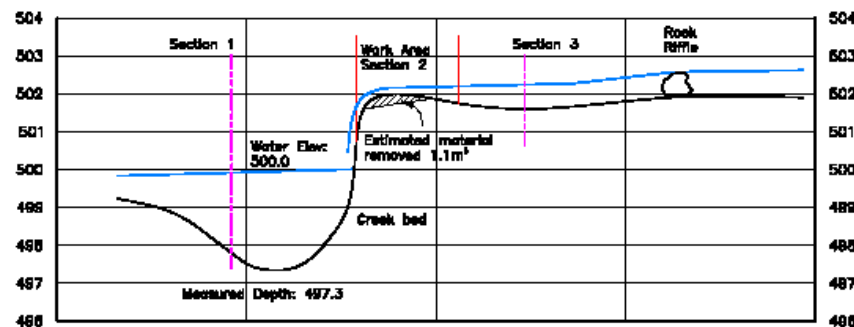
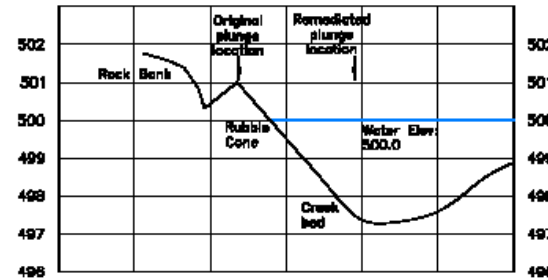
Plan, Profile and Sections
As-built Survey of Passage
Remediation Works
Silver Salmon Creek
Site SR3-3

Site SR3-3 Sketch

Silver Salmon Creek Profile
Through Confluence of Creek
