# Southern Boundary Restoration and Enhancement Fund

## Annual report 2020

**Project Title:** Cowichan River – Stoltz Bluff Sediment Remediation Maintenance

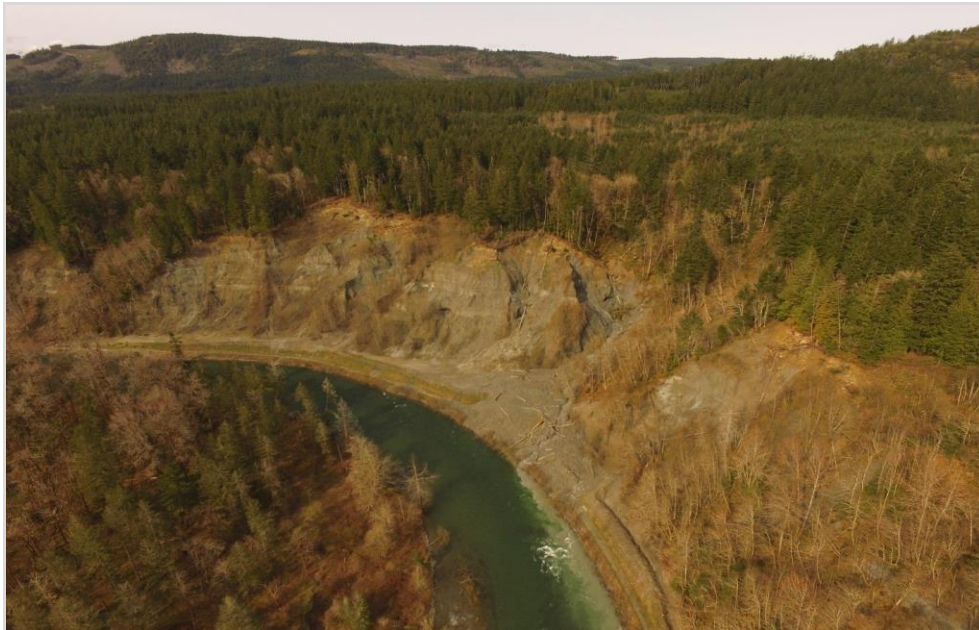
Figure 2. Aerial view of Stoltz Bluff following the Clearwater Creek slope failure in 2017. The sediment flowing from the creek into the Cowichan River can be seen on the center-right of the photo, as can damage to the access road.

Stoltz Bluff underwent a slope hazard assessment following severe winter storms in 2016 and 2017. As indicated by McQuarrie (2017), the bluff will continue to fail, largely due to the instability of Clearwater Creek's gully, which is "severely over-steepened, highly unstable, and cannot be stabilized" (see Figure 2). Ongoing Stoltz Bluff sediment management is needed to meet water quality goals in the Cowichan watershed and to mitigate for the effects of fine sediments on downstream salmonid spawning and rearing habitats.

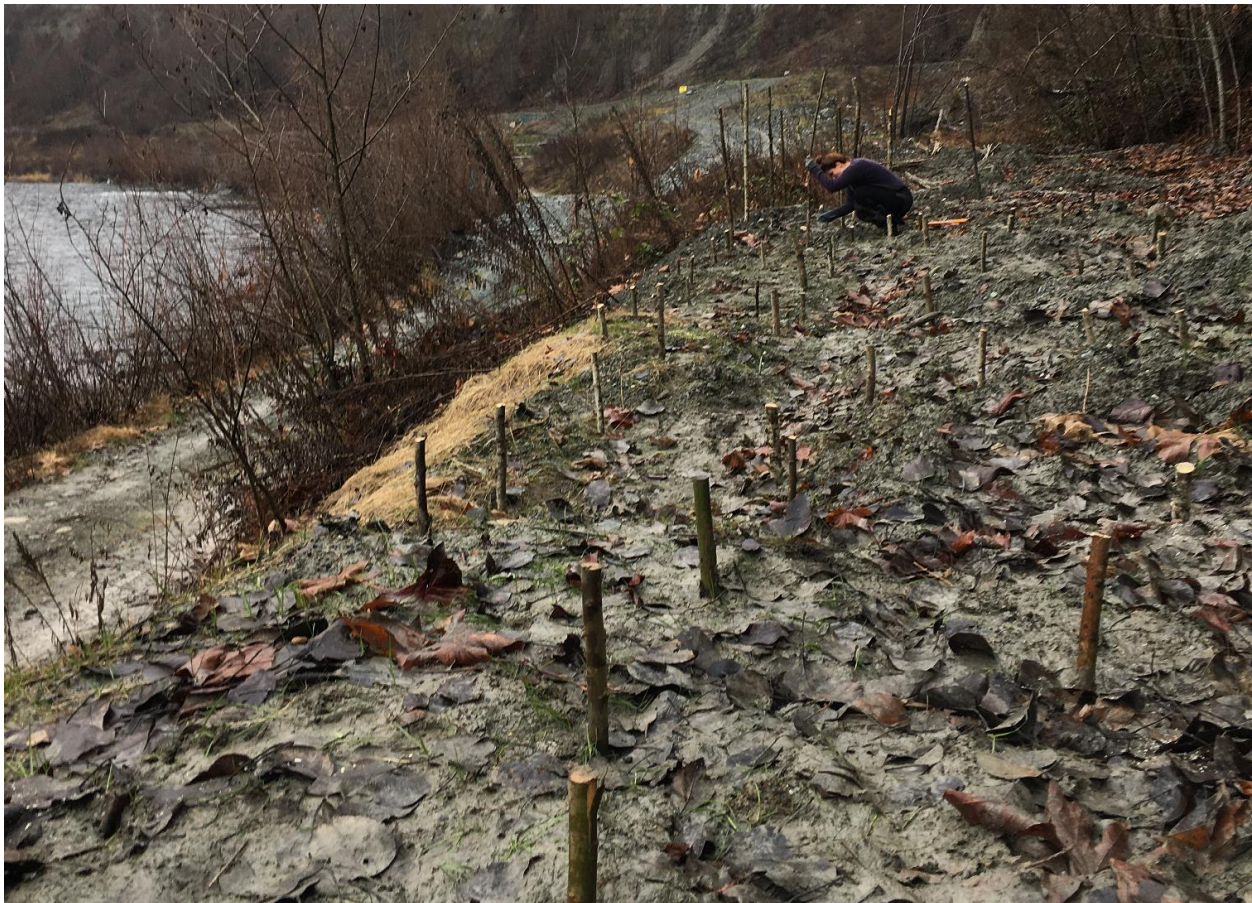
Figure 3. Bioengineering work completed at Stoltz Bluff during the winter of 2019/20.

Bioengineering was undertaken at Stoltz Bluff by BCCF staff and Cowichan Tribes planting crews. In November 2019, BCCF staff met with Dave Polster on site to discuss an overall restoration prescription for Stoltz Bluff. Following recommendations from this site visit, a small crew of Cowichan Tribes members and BCCF staff harvested and planted ~1500 live stakes over a total area of 1564 meters squared at the Stoltz bluff site. ~700 stakes were planted in the spoil piles left over from sediment extracted from the containment pond in 2019 and ~800 stakes were planted on the perimeter of the containment pond and the outer edge of the containment berm. Planting and harvesting occurred from December 2019 through January 2020. The species composition of the stakes planted were as follows: 5% - Red Osier Dogwood, 20% - Willow Sp. and 75% Balsam poplar. While all three of these species have been successfully staked on site in previous years, it was decided to primarily plant balsam poplar based on their observed natural recruitment and success in the area.

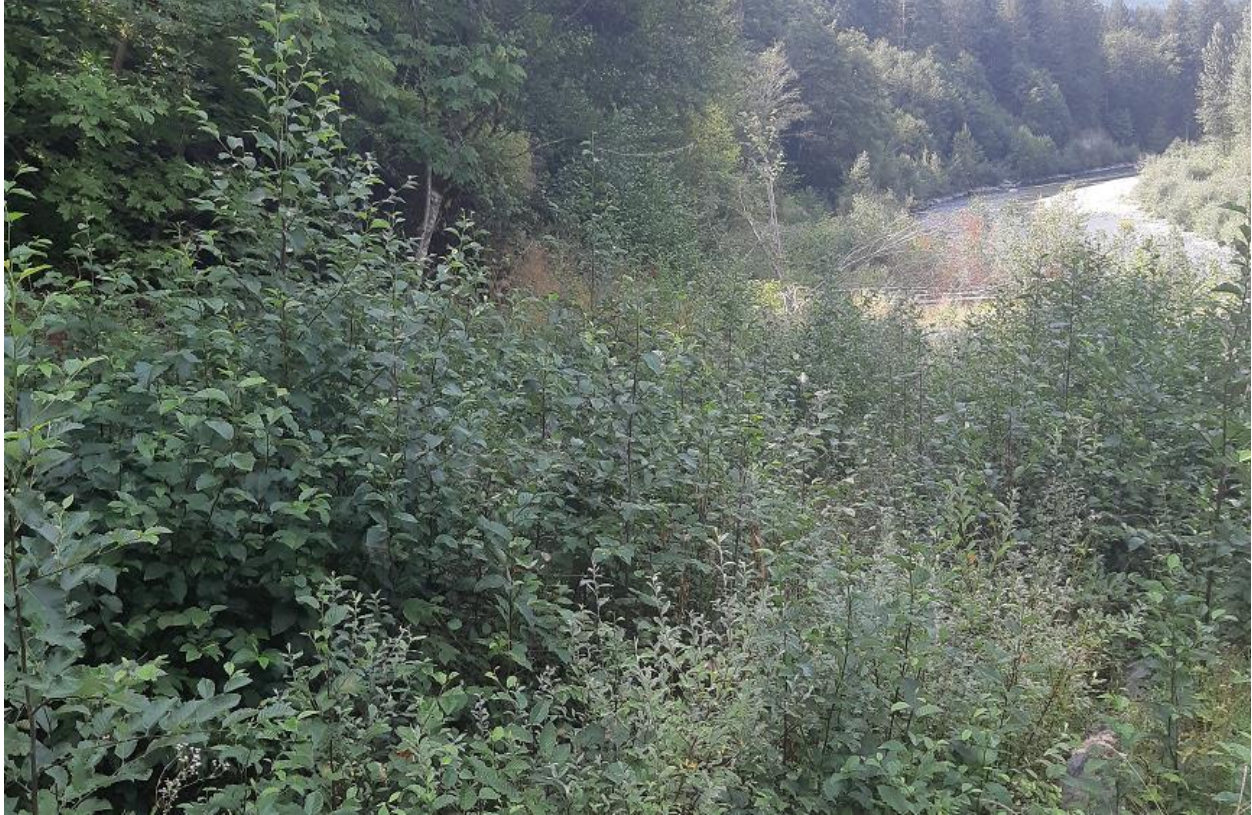
Figure 4. Site shown in figure 5 after one summer's growth (July 2020)
