**Kuthai Lake access improvement project
2017 Final Report**

March 31st, 2018

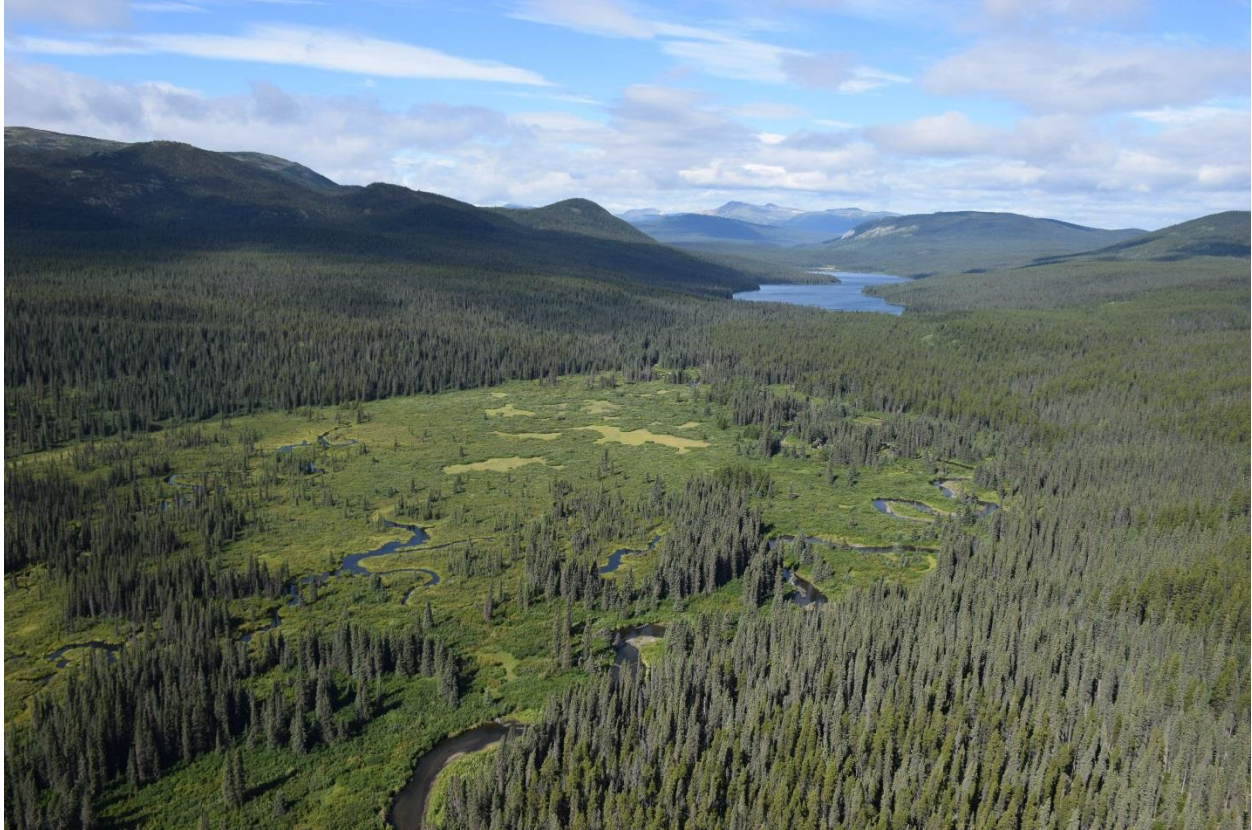
Photo 1: The view looking northwest toward Kuthai Lake. Silver Salmon River can be seen in the foreground meandering across the wide alluvial plain of the glacial paleo-channel that underlies the valley bottom. The alluvium of the paleo-channel has high potential for groundwater aquifers that likely give the Silver Salmon River a stable flow regime and high groundwater ratio.

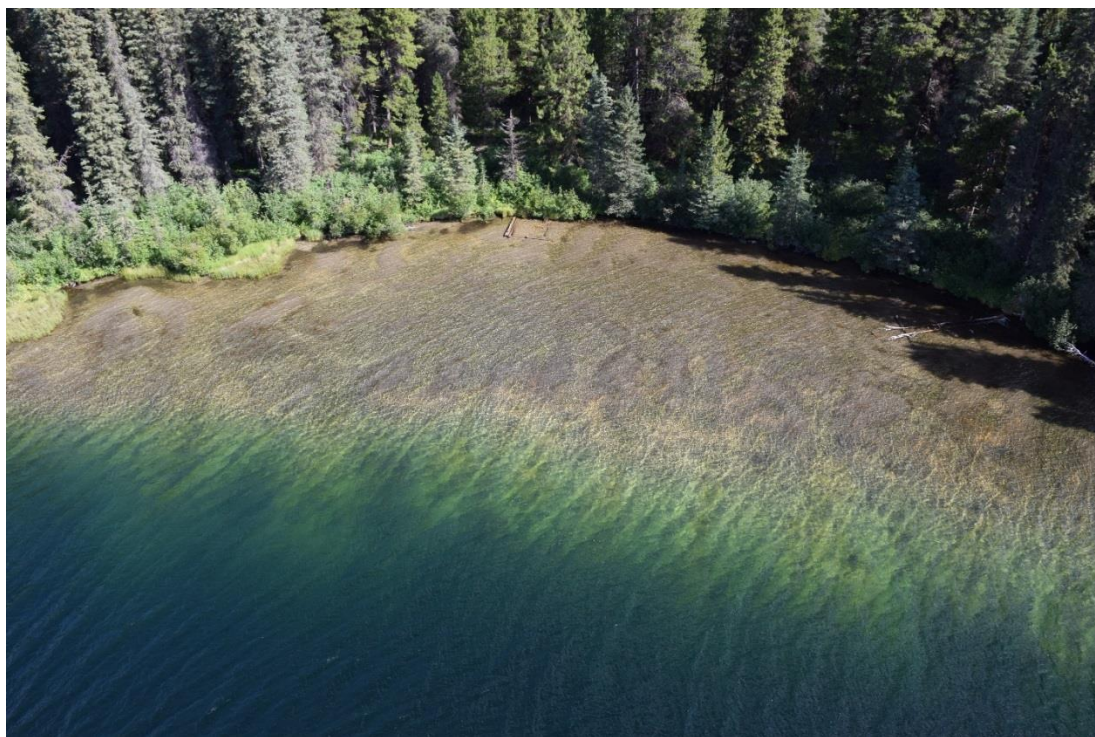
Photo 3: Glacio-fluvial deposit on the eastern shore of Kuthai Lake that supports sockeye spawning (July 2016). Note the partially dewatered spawning dunes near the shoreline.

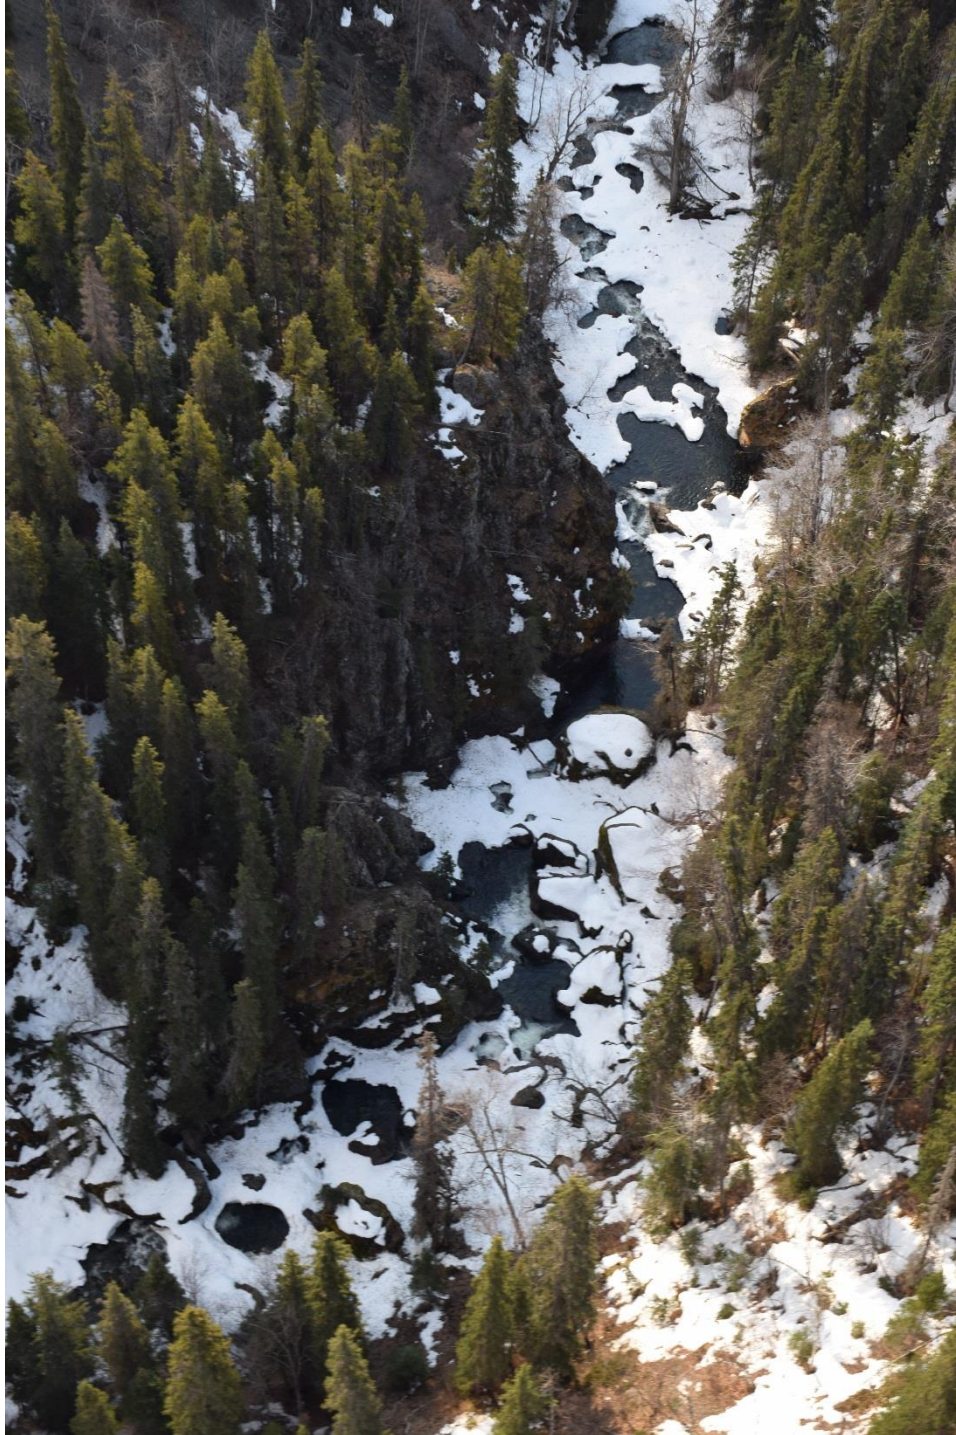
Photo 4: Ice cover in the upper canyon sub-reach (SR3) at the time of the site visit on April 9th, 2018.

Conducting field assessments in April was instructive as it allowed the assessment of the nature of instream ice in terms of total depth and percent cover. Ice cover was extensive across the active channel with an estimated 60% coverage at the time of the site visit.

Ice cover was well anchored to instream boulders and banks but also included shelf ice and bridging over pools and steps. Ice formation appears dynamic as there were numerous places where there were internal voids and overflow / through-flow paths and glaciating indicating lateral flow shifts and ice damming. This is not surprising given the cold microclimate in the canyon due to cold air ponding from the plateau and the shading of the canyon walls (even in the summer there is little direct solar insolation).

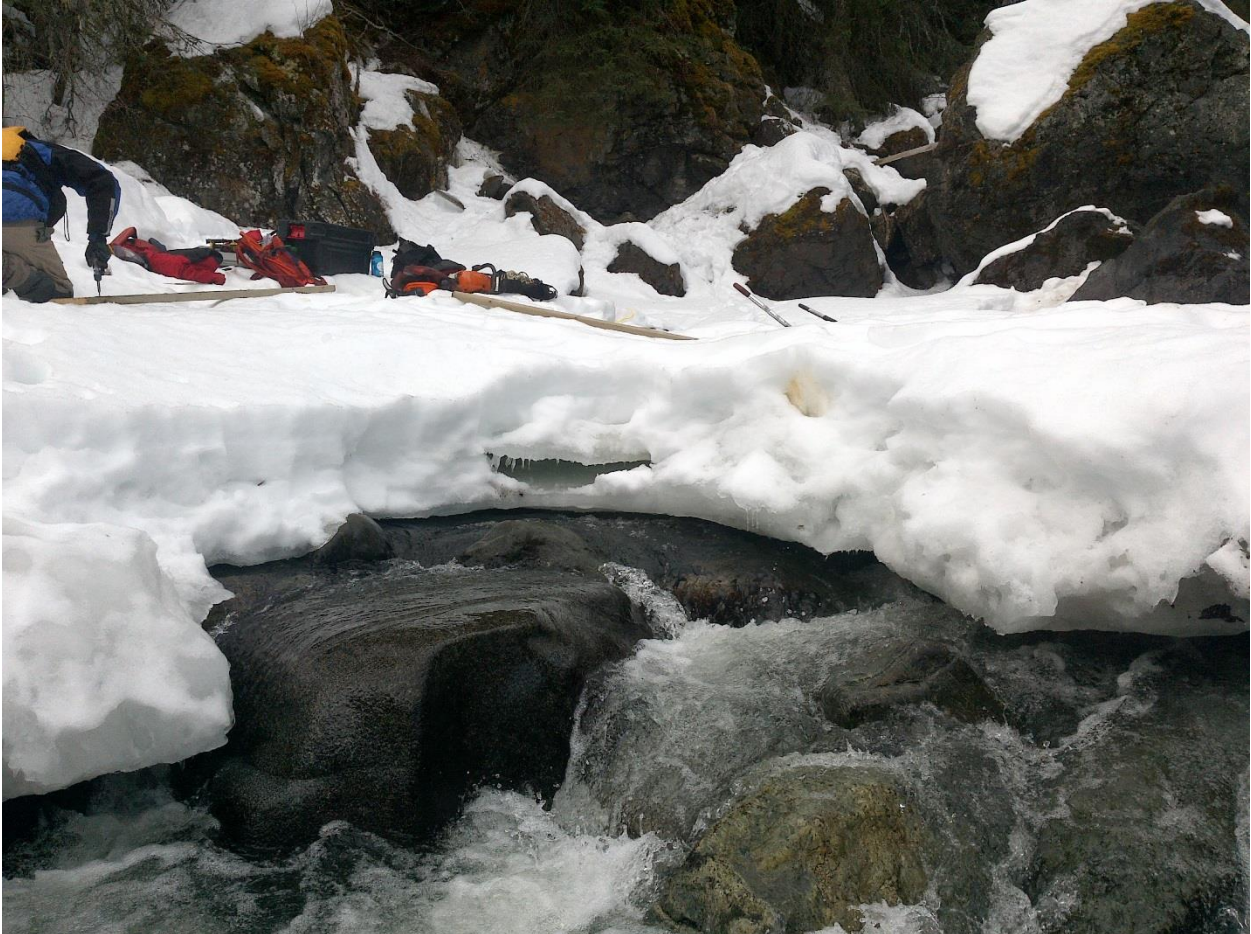
Photo 5: Ice profile at SR1-1 (the confluence pool) showing abandoned internal flow structure suggesting complex ice dynamics and flow paths.

The cold micro-climate combined with the high vapor pressure and spray associated with turbulence and strong base-flows in the winter leads to thick ice accumulations that persist into the freshet period. It is assumed that very cold air temperatures combined with high base flows from the lake and wetland aquifers on the plateau results in frazil ice accumulations that contribute to icing and backwatering in the canyon. Photo 5 (below) was taken during the spring site visit and includes an internal void (in the

center of the photo) indicating internal flow paths indicating a dynamic ice formation process. The issue of dynamic ice formation and high levels of ice formation is relevant to this project as it speaks to the viability of installing a fabricated aluminum steep-pass structure versus a rock notch style of steep-pass. The high degree of ice formation and its persistence raises some risks around the fabricated aluminum structure as it may indicate a higher risk of ice damage that is not likely in the case of a rock cut steep-pass.

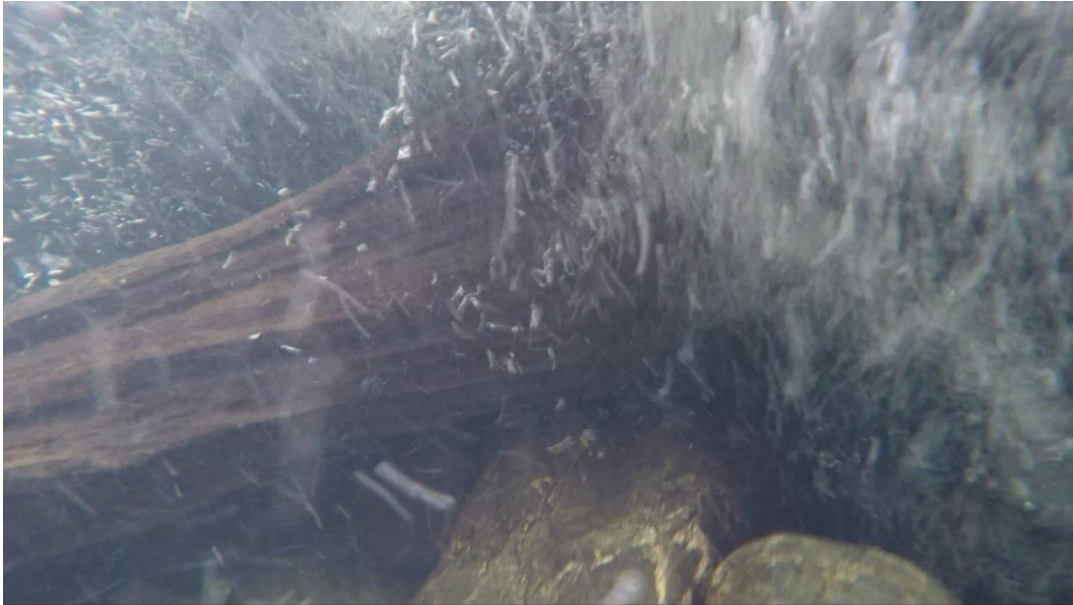
Photo 6: Underwater view of a LWD piece lodged at the transition between the cascade and pool in site SR1-1.

Migration period monitoring in 2016 indicated a backlog of sockeye in the pool at the first challenge at site SR1-1. Underwater video and aerial observation indicated that there was a single piece of LWD obstructing the staging pool at this location that was degrading the passage (See photos 6 and 7 below). This LWD piece was cut during the 2017 spring site visit. The piece was eventually blown out during high flows later in the freshet period

A similar scenario has played out in the confluence pool at Silver Salmon (SR1-1) where a single piece of LWD had lodged in the cascade to pool transition and was accumulating small woody debris that resulted in passage delays and sockeye that eventually backed out and wasted in the main stem.

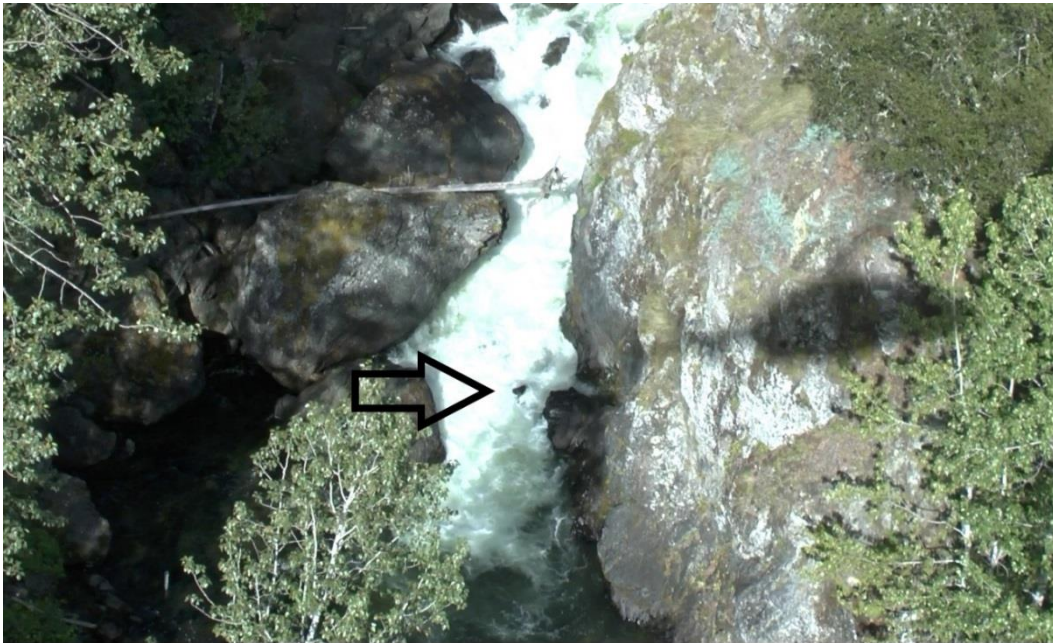
Photo 7: Aerial view of LWD piece at the transition point of the pool at SR1-1 (July 2016).

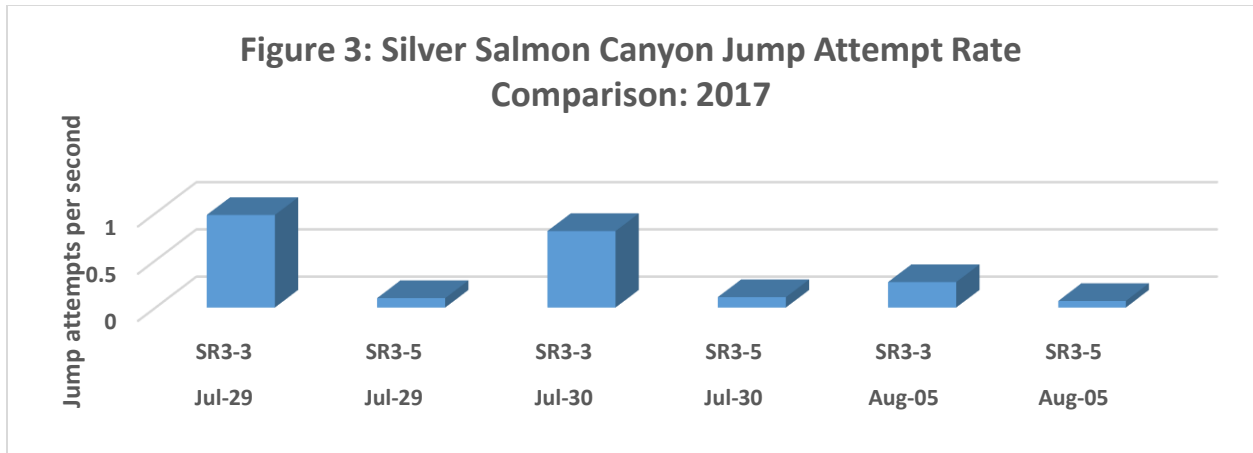
Figure 3: A comparison of jump attempt rates at SR3-3 and SR3-5 that shows the passage of sockeye during the migration period in 2017.

The objective of the jump rate monitoring is to estimate the passage difficulty posed by the two SR3 challenge locations being monitored (SR3-3 and SR3-5) Figure 3 (below) suggests that the largest number of fish (highest jump rate) were located below site SR3-3 throughout the monitoring period. From this we deduce that SR3-3 is the least passable challenge in this series of upper canyon steps. It is not possible to say definitively how many of these jump attempts were successful as some of the fish disappear into the turbulence after attempting to jump and there are likely interstitial paths that are not readily observable. Of the jump attempts observed at SR3-3 none were confirmed successes and the majority were confirmed failures. The jump attempt observations at SR3-5 included several confirmed successful attempts. Figure 3 shows that during the monitoring period the pool at SR3-3 is holding the most fish and it takes a week for the numbers to drop. During that period the numbers of fish holding above (SR3-5) does not increase indicating that fish are navigating SR3-5 more easily. It is interesting to note that the total sockeye escapement to Kuthai Lake for 2017 was 299 individuals. Given that the jump attempt rate at SR3-3 showed an average attempt rate of about 1 per second for the July monitoring (July 29th and 30th) that translates to a cycle rate (time between jump attempts for an individual fish), assuming the entire 300 fish (the 2017 total escapement) was in the pool below SR3-3, of about 1 jump every 5 minutes. This seems unlikely given the fact that the jump attempt monitoring showed fish attempting the obstacle at SR3-3 for a number of days. Energetically this would be unsustainable as it doesn't leave much time for recovery. More likely is that there were many more fish holding in the pool below SR3-3 and that mortality at SR3 is quite high. Using an average cycle rate of 10 minutes this translates to an estimated 600 fish holding below SR3 which suggests a 50% mortality between the upper reach of the Silver Salmon canyon and Kuthai Lake.

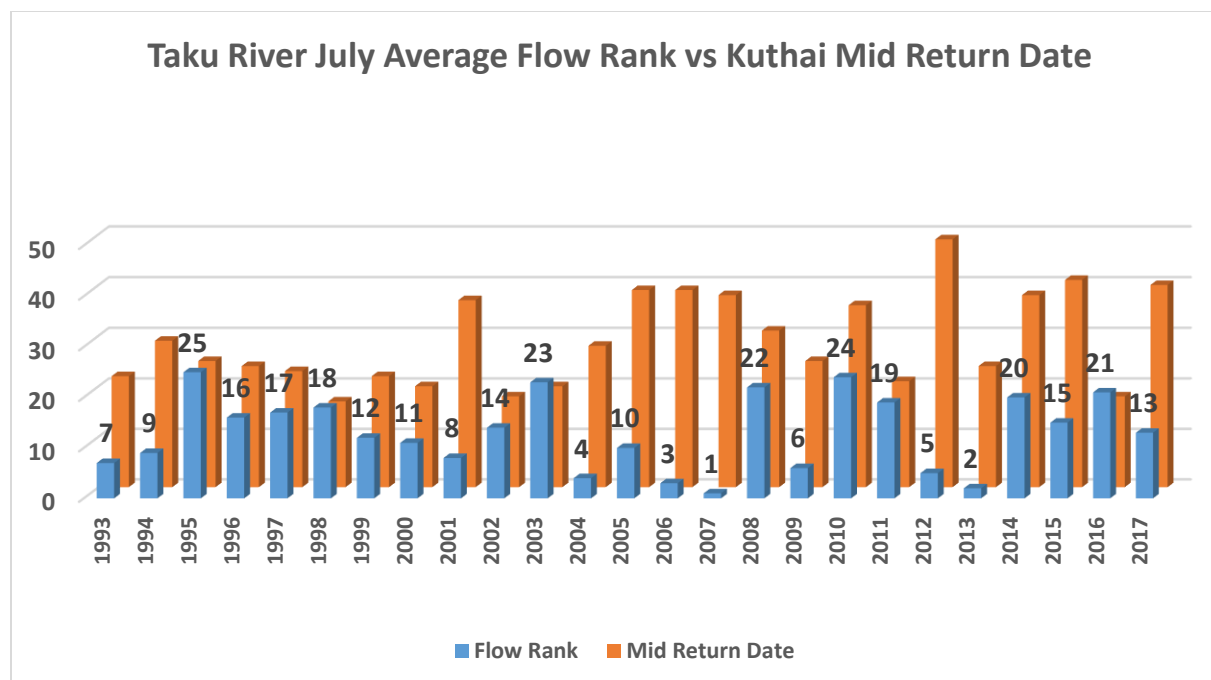
Figure 5: A plot of Taku River July mean flow rank vs the mid-return date (days after July 1st required to pass 50% of the annual escapement) past the weir at Kuthai. Mean monthly flows are ranked from largest to smallest so the shortest orange columns represent the largest July flows. Data labels are the July Average flow ranks.

Figure 5 shows that there is an increase in the "mid return date" of total escapement to Kuthai Lake from the 2004 run year to 2017. The "mid return date" has increased by 10 days (from July 23rd to Aug 2nd) since 2004 suggesting that there is an average migration delay that started in 2004 and has persisted ever since. Averaging the July average monthly flow rankings over the two periods (before and after 2004) indicates that the period 1993 to 2003 had an average flow ranking of 14.5 versus 11.8 since 2004. The highest July flow rates in the series have occurred since 2004 and in particular during 2005, 2006 and 2007 (the #1 ranked flow).

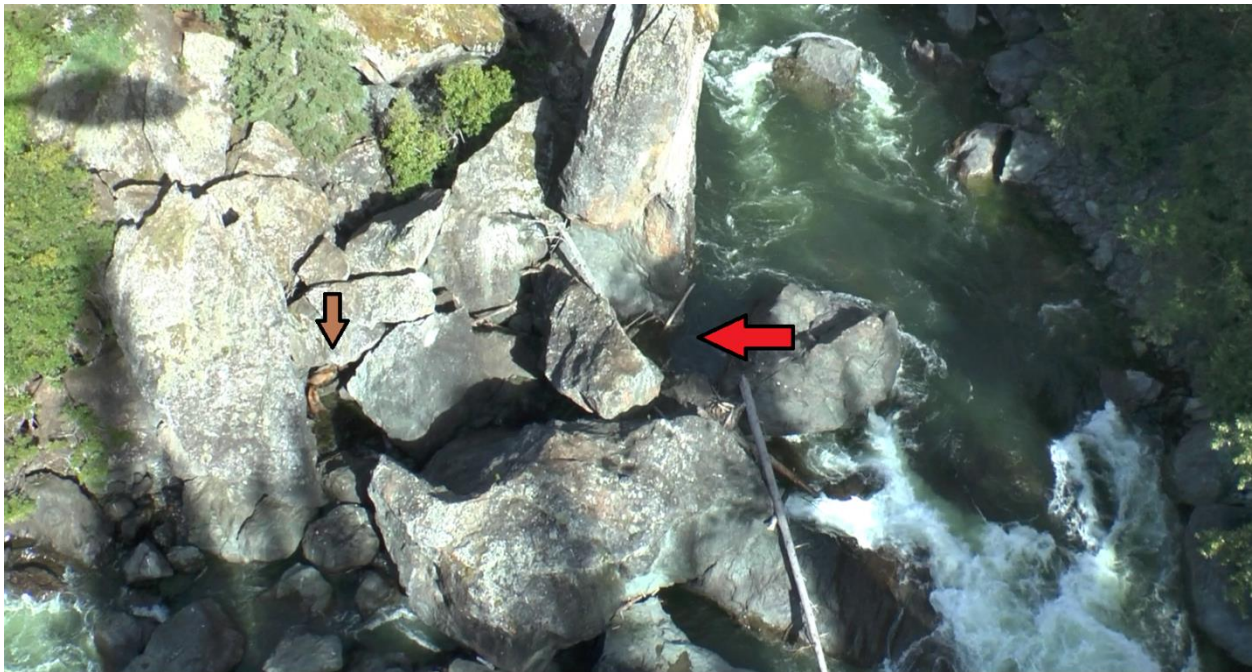
Photo 8: An overhead view of Village Falls downstream of the confluence with Silver Salmon River. The red arrow indicates the head of one of the “sneaker channels” that allow for high flow passage around the main steps of the falls. The brown arrow shows 2 Grizzlies fishing in the boulder pile in July 2017. Also visible is a strand line of large and small woody debris at the head of the by-pass channels.

can be transported long distances before becoming re-lodged at channel obstructions or constrictions. Several kilometers downstream from the confluence of the Silver Salmon and Nakina Rivers is Village Falls, a stepped rock boulder cascade channel constriction that has a number of flow paths through the boulder pile that offer bypass routes around the falls. These boulder pile by-pass flow paths (“sneaker channels”) offer migrating salmonids the opportunity to navigate the falls without ascending the main flow cascade. The boulder pile also has a high woody debris capture efficiency by virtue of its many protruding boulders and right angle planform turns. Small woody debris “strand lines” of floated and re-deposited material are reliable field indicators of peak flows as they represent the maximum elevation of the water surface in the year they were formed. In the case of Village Falls a strand line of large and small woody debris is evident at the head of the boulder pile sneaker channels that is likely obstructing passage. The fact that there were bears in the boulder pile fishing at the time of the photo indicates that sockeye were attempting to by-pass the falls during the 2017 migration window. The obstruction was clearly significant as there were a large number of sockeye and some Chinook holding below the falls.

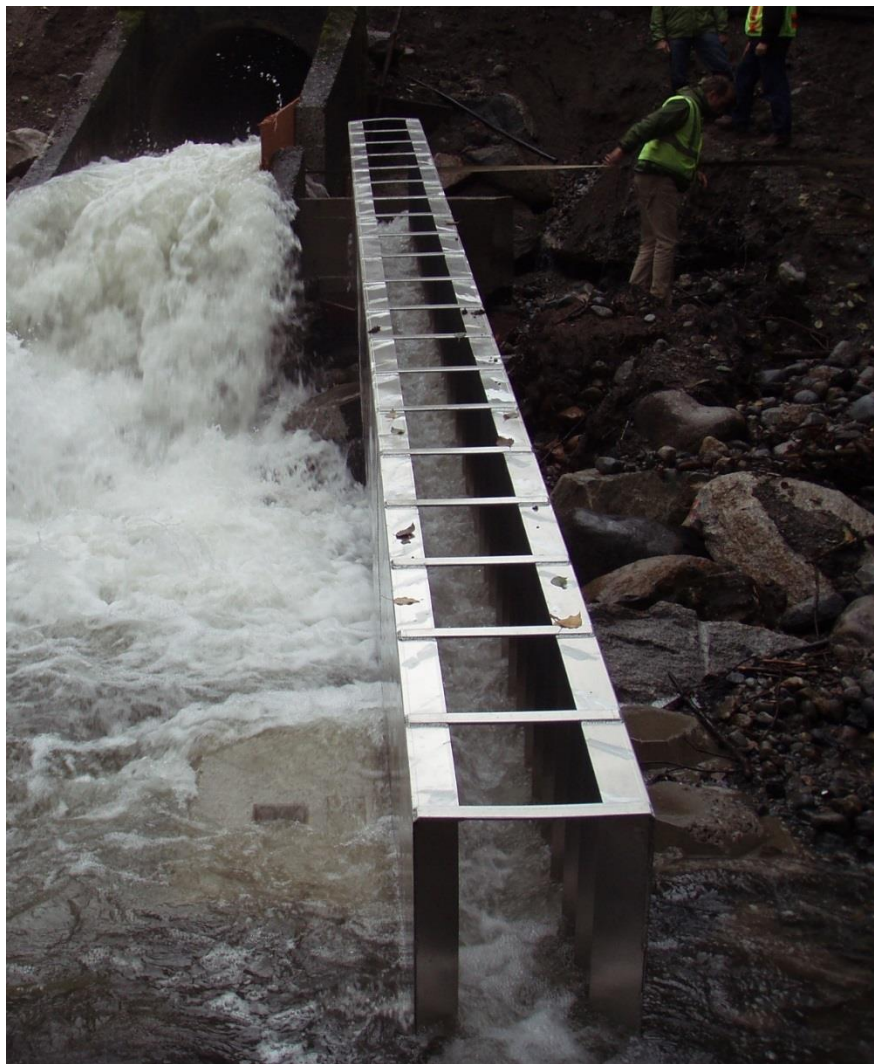
Photo 9: An example of an Alaska Steeppass structure.

Two alternative styles of by-pass have been considered as mitigation options, 1) a welded aluminum “Alaska Steeppass (SP)” style structure (Photo 9, below), and 2) a rock notch (RN) bypass (Photo 10, below) cut into the native bedrock. As can be seen from the example in Photo 9, the Alaska Steeppass structure is (usually) an aluminum structure that is fabricated off site and would need to be flown in by helicopter after being trucked from the Lower Mainland. This is essentially a closed structure where fish swim into the outlet and navigate up the baffled section to the inlet.

The Steeppass can be width and gradient sized to accommodate any species although accommodating larger species (like Chinook) would scale the overall structure upwards with a commensurate increase in fabrication and deployment cost. The top and bottom of the Alaska structure would need to span from pool to pool to allow for acceptable entrance and exit velocities which makes it more vulnerable to icing.

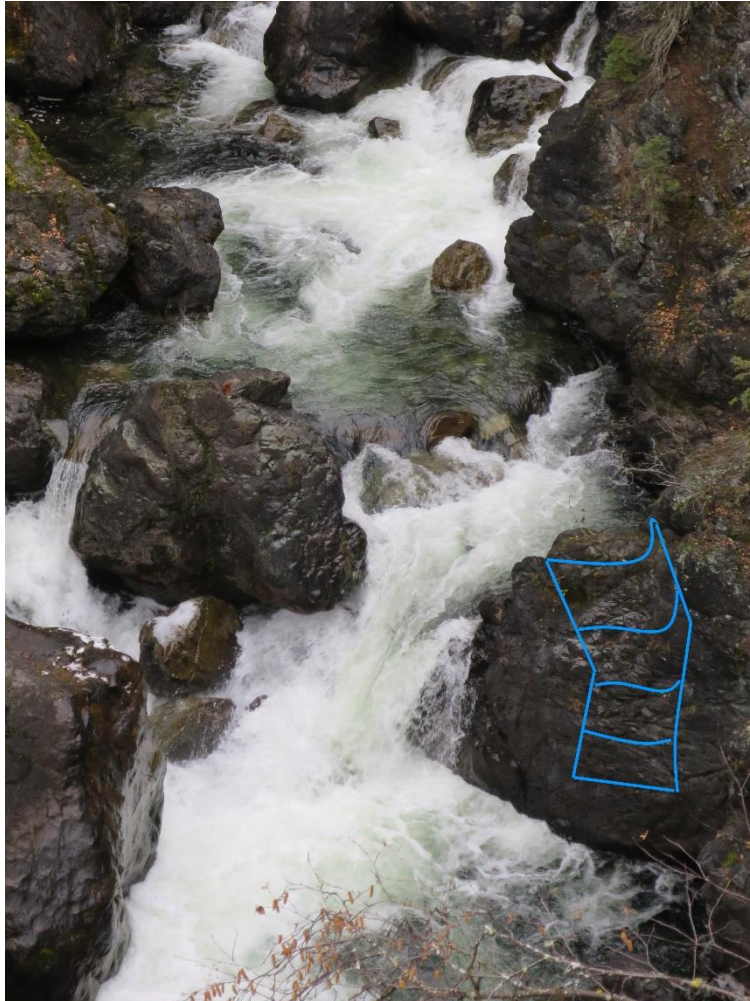
Photo 10: A conceptual design configuration for the rock notch design option.

The second option is a Rock Notch bypass where a design notch is cut into the native bedrock to create a bypass channel. This design is based on an analog similar to the natural “sneaker channels” found elsewhere in the canyon. The notch is designed to have an appropriate hydraulic geometry for the site insofar as it is matched to the swimming abilities of the target species. Unlike the Alaska Steeppass, the notch does not have to fully span from pool to pool it just needs to have an entry channel that reduces the total jump height and a “landing pad” that is elevated above the lower pool residual elevation. Fish passage enhancement is achieved by reducing the total jump height and improving the hydraulics for better swimming performance. The “landing pad” is a widening in the bottom of the notch with a trapezoidal cross section that allows easy jump access. It is designed to be deeper on one side than the other which will allow jumping migrants to find it and be directed to the deeper side for good hydraulic purchase and swimming performance.

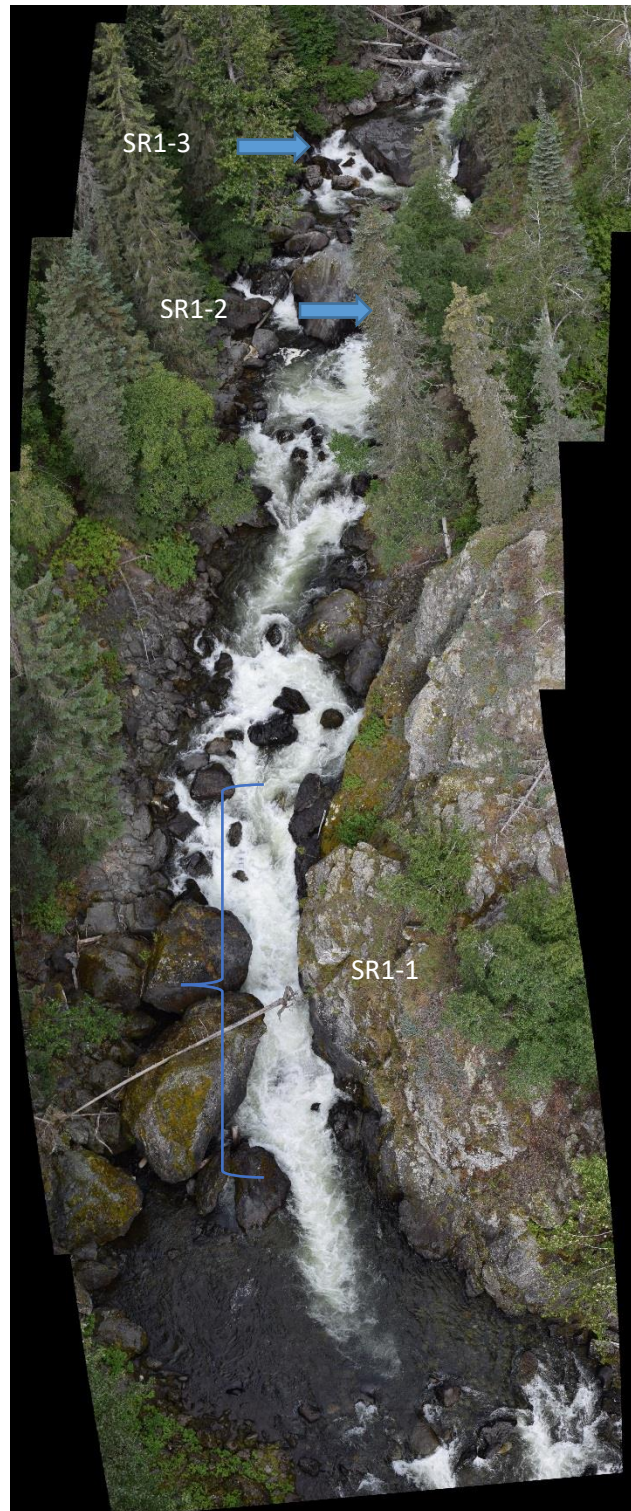
Photo A1: The three passage obstructions in the lower Silver Salmon canyon. Picture date July 2016.

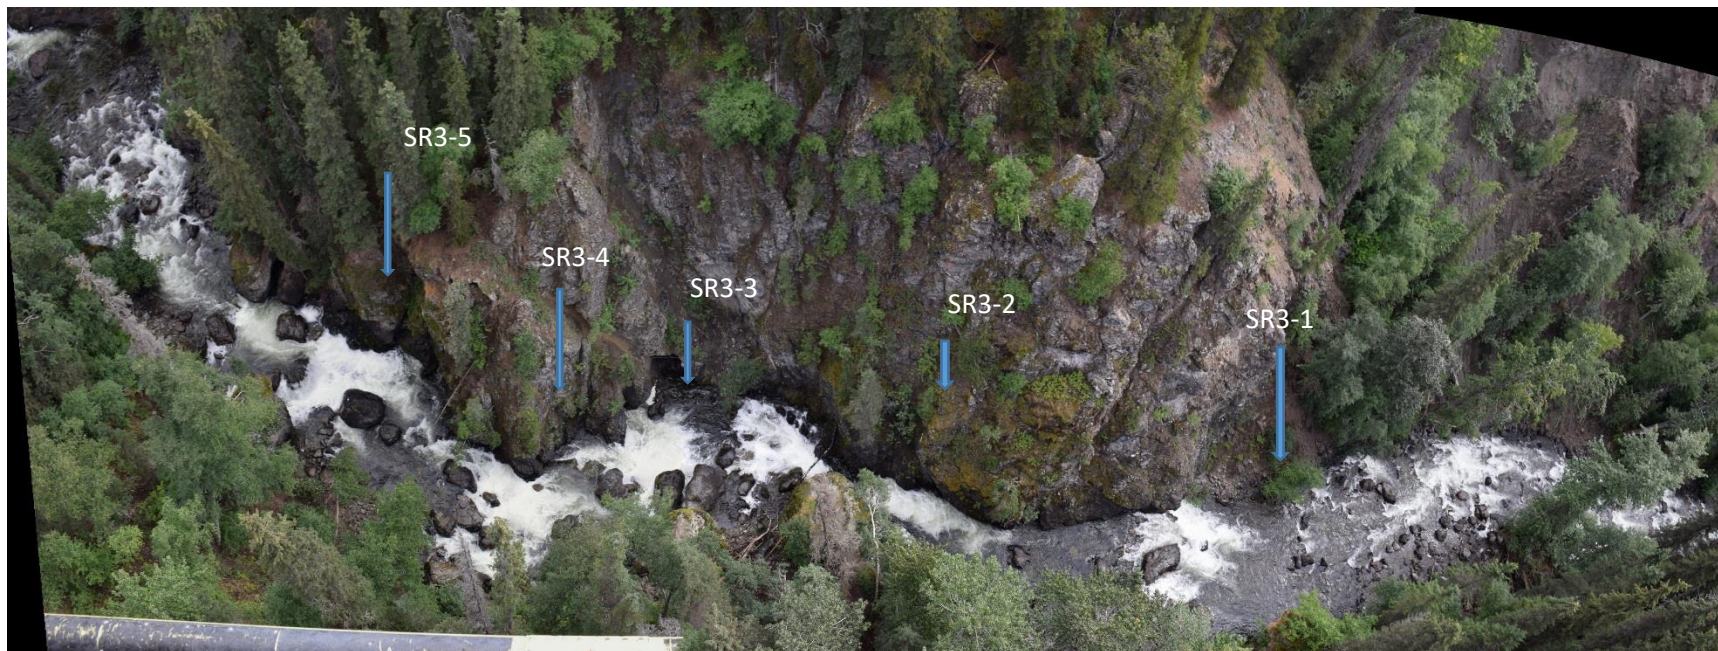
Photo A2: The upper Silver Salmon canyon obstacles. Photo date July 2016.
