# **Kuthai Lake Access Improvement Assessment - 2016**

March, 2017

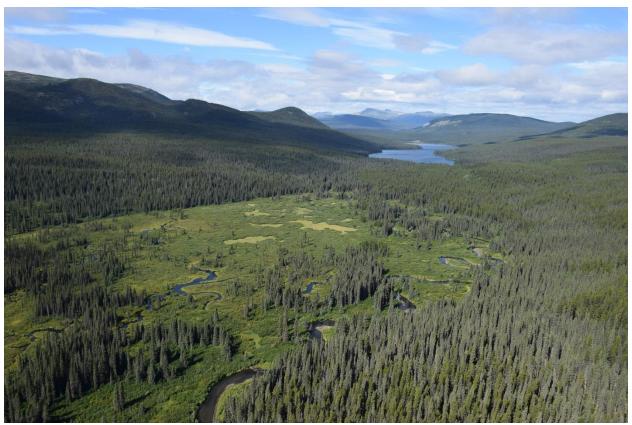
Photo 1: The view looking northwest toward Kuthai Lake. Silver Salmon River can be seen in the foreground meandering across the wide alluvial plain of the glacial paleo-channel that underlies the valley bottom. The alluvium of the paleo-channel has high potential for groundwater aquifers that likely give the Silver Salmon River a stable flow regime and high groundwater ratio.

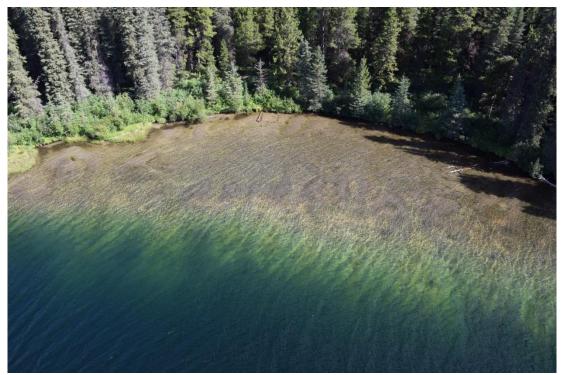
Photo 3: Glacio-fluvial deposit on the eastern shore of Kuthai Lake that supports sockeye spawning (July 2016). Note the partially dewatered spawning dunes near the shoreline.

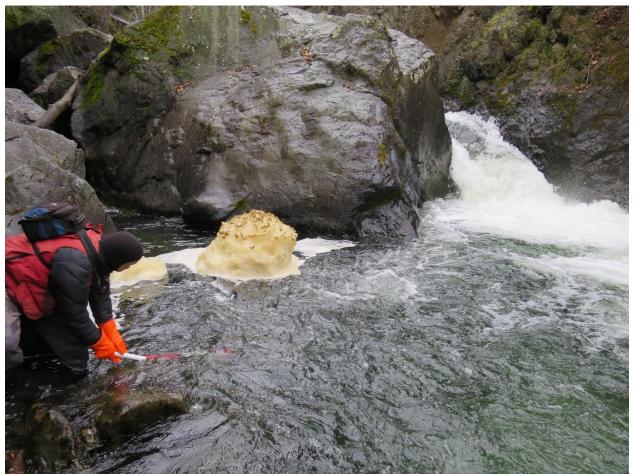
Photo 4: Underwater pole photography at the "Foam Pool" during the fall 2016 assessment.

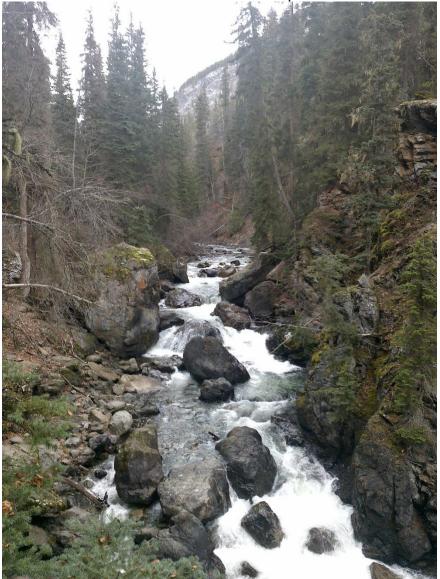
**SR-3:** This is the uppermost 100 meters of the assessed reach. The reach has an approximate gradient of 12% and an active channel width of approximately 8 meters. There are 5 rated obstructions in the reach. SR-3 is confined between a bedrock wall on river left and large boulder clusters, colluvium and bedrock outcrops on river right. Above this reach the channel gradient drops and the channel form transitions to alluvial pool-riffle.

Photo 12: The top end of SR-3, in the upper Silver Salmon canyon.
