South Thompson Streambank Restoration

INTRODUCTION

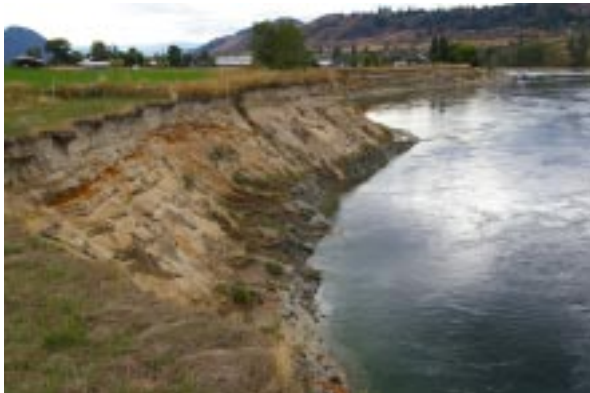
On the South Thompson River immediately below the outlet of Little Shuswap Lake a one Kilometer stretch of the river bank was being actively eroded as a result of wave action from boat activity undermining the river bank.

Bank View showing boat wakes

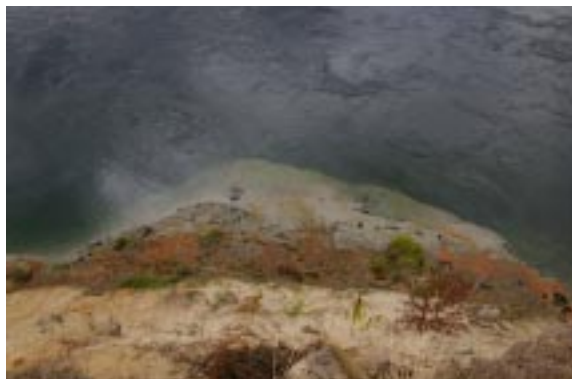
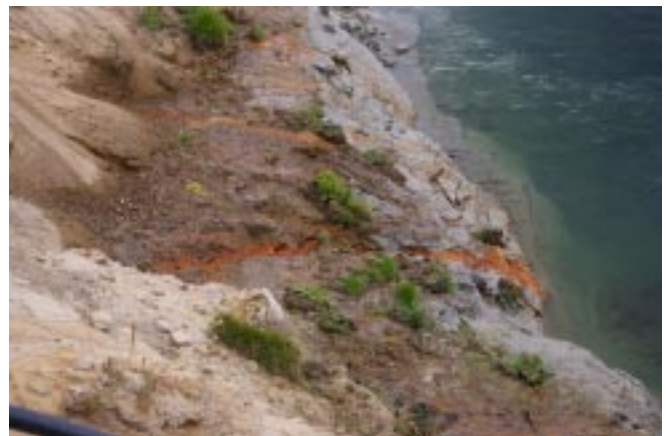
A combination of boat activity causing wave erosion, natural soil stratification consisting of layers of silt and adjoining layers of clay, and high stream banks composed of fine silty material has caused large sections of the bank to become unstable and fall into the river. The deposited silty material has been identified as an impediment to Chinook juvenile survival rates in terms of egg to fry survival.

Blue Clay toe in river

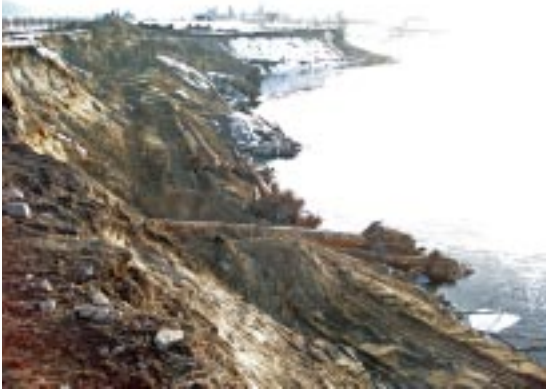
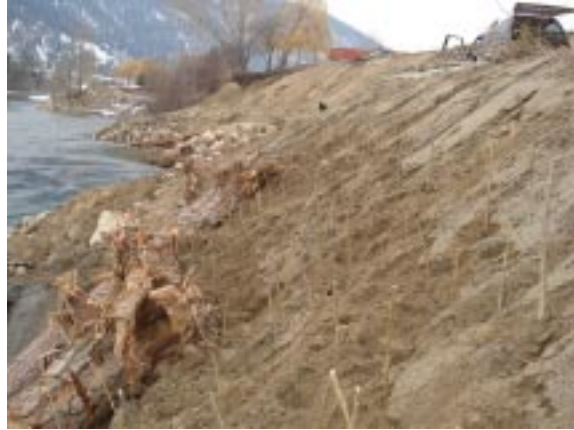
The uplands are also subjected to irrigation, in season, and, because of this, it is suspected that an excess of groundwater makes its way to the South Thompson. The Village of Chase also operates a ground injection process to dispose of their sewage and it is suspected that this has the potential to increase the amount of fluids making their way to the river.

Ground water exiting bank

Extensive planting at the toe of the slope using quick growing and deep rooted species, such as one or more of several native varieties of willow or cottonwood. The suggested planting method is to use stakes that are a minimum of 1.5 to 2 m in length and 10 to 15 cm in diameter and drive them into the slope at 1 m intervals.

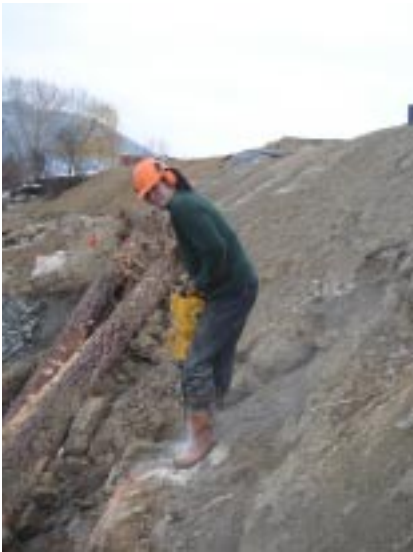
Cables holding logs were anchored to the bank

Dampening logs were placed between the groynes to slow the wave action from passing boats. These were anchored to the large rocks as well. The groynes were placed in areas that groundwater appeared to be concentrated and it was expected that this would serve to channel the excess water through the rock and lessen the collapse of the fine silty material.

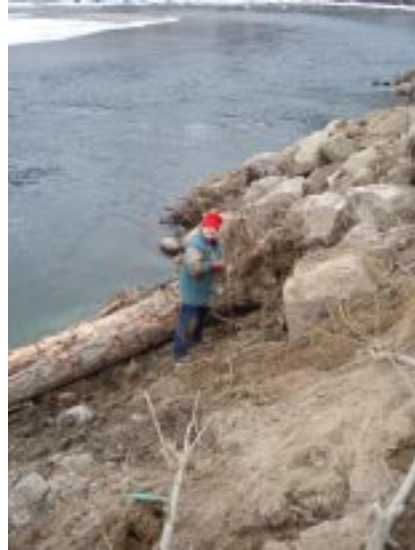
Hand planting of Willows and Aspen on Toe.

Mr. Park trimmed his existing trees and planted them along the bank. These trees were fast growing poplars from the BCFS Vernon Experimental nursery and have proven to be excellent in developing root systems to hold material together. This planting was also interspersed by planting of local willows and indigenous species of roses and other shrubs. This planting proved to be a temptation for the local beavers and an electric fence was installed to stop their advances. Seed selection for ground cover was done through Ducks Unlimited and their orchard mix was purchased from Purity Feeds. The seed was planted in April after frost was finished.

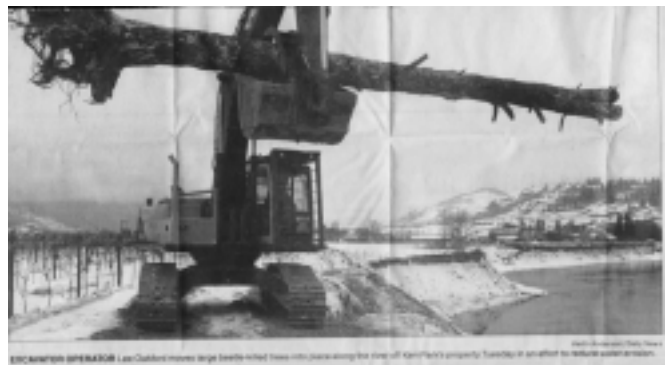
Placing Logs

Nine Groynes were constructed consisting of large pine root wads being placed in the riverbank and covered with the rock. All logs were anchored to the heavier rock and tree stems were incorporated into the bank itself. These were covered with finer material and planted with willow and poplar stems.

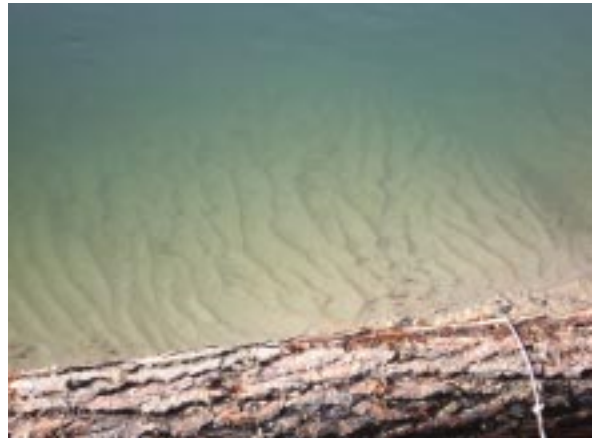
Early Success

Much of the work was completed by February and smaller tasks such as planting were forced to await warmer weather. This was completed by April and we awaited the freshette to determine if we needed additional effort. This proved to not be needed and the project is substantially completed.
